OAK PARK POLICE DEPARTMENT

SPACE NEEDS ASSESSMENT

November 25, 2019
FGM # 19-2639.01

Existing Condition Analysis

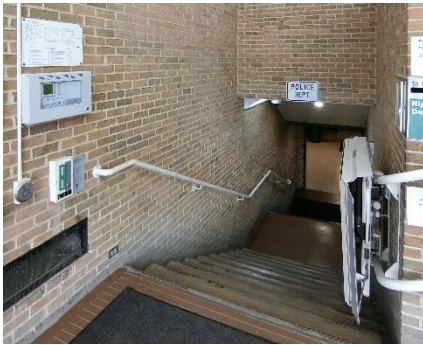
Non-functioning ADA chair lift

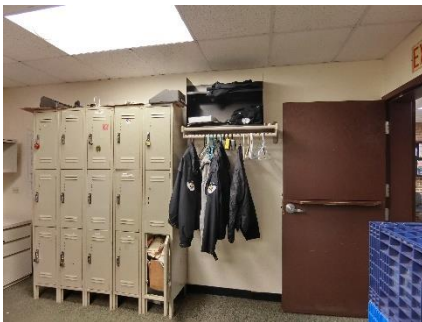
Non-compliant fire rated Dutch door at Parking Enforcement

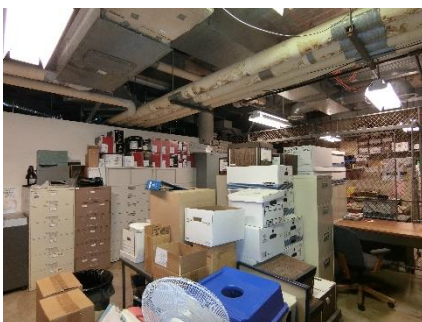
Non-compliant fire rated wall at record storage.

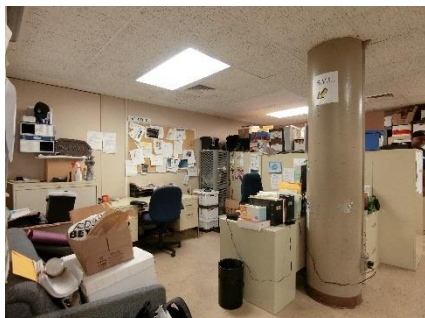
Cords dropped over furniture within Investigation Department

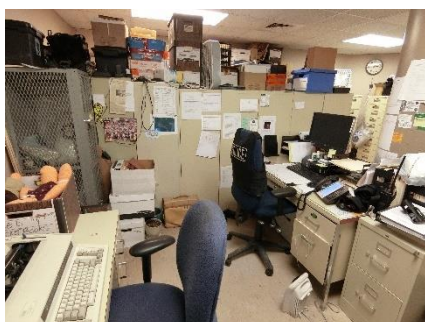
Boxes being stored too close to the ceiling

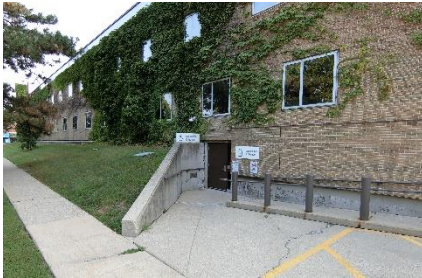
Lack of wayfinding to ADA ramp

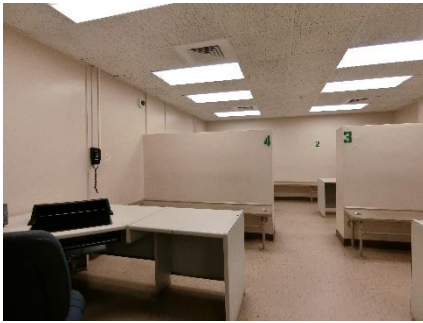
- The prisoner processing area is not secure and is remote from booking.
- The security glazing on the lock-up cell is damaged and cloudy making it difficult to monitor prisoners within.
- There is a water leak above the report room as witnessed by damaged ceiling tiles.

Unsecured prisoner processing area

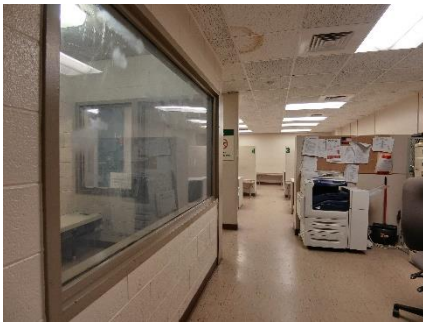
Security Glazing on lock up cell is damaged and cloudy

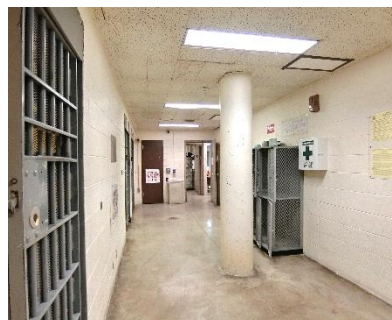
Damaged ceiling tiles within detention area

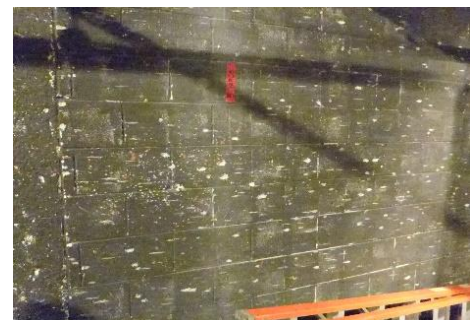
Unprotected CMU walls in Firing Range

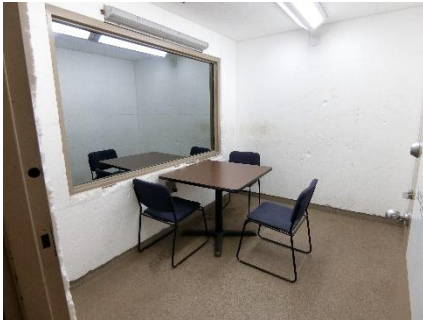
Damaged acoustical walls within interview rooms

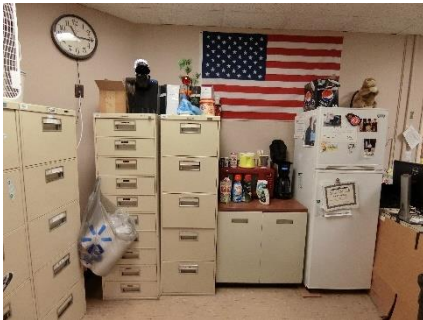
Lack of storage and break areas

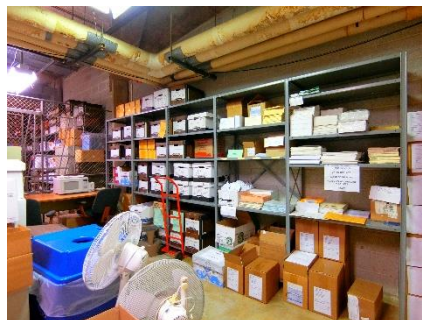
- There are several large pipes running above the main records storage area. The pipes show signs of previous water leaks.
- Within the records department the desks are located close together and do not allow for adequate circulation space throughout the department.
- The air circulation within the department is poor, several fans have been located throughout the space to help move the air.

Water damaged pipes above record storage

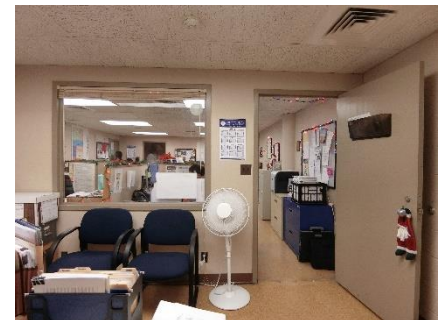
Insufficient air circulation

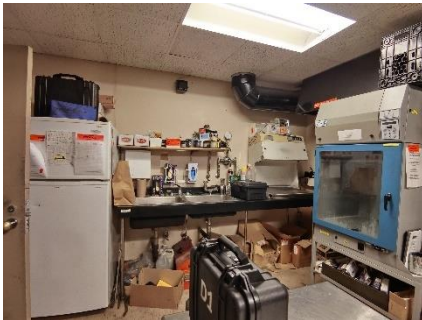
- Due to overcrowding, the evidence lockers cannot be located near the bag and tag area and have been put in the main corridor. This location is not recommended as it requires moving evidence through the main circulation corridor.
- The bag and tag area is currently being shared with the evidence processing lab. The space is too small and does not allow for proper layout, circulation or processing space. There is insufficient space for storage and an overcrowding of equipment. In order to perform a task several items need to be relocated in order to access the required equipment.

Evidence processing

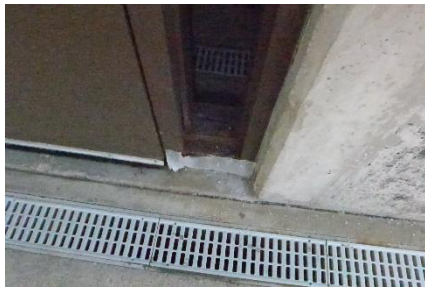
Steel door frame is corroding

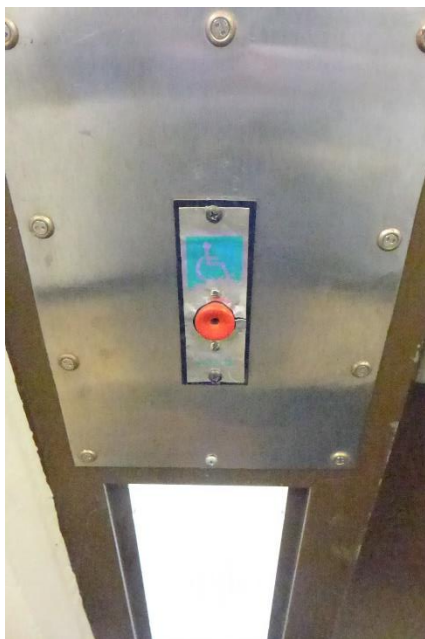
- The exterior elevator buttons are damaged.
- The elevator serving the police station is not designed for gurneys (stretcher size). While not a code requirement in Oak Park, a stretcher size elevator is recommended as they are safer for emergency response staff for moving the injured or sick and allow a person on a gurney to be moved without unnecessary trauma, for example, being shaken when carried up a stairway.

Damaged buttons at elevator

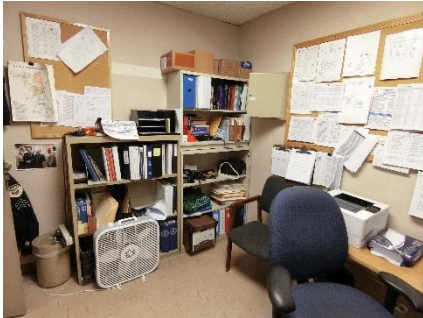
*Supplemental fans
located throughout
building to help circulate air*

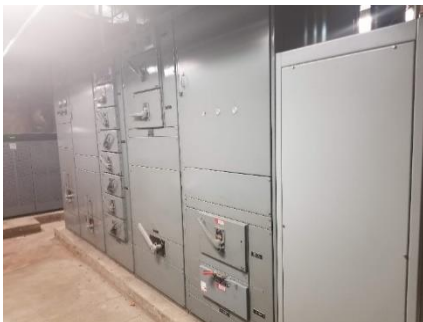
The main switchboard is original to the building and is a Square D manufactured assembly labeled with a rating of 2000 amps, 208 volts, three-phase, four-wire. There are two main disconnect switches provided, one 800 amp three-pole switch supplying the facility chiller equipment and one 1200 amp three-pole switch supplying the rest of the building power. Each additional vertical switchboard section is rated for 1200 amps which limits the largest feed the board can supply to 1200 amps. The switchboard is in fair condition. The switchboard, excluding the cooling load, has recently been re-worked to feed through a full building transfer switch at the end of the switchboard lineup.

Main electric service switchboard

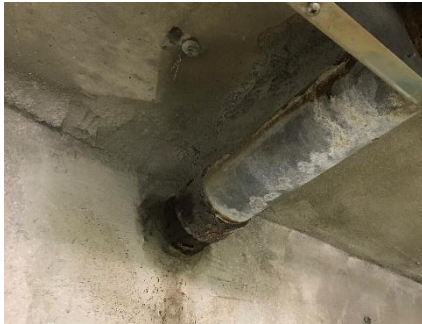
The branch circuitry associated with the panelboards was specified as thermoplastic covered copper and should be in fair condition given its current age. The conduit system is in poor condition in several locations. Of concern are the exterior, or covered, parking locations. The conduit and concrete has

Repaired conduit within garage

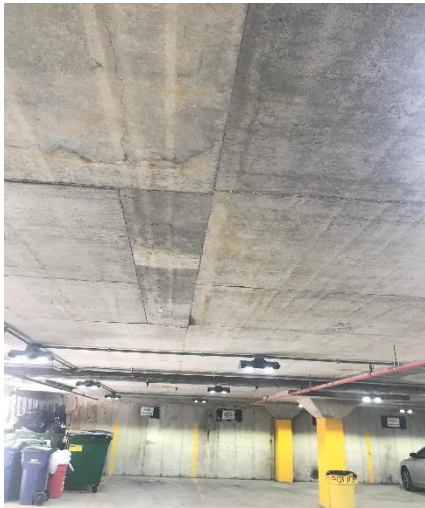
Repaired concrete deck at garage

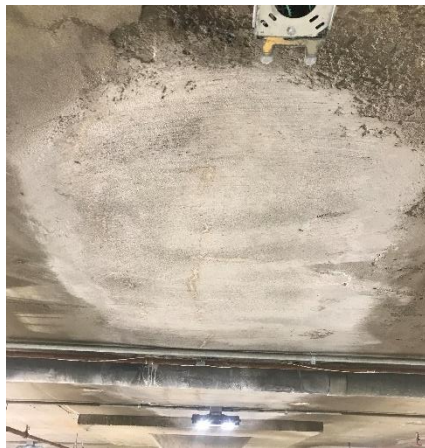
Area of patched concrete deck at garage

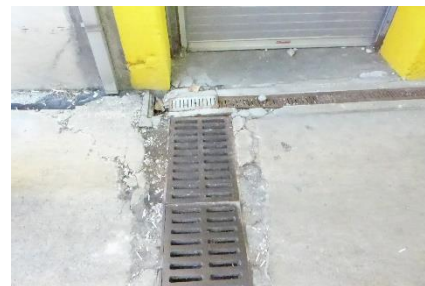
Broken concrete at trench drain

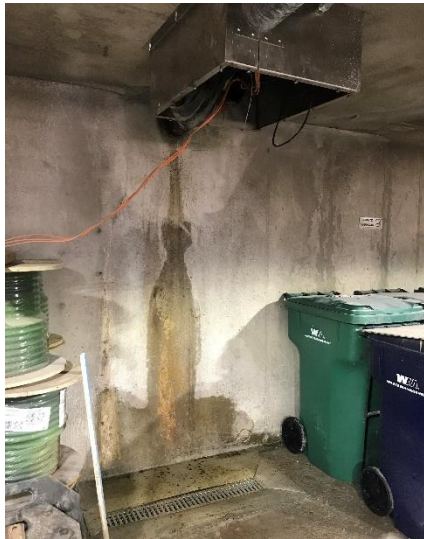
Within the building basement area utilized by the Police Department, the extent of visible structural concrete was limited. The areas with accessible concrete include building maintenance, storage, the sally port, the firing range, and the mechanical and generator rooms. Overall, the structure in these areas was in good condition. There is a small area of efflorescence visible in the slab above the sally port and a pipe penetration in the HVAC mechanical room shows significant leakage of ground water.

Water infiltration at pipe penetration

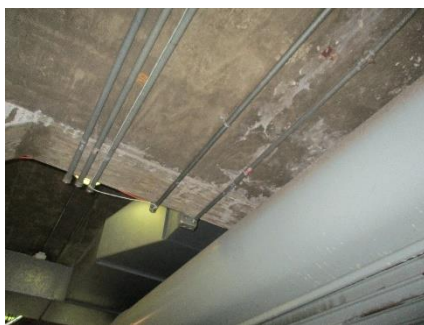
The condition of the basement structure of the building is in very good condition. The few items noted above are not structurally significant. The efflorescence is the result of water infiltration. It is not known if the water issue is still present. It is recommended that this location be monitored over time to check for water leakage. Preventing water infiltration will stop additional efflorescent from developing. No structural concerns exist currently. Within the HVAC room the leakage at the pipe penetration should be repaired in order to create a seal to prevent possible damage to the concrete.

Efflorescence in hall at Sally port

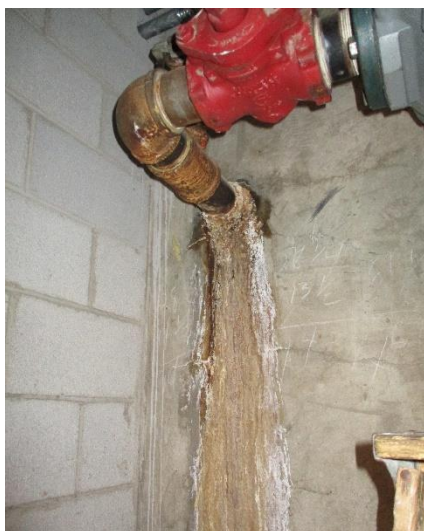
Water infiltration and corrosion at pipe in mechanical room
