## SOUTH TOWN DISTRICT SURVEY FINDINGS

May, 2010

# Survey Findings for the South Town District

School of the Art Institute  
Historic Preservation Program  
Professor Vincent L. Michael, PhD

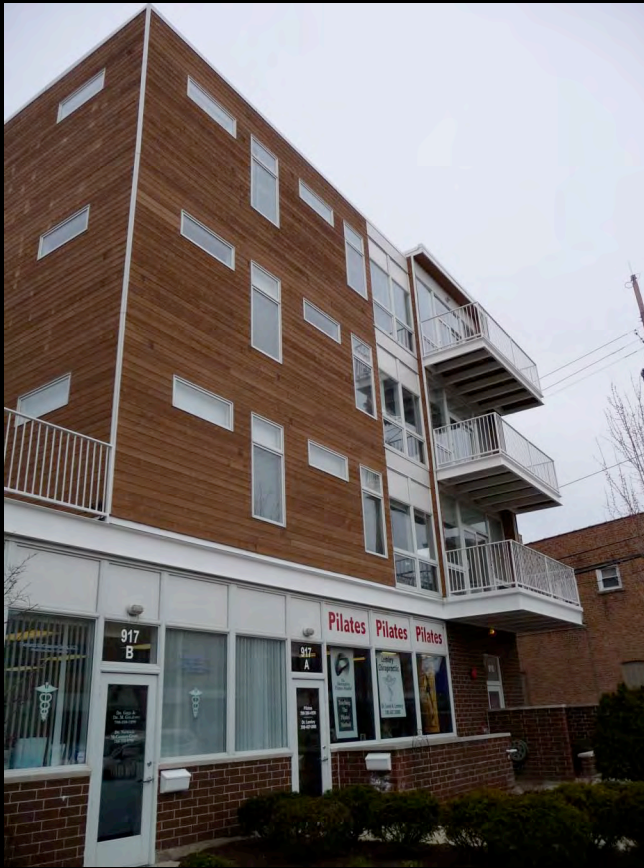
917 S. Oak Park

# No Merit: New Construction

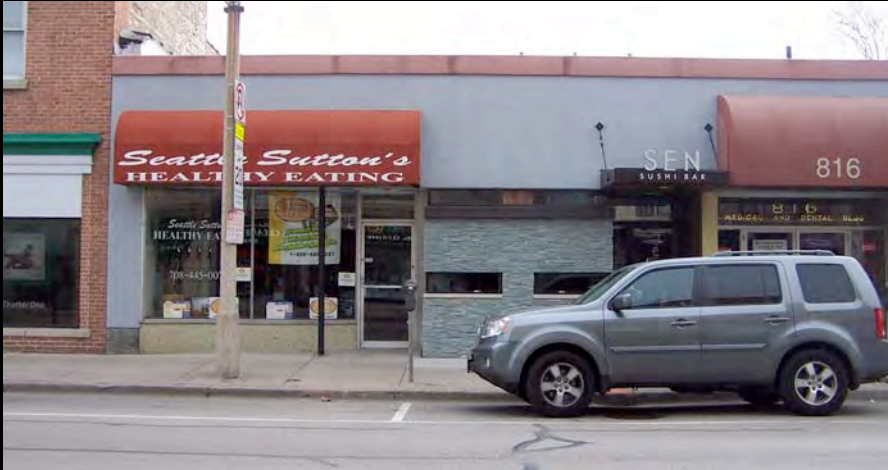
812-816 S. Oak Park

# No Merit: Altered or Infill

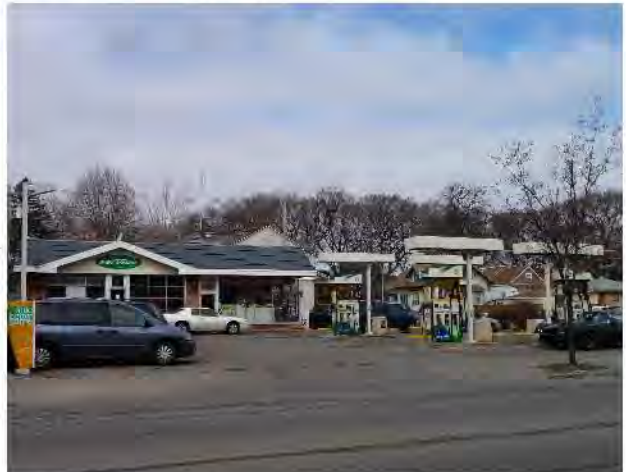
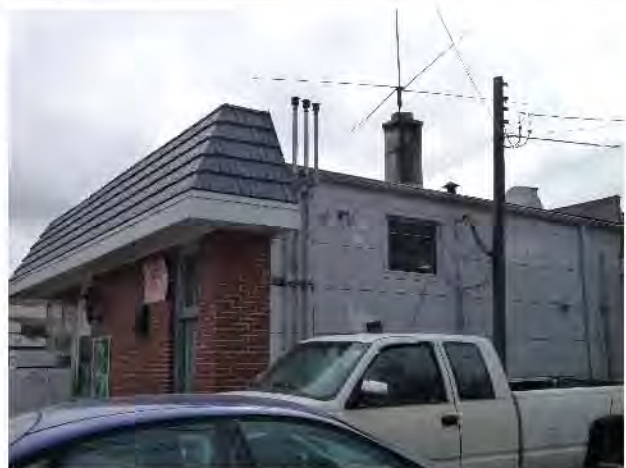
Address	801 S. Oak Park	Map ID Number	W21	PIN Number	
Significance	Merit				
Current Owner					
Current Use	Gas station

Small gas pump canopies, open corner window, and porcelain enamel panels remaining on rear facade.

Date or Approx. Decade	1948	Original or Prior Uses	
Architect		Gas station (Standard Oil)	
Contractor			
Original Owner	J.T. Hyde	Additions/Alterations	
Field Notes		Brick cladding, shingle mansard roof, signage.

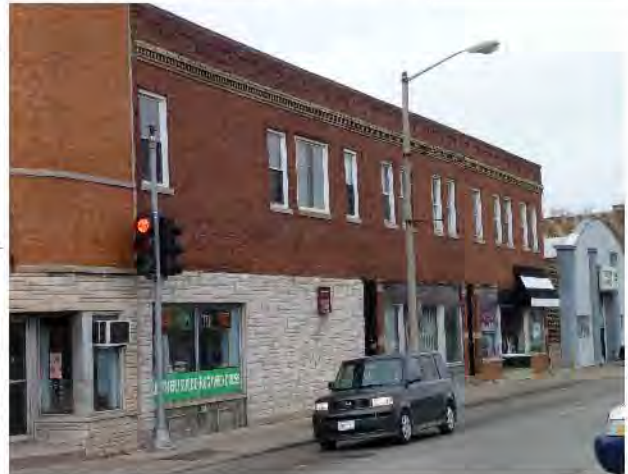
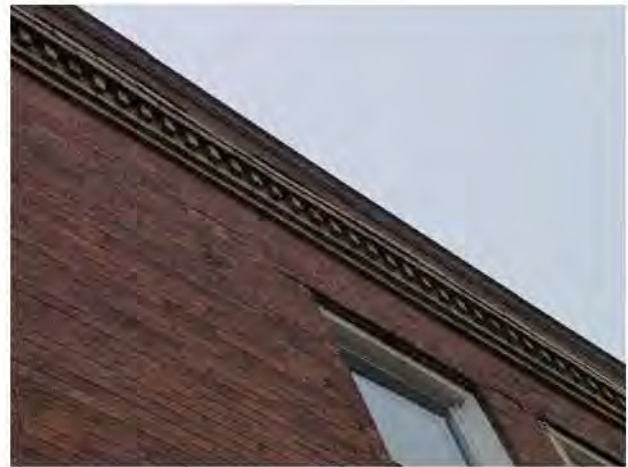
Front Orientation	N	Number of Stories	2
Style/Detailing	simplified neo-classical		
Wall Material(s)	brick		
	limestone		
Storefront	altered		
Other Windows	vinyl replacement		
Visible Roof Materials			
Overall Condition	fair

dentil molding at cornice

Date or Approx. Decade	1929	Original or Prior Uses	
Architect		Additions/Alterations	storefront, cladding, awning, and windows
Contractor			
Original Owner		History Notes

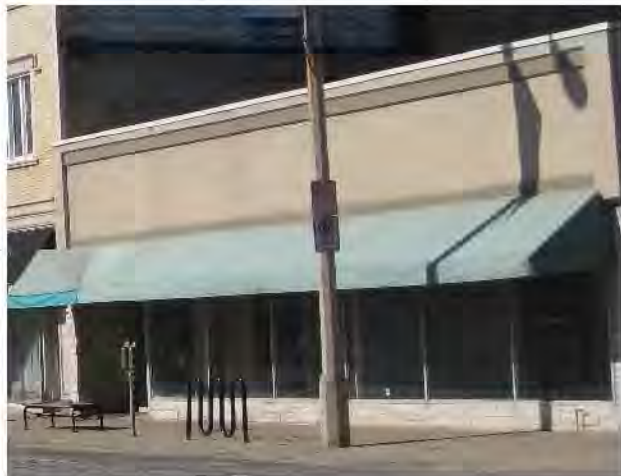
Address	809 - 811 S. Oak Park	Map ID Number	W20	PIN Number	
Significance	No merit				
Current Owner					
Current Use	vacant

Front Orientation	E	Number of Stories	1
Style/Detailing			
Wall Material(s)	dryvit		
	Lannon stone		
Storefront			
Other Windows			
Visible Roof Materials			
Overall Condition

Date or Approx. Decade		Original or Prior Uses	
Architect		Additions/Alterations	Cladding and awning
Contractor			
Original Owner

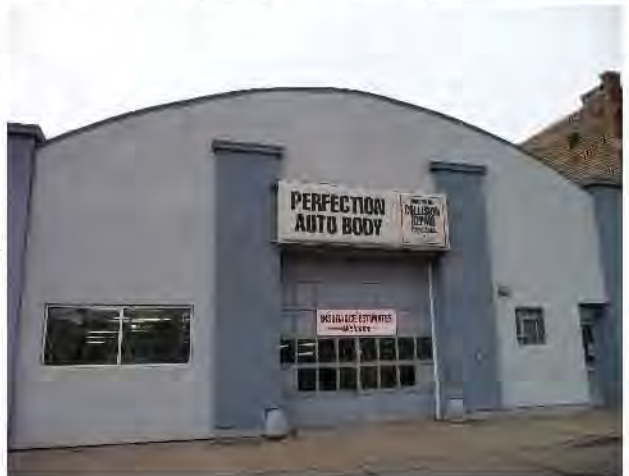
Address	811 Garfield	Map ID Number	W10	PIN Number	
Significance	No Merit				
Current Owner					
Current Use	Commercial

Date or Approx. Decade		Original or Prior Uses	
Architect		Additions/Alterations	Entire facade.
Contractor			
Original Owner		History Notes

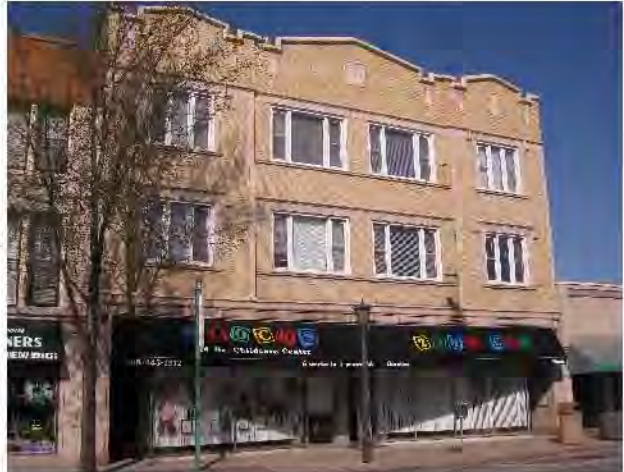
Front Orientation	E	Number of Stories	3
Style/Detailing			
Wall Material(s)	brick		
	terra cotta		
Storefront	altered		
Other Windows	vinyl replacement		
Visible Roof Materials			
Overall Condition	good

symmetrical parapet wall, terra cotta details

Date or Approx. Decade	1928	Original or Prior Uses	
Architect	J.S. Canfield	Additions/Alterations	awning, upstairs windows
Contractor			
Original Owner	Dr. Henry Way	History Notes

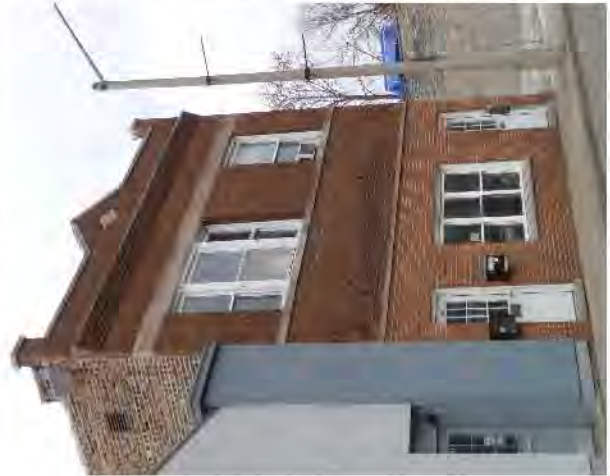
Storefront replaced

Other Windows vinyl replacement

Overall Condition fair

windows, doors, first floor brick facade

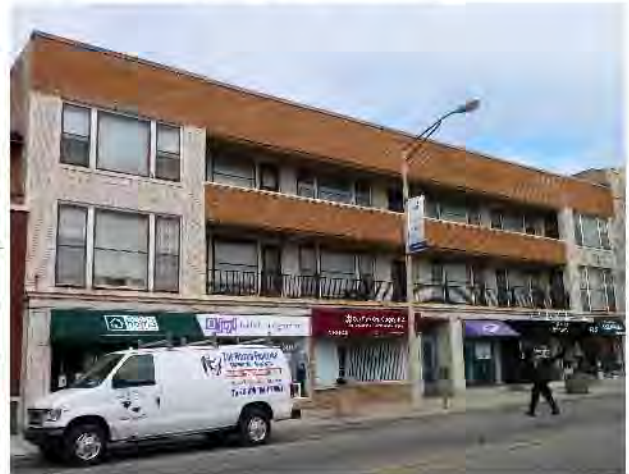
Overall Condition highly altered

Some original storefronts, some 1960s. Arcade design is original, terra cotta details.

Cornice and balcony claddings replaced, first floor awnings and some storefronts.

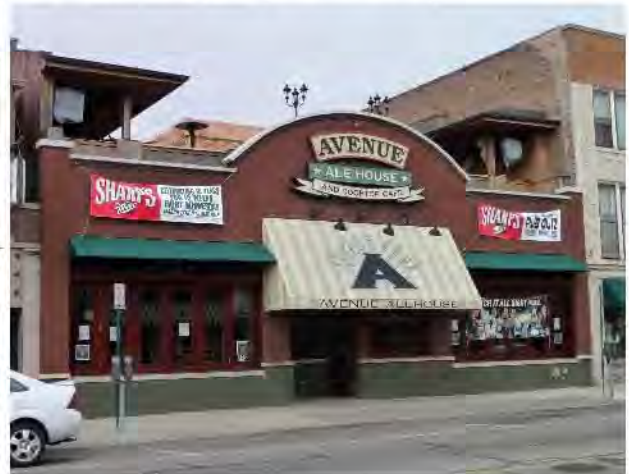
Significance No merit

Wall Material(s) dryvit

Entire facade

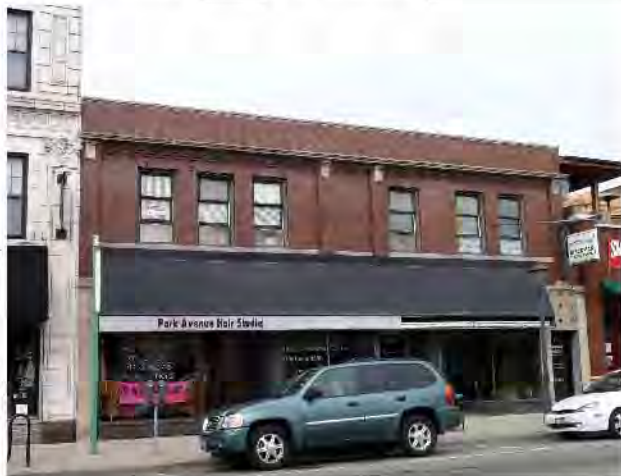
Front Orientation	E	Number of Stories	2
Style/Detailing	simplified neo-classical		
Wall Material(s)	brick		
	limestone		
Storefront	altered		
Other Windows	vinyl replacement		
Visible Roof Materials			
Overall Condition	good

Limestone stringcourse

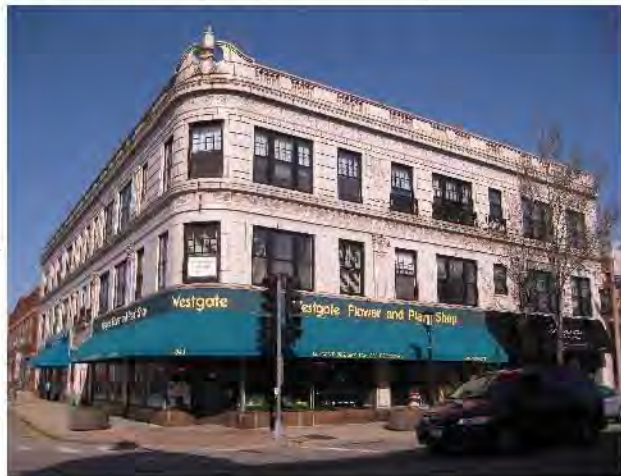
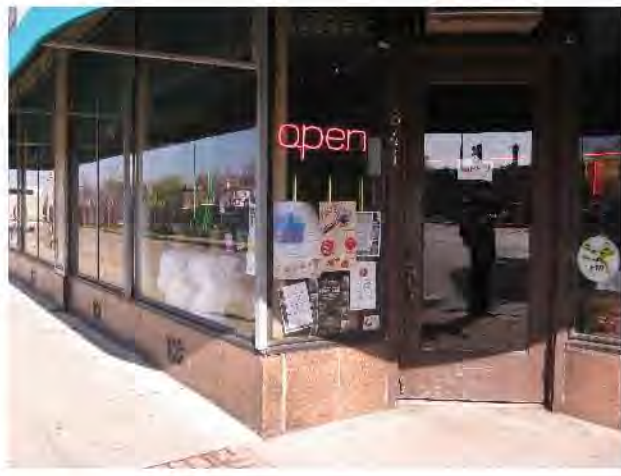
Overall Condition very good

SVBVRBAN APARTMENTS sign along roofline on south facade. White terra cotta facade and storefronts all intact.

Awning

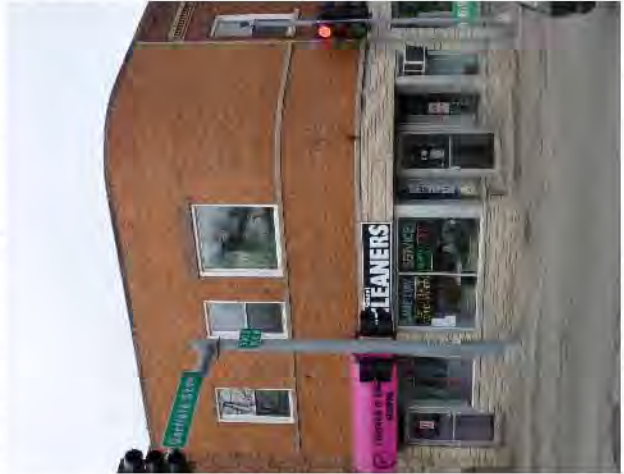
Significance No merit

Entire facade altered c. 1955

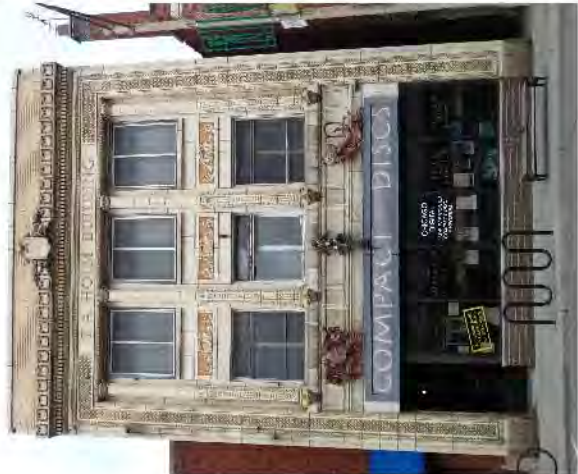
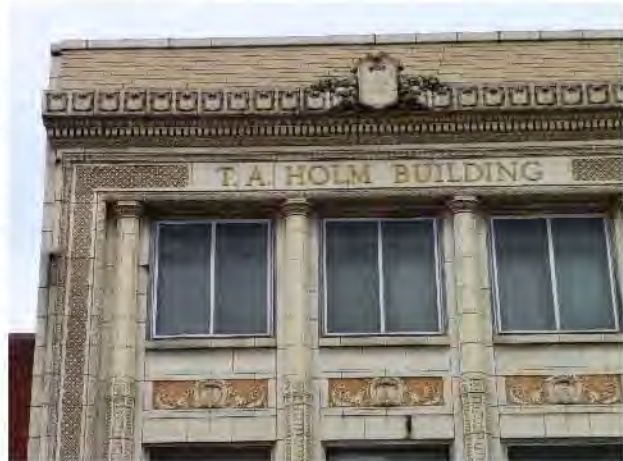
Overall Condition Good

Intact polychrome terra cotta facade

Sign and storefront, storm windows

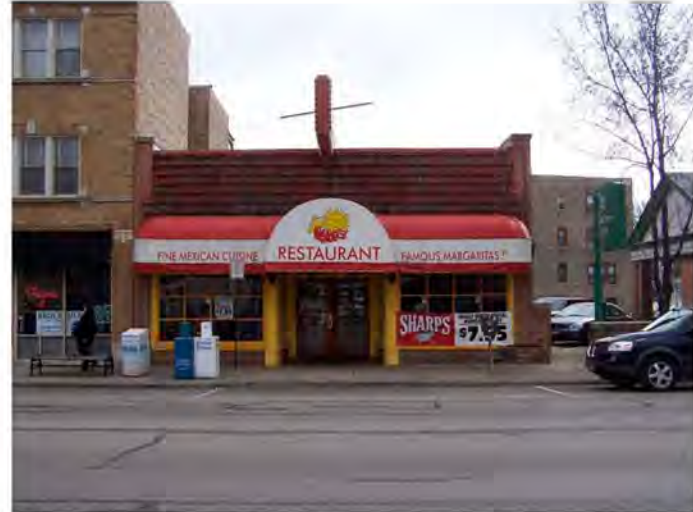
Front Orientation	W	Number of Stories	1
Style/Detailing	Bad Colonial Revival		
Wall Material(s)	Brick, Wood		
Storefront	Wood		
Other Windows	None		
Visible Roof Materials	False Wood Shingle		
Overall Condition	Structure is good

Large Storefront  
Mansard Roof

Date or Approx. Decade	1922	Original or Prior Uses	
Architect		804-806 3 brick stores	
Contractor			
Original Owner			
Field Notes		Additions/Alterations	
		1963 alterations

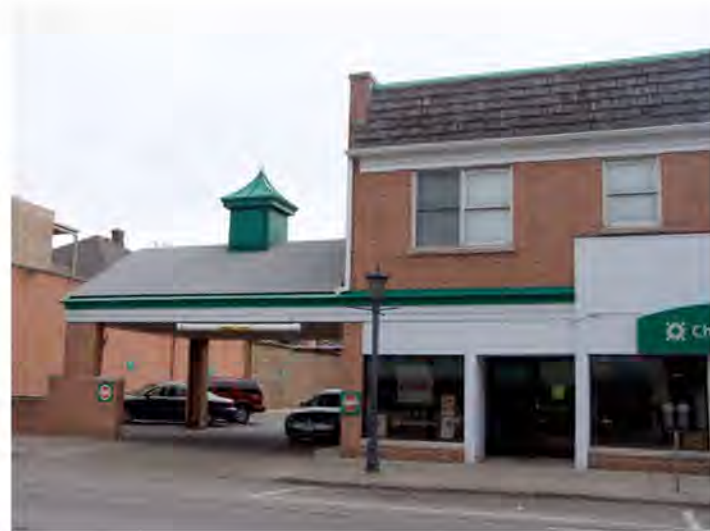
Address	810 S. Oak Park	Map ID Number	SE4	PIN Number	
Significance	No Merit				
Current Owner					
Current Use	Charter One Bank

Front Orientation	W	Number of Stories	2
Style/Detailing	Bad Colonial Revival		
Wall Material(s)	Brick, Wood		
Storefront	Aluminum		
Other Windows	Vinyl		
Visible Roof Materials	Mansard Wood Shingles		
Overall Condition	Structure is good

Wood clad first floor  
Drive thru
