Harrison Street Arts District Architectural Survey

Developed by the Historic Preservation Program at the School of the Art Institute of Chicago, under Prof. Vince Michael.

Spring 2010

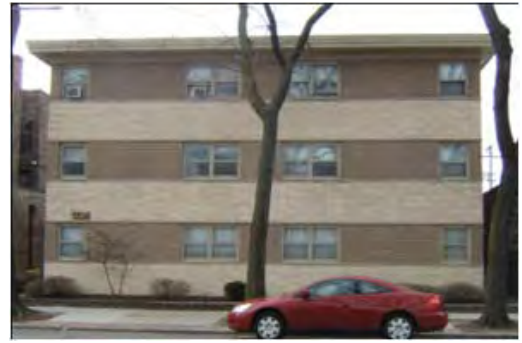
An example of a structure rated as No Architectural Merit.

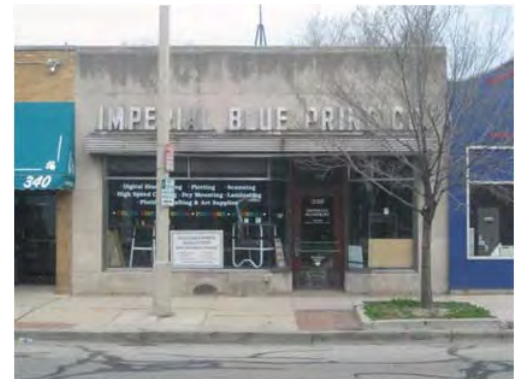
An example of a structure rated as Architectural Merit.

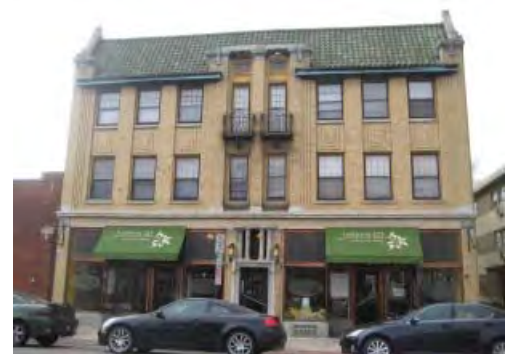
An example of a structure rated as Architecturally Significant.

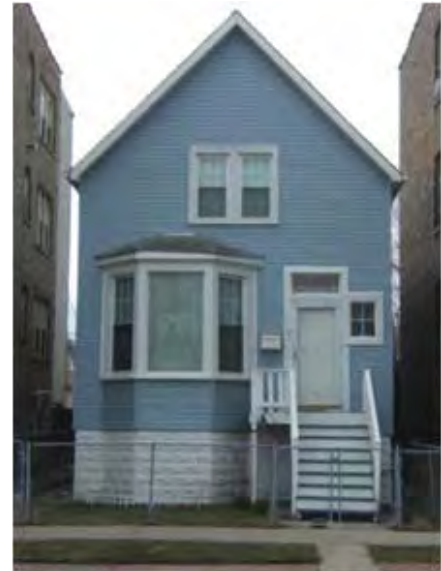
A typical example of the first wave of development along Harrison, from about 1900 to 1915.

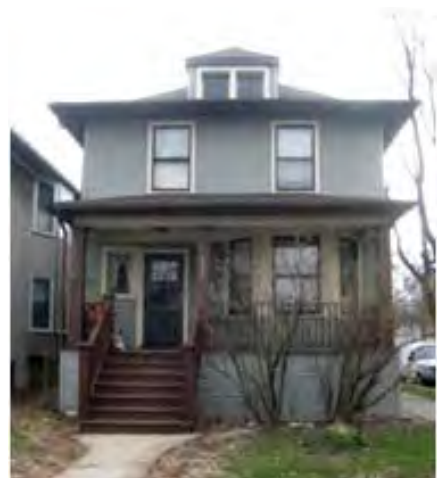
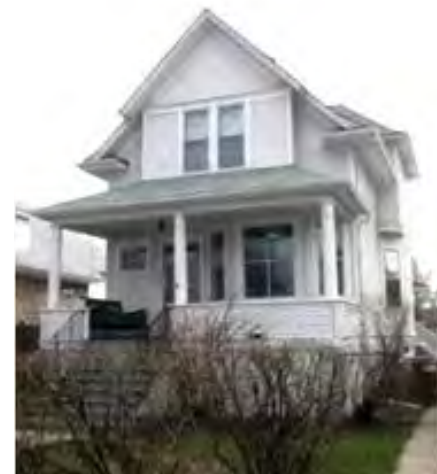
Examples of single-family residences found along the residential streets just off Harrison.

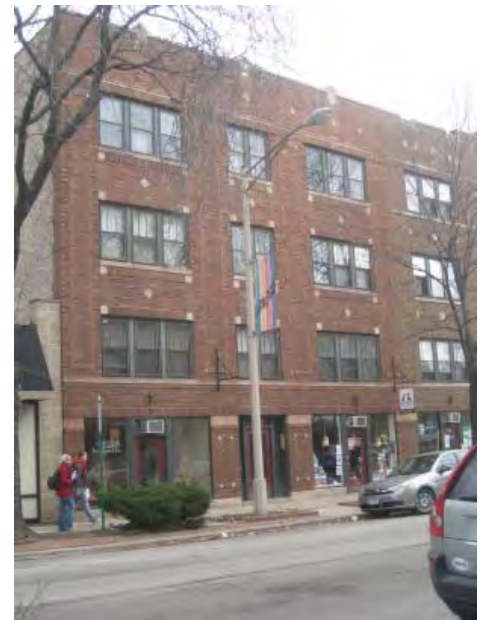
138-144 Harrison Street

This set of two four-story apartment buildings with English basement-level retail storefronts was completed in 1929. They both have very high integrity, in that they retain their original wood windows with storms, the tuckpointing on their tapestry brick seems to be of good quality, and they seem to still have their original details. The half at 142-144 Harrison has a

storefront built of wood and copper, though it is unknown whether the storefronts are original to the building. Both buildings, which were designed by the same architect and constructed by the same developer at the same time, are known to have been early examples of Haydite construction. Haydite seems to have been a very early type of concrete block construction with blocks including a special lightweight aggregate.³

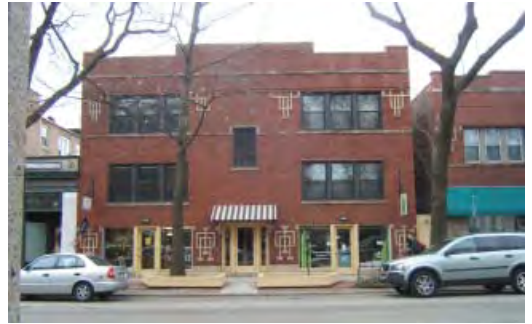
145-147 Harrison Street

This three-story red brick apartment building includes storefronts at the first floor level. The brick facade is inlaid with patterns in cream-colored brick. The storefronts are of wood, with the floors of the retail spaces several feet below street level. While the windows have been replaced, the building has been exquisitely maintained inside and out.

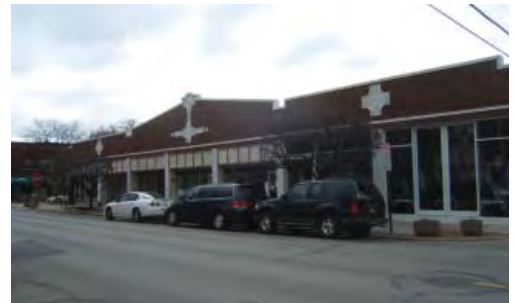
201-211 Harrison Street

This long building with a pedimented parapet was previously a laundry and was a location of the Great A & P Tea Company before settling into its current use as a variety of smaller retail spaces. Its textured red brick facade is offset by several catalog Sullivanesque details that have been painted white.

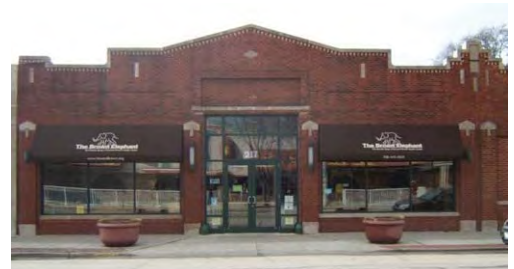
217-219 Harrison Street

Constructed of red brick with limestone details, this building was formerly an auto garage. That former use can be easily discerned from its clear-span metal trusswork above. The building became vacant and in 2002, a search began for a new use. It was briefly a practice area for the Huskies softball team before reopening as the Oak Park location of the Brown Elephant Resale Shop. Its sensitive reuse of the building earned it a Historic Preservation Award from the City of Oak Park for 2006.

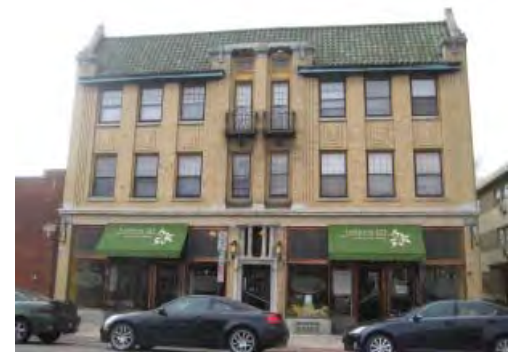
225-227 Harrison Street

This is perhaps the most spectacular building on the Harrison Street strip. It is three stories and built of buff brick, with a steeply-pitched Spanish tile roof, and has Spanish Revival ornament on its spandrel panels,

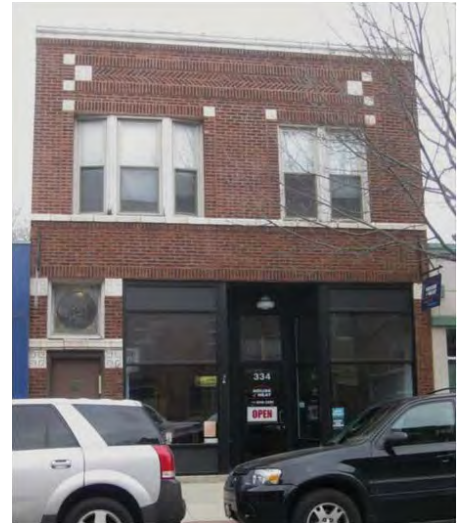
334 Harrison Street

This Chicago commercial-style building was completed in 1921. Its ground floor consists of a retail space which has been replaced but seems to retain its original opening width and height. The transom above the door displays the building number in art glass. The door is of a distinctive diamond-plate design of an unknown vintage. In 1930, it was headquarters of the National Tea Company, which also had a store along Harrison.

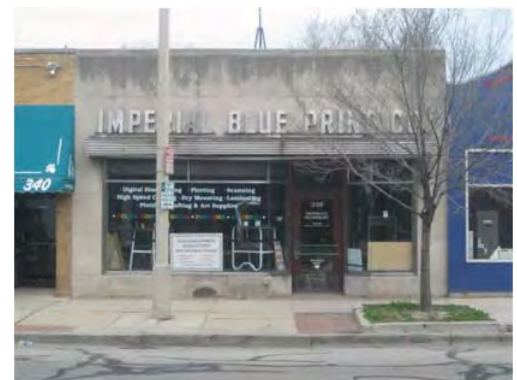
338 Harrison Street

This unique building in the art moderne style has housed the same printing company since it was built in 1947. It is built of concrete with large chrome lettering above a chrome awning and a large glazed storefront with the glass panes butt-glazed at the joints. Permit drawings were found from the year of construction and it is evident that almost no changes have been made since the building was originally constructed. The only element that is missing is an art deco style ornamental address plaque that is shown in the drawings but may or may not have actually been constructed.

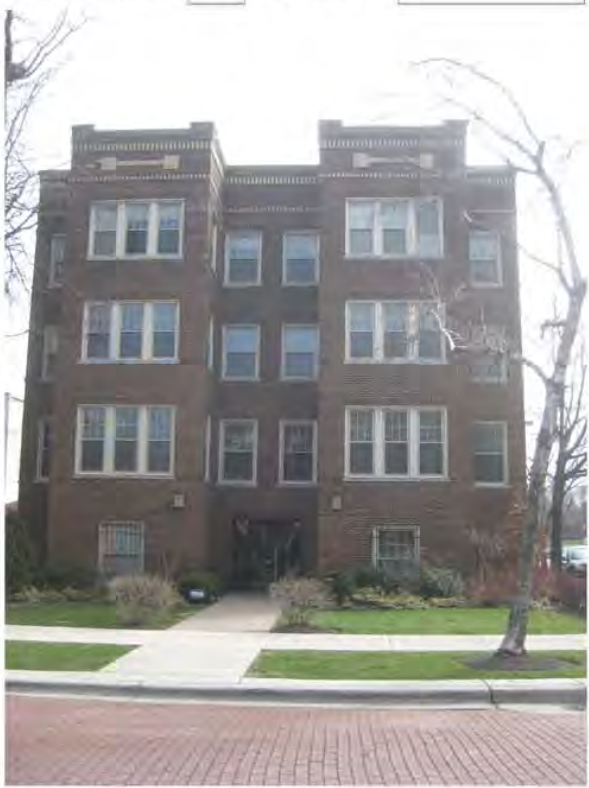
Address	844-846 S Humphrey St.	Map ID Number	2	PIN Number	
Significance	With Merit				
Current Owner					
Current Use	Apartments

Front Orientation	W	Number of Stories	4
Style/Detailing			
Wall Material(s)	brick		
	concrete foundation		
Storefront			
Other Windows	vinyl		
Visible Roof Materials			
Overall Condition	good		
Notable Features

Date or Approx. Decade	1922	Original or Prior Uses	
Architect	Dubin & Eisenberg		
Contractor	John C. Nixon		
Original Owner	H. Savner

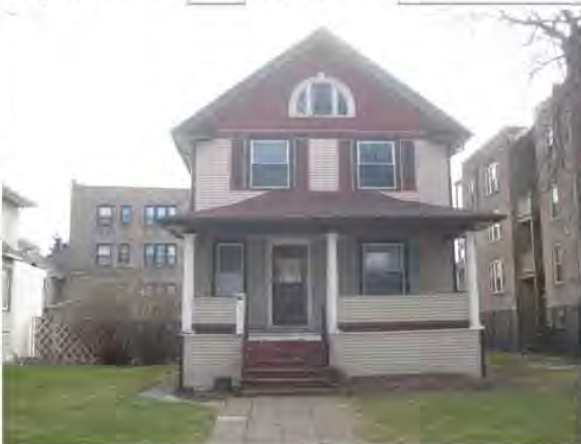
Address	840 S Humphrey St.	Map ID Number	3	PIN Number	
Significance	With Merit				
Current Owner					
Current Use	Residence (abandoned)

Front Orientation	W	Number of Stories	2
Style/Detailing	Queen Anne		
Wall Material(s)	wood		
	vinyl siding		
Storefront			
Other Windows	aluminum		
Visible Roof Materials	asphalt shingles		
Overall Condition	poor

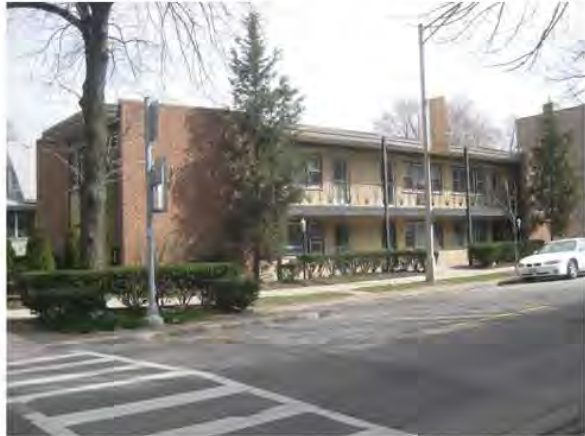
Address	40-48 Harrison St.	Map ID Number	6	PIN Number	
Significance	No merit				
Current Owner					
Current Use	Apartments

Front Orientation	S	Number of Stories	2
Style/Detailing	Modern		
Wall Material(s)	Brick		
Storefront			
Other Windows	Aluminum		
Visible Roof Materials			
Overall Condition	Good

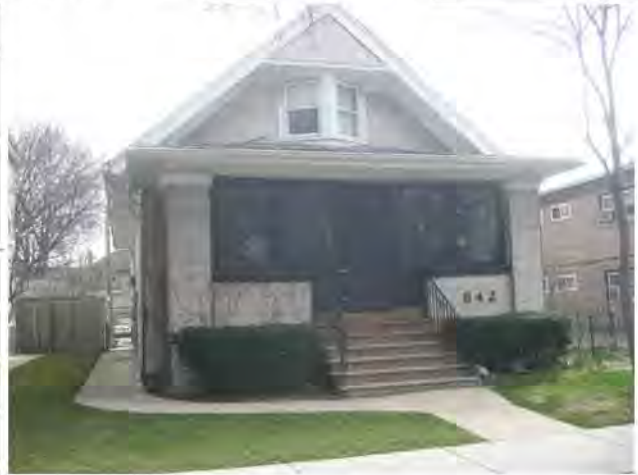
Address	842 S Lyman St.	Map ID Number	7	PIN Number	
Significance	No Merit				
Current Owner					
Current Use	Residence

Front Orientation	W	Number of Stories	2
Style/Detailing			
Wall Material(s)	asbestos siding		
	concrete foundation		
Storefront			
Other Windows	wood		
Visible Roof Materials	asphalt shingles		
Overall Condition	Fair

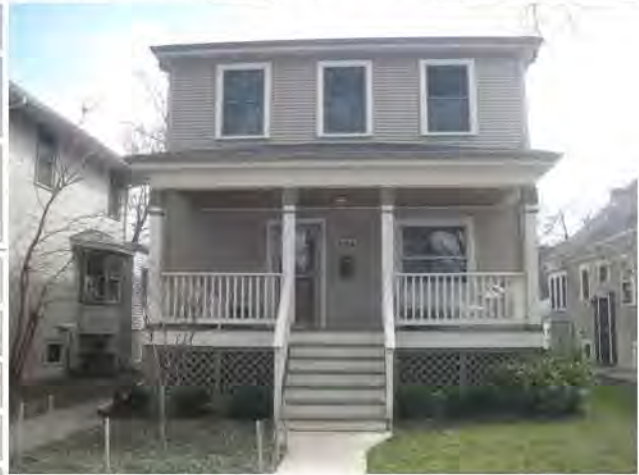
Address	836 S Lyman St.	Map ID Number	8	PIN Number	
Significance	No Merit				
Current Owner					
Current Use	Residence

Front Orientation	W	Number of Stories	2
Style/Detailing	Four Square		
Wall Material(s)	vinyl siding		
	stucco		
Storefront			
Other Windows	vinyl		
Visible Roof Materials	asphalt shingles		
Overall Condition	Good

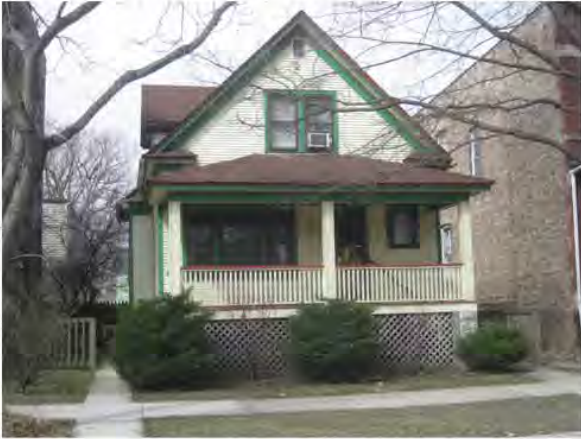
Address	841 S Lyman St.	Map ID Number	10	PIN Number	
Significance	With Merit				
Current Owner					
Current Use	Residence

Front Orientation	E	Number of Stories	2
Style/Detailing	Cottage		
Wall Material(s)	wood siding		
	concrete		
Storefront			
Other Windows	aluminum		
Visible Roof Materials	asphalt shingles		
Overall Condition	fair

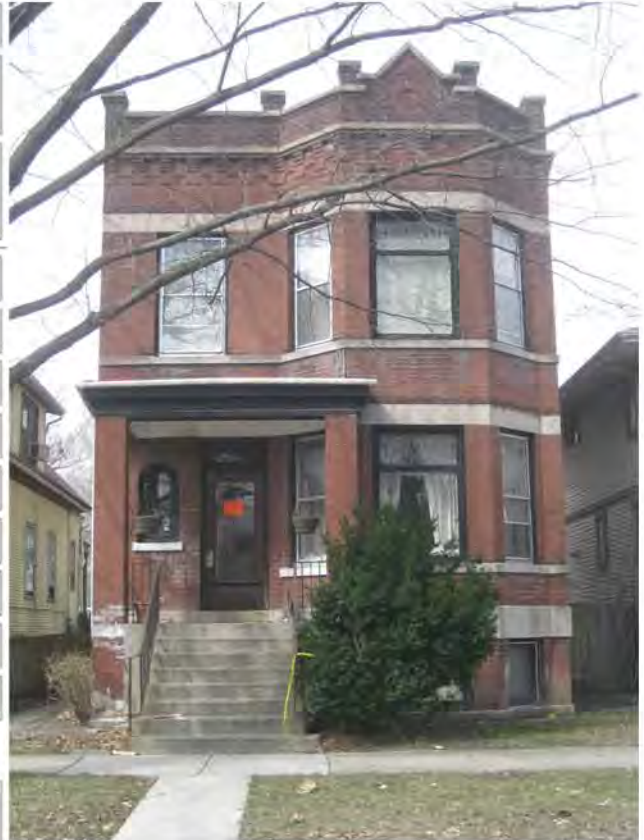
Address	839 S Lyman St.	Map ID Number	11	PIN Number	
Significance	no Merit				
Current Owner					
Current Use

Front Orientation	E	Number of Stories	2
Style/Detailing			
Wall Material(s)	brick		
	limestone		
Storefront			
Other Windows	wood; aluminum		
Visible Roof Materials			
Overall Condition	poor		
Notable Features	<p>Leaded glass; Arched front window; Circular brick ornament on top; Corbelled bricks at parapet</p>

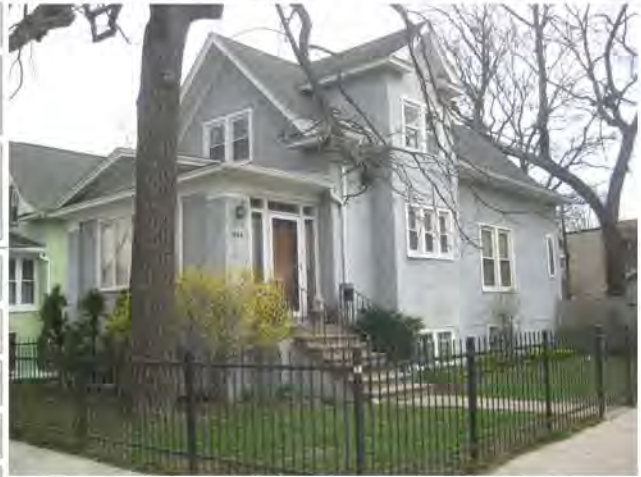
Address	844 S Taylor St.	Map ID Number	13	PIN Number	
Significance	No Merit				
Current Owner					
Current Use	Residence

Front Orientation	W	Number of Stories	2
Style/Detailing	Cottage		
Wall Material(s)	stucco		
Storefront			
Other Windows	vinyl; aluminum		
Visible Roof Materials	asphalt singles		
Overall Condition	excellent

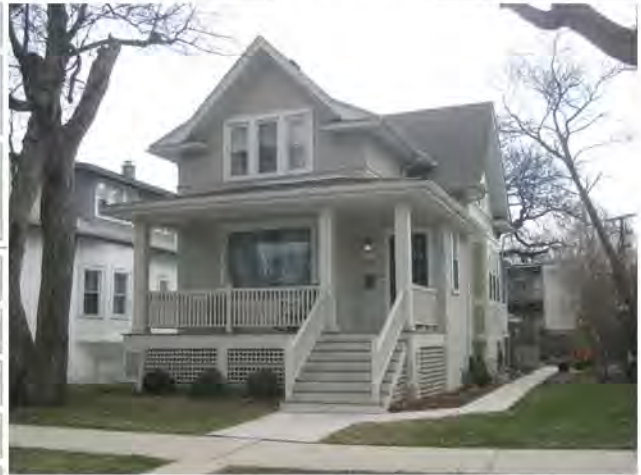
Address	838 S Taylor St.	Map ID Number	15	PIN Number	
Significance	No Merit				
Current Owner					
Current Use	Residence

Front Orientation	W	Number of Stories	2
Style/Detailing	Cottage		
Wall Material(s)	stucco		
	wood siding		
Storefront			
Other Windows	vinyl		
Visible Roof Materials	asphalt shingles		
Overall Condition	excellent

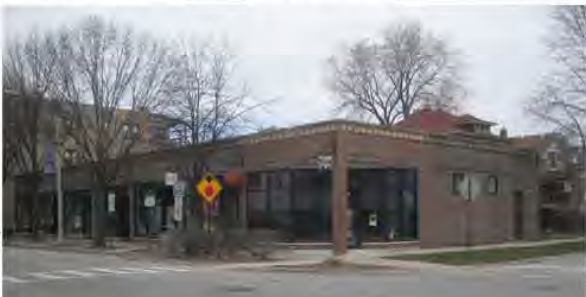
Address	126-136 Harrison St.	Map ID Number	16	PIN Number	
Significance	With merit				
Current Owner					
Current Use	Regal Shoe Emporium; Pamela Penney Textile Arts; Careful Peach Boutique; Tokushinkao Dojo Aikido; Sister & Sister Hair Dimension; Boots to Wings BarberShop

Front Orientation	S	Number of Stories	1
Style/Detailing			
Wall Material(s)	Brick		
	Concrete foundation		
Storefront	Steel		
Other Windows	Steel		
Visible Roof Materials			
Overall Condition	Good

Date or Approx. Decade	1922	Original or Prior Uses	
Architect	Dubin & Eisenberg	Additions/Alterations	Side window filled in; Storefronts replaced
Contractor	John C. Nixon		
Original Owner	H. Lederman

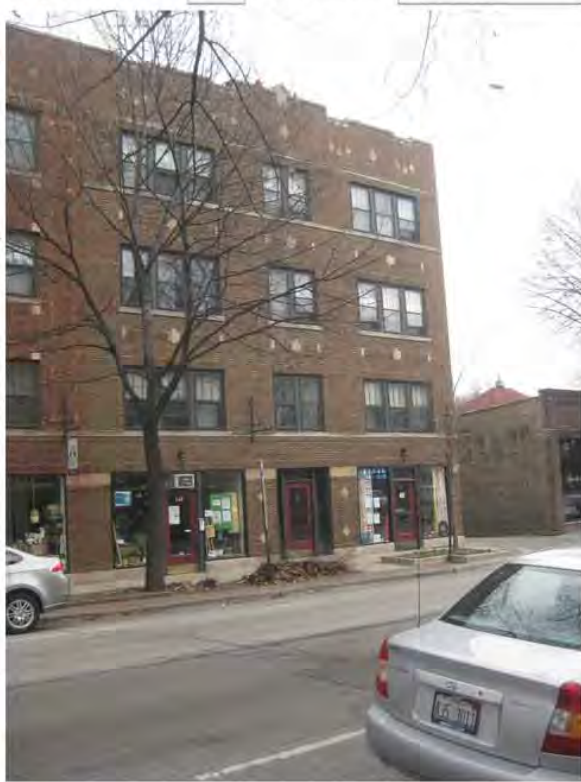
Address	138-140 Harrison St.	Map ID Number	19	PIN Number	
Significance	With Merit				
Current Owner					
Current Use	Apartment / Retail: Right-Brained Studio; Creative Changes Studio

Front Orientation	S	Number of Stories	4
Style/Detailing			
Wall Material(s)	Tapestry brick		
	Limestone		
Storefront	Wood and steel		
Other Windows	Wood		
Visible Roof Materials			
Overall Condition	Excellent

Limestone ornament in brick throughout;
Little lantern above entry

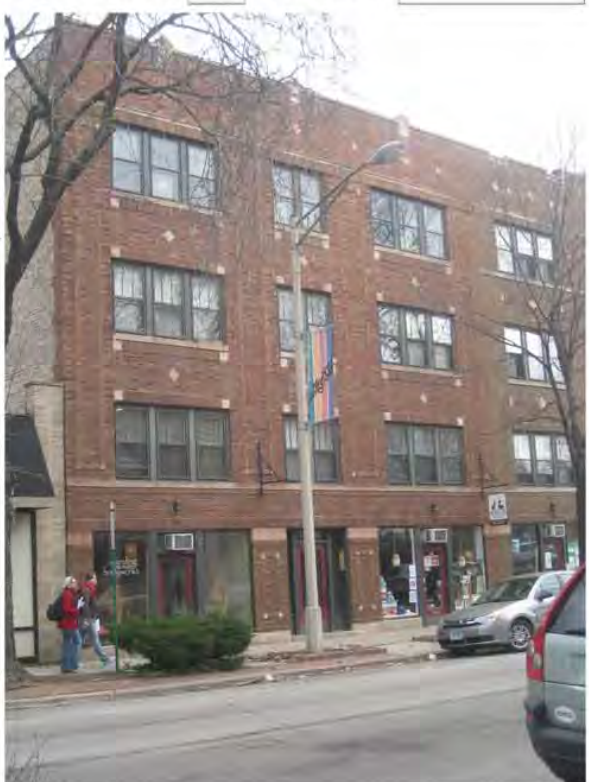
Front Orientation	S	Number of Stories	4
Style/Detailing			
Wall Material(s)	Brick		
	Limestone		
Storefront	Wood and copper		
Other Windows	Wood		
Visible Roof Materials			
Overall Condition	Excellent

Limestone ornament in brick throughout

Date or Approx. Decade	1929	Original or Prior Uses	
Architect	A.J. Buerger	Additions/Alterations	Storm windows; Repointed
Contractor	Huntington & Co.		
Original Owner	Huntington & Co.

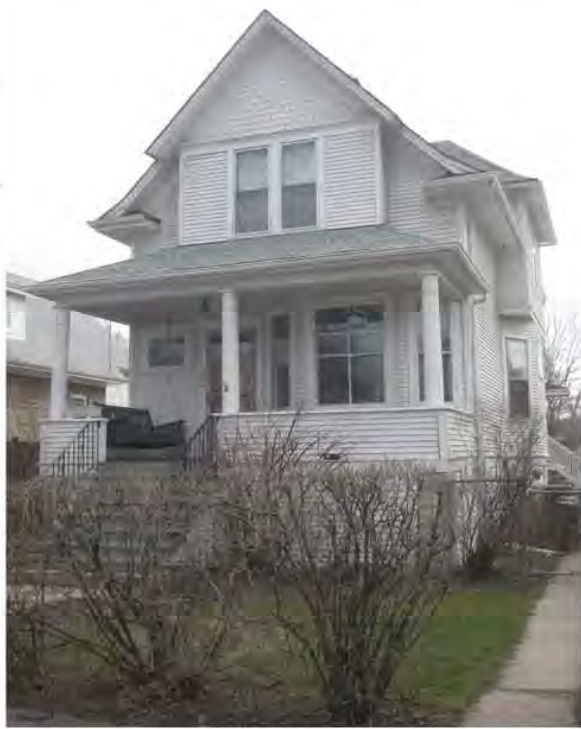
Front Orientation	W	Number of Stories	2
Style/Detailing	Queen Anne		
Wall Material(s)	wood		
Storefront			
Other Windows	wood		
Visible Roof Materials	asphalt shingles		
Overall Condition	fair		
Notable Features

Fish scale at gable;
leaded glass windows;
fluted wood columns

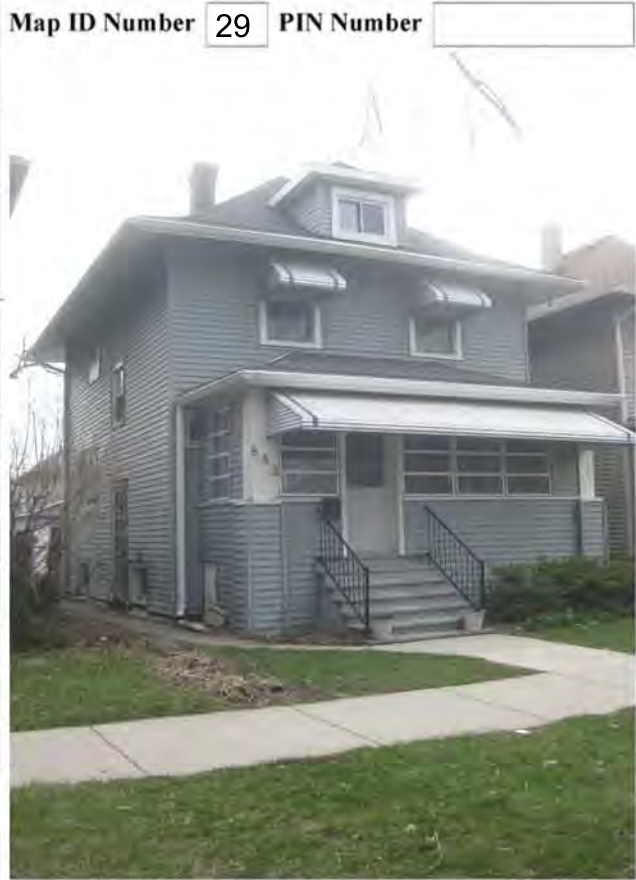
Address	842 S Highland St.	Map ID Number	29	PIN Number	
Significance	No Merit				
Current Owner					
Current Use	Residence

Front Orientation	W	Number of Stories	2
Style/Detailing	Four Square		
Wall Material(s)	vinyl siding		
Storefront			
Other Windows	aluminum		
Visible Roof Materials	asphalt shingles		
Overall Condition	Good		
Notable Features

Date or Approx. Decade	1910	Original or Prior Uses	
Architect			
Contractor	Michael Gideon		
Original Owner	Michael Gideon		
Field Notes			
	Additions/Alterations	Porch added on

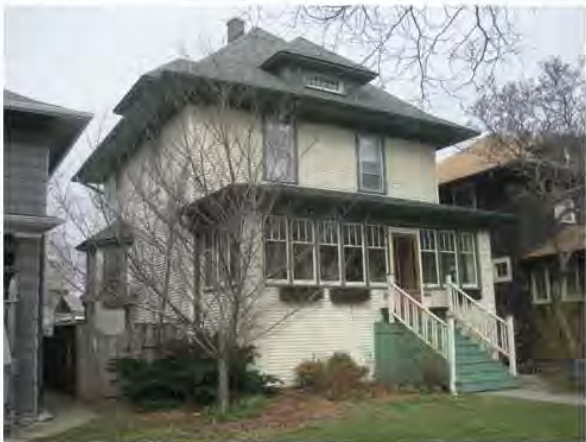
Address	841 S Highland St.	Map ID Number	33	PIN Number	
Significance	With Merit				
Current Owner					
Current Use	Residence

Front Orientation	E	Number of Stories	2
Style/Detailing	Four Square		
Wall Material(s)	wood		
	artificial stone		
Storefront			
Other Windows	wood		
Visible Roof Materials	asphalt shingles		
Overall Condition	good

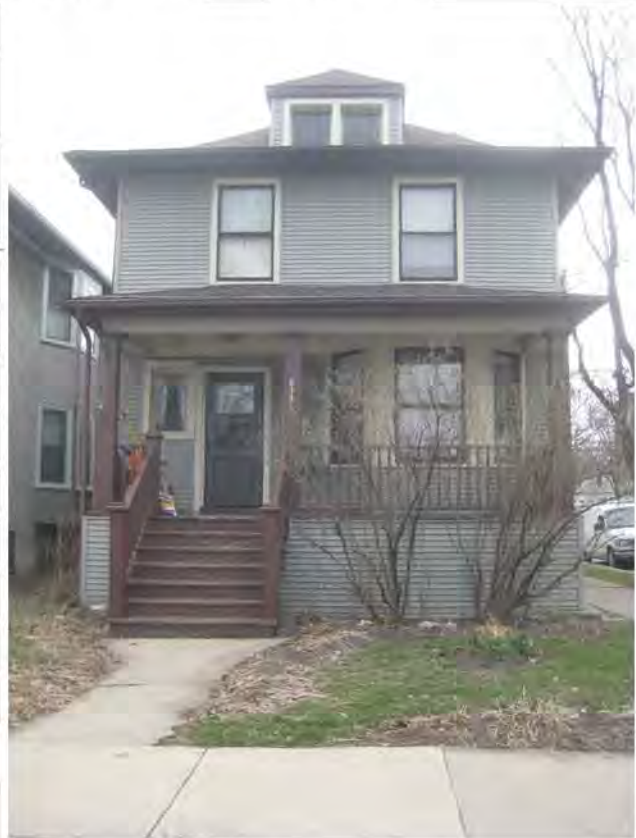
Address	844 S Cuyler St.	Map ID Number	34	PIN Number	
Significance	No Merit				
Current Owner					
Current Use	Residence

Front Orientation	W	Number of Stories	3
Style/Detailing	Four Square		
Wall Material(s)	vinyl		
	concrete foundation		
Storefront			
Other Windows	wood		
Visible Roof Materials	asphalt shingles		
Overall Condition	Good

Leaded glass window;
Bay window

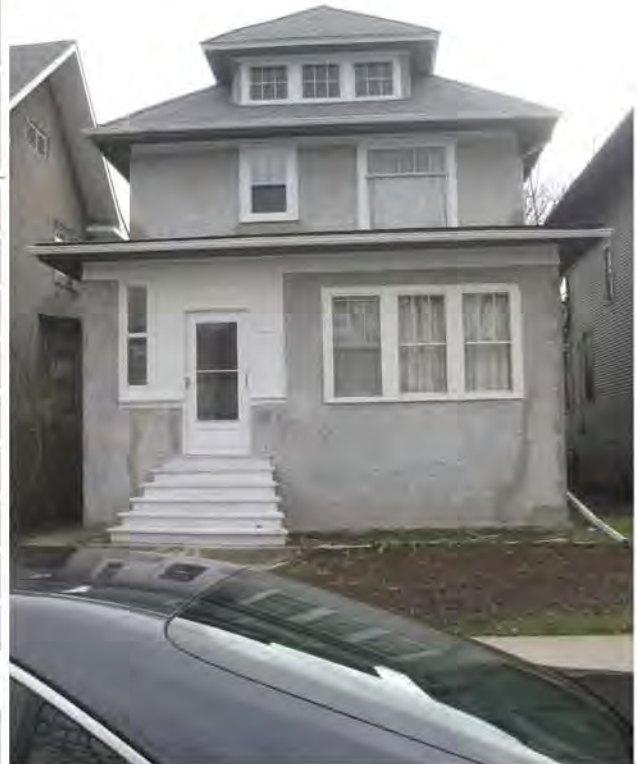
Address	842 S Cuyler St.	Map ID Number	35	PIN Number	
Significance	No merit				
Current Owner					
Current Use	Residence

Front Orientation	W	Number of Stories	2
Style/Detailing	cottage		
Wall Material(s)	stucco		
Storefront			
Other Windows	wood		
Visible Roof Materials	asphalt shingles		
Overall Condition	fair		
Notable Features

Date or Approx. Decade	1913	Original or Prior Uses	
Architect		Additions/Alterations	Porch filled in.
Contractor	A. Borema		
Original Owner	A. Borema		
Field Notes

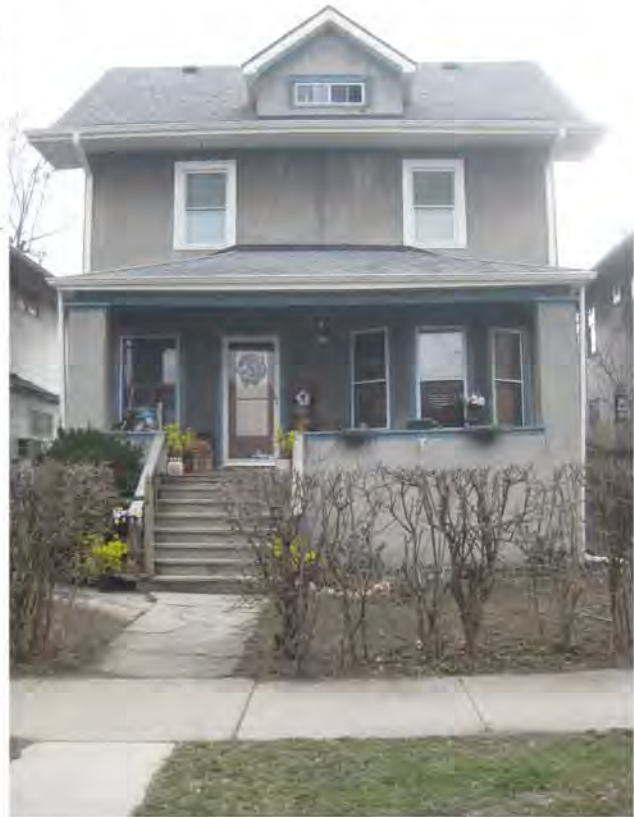
Address	840 S Cuyler St.	Map ID Number	36	PIN Number	
Significance	No merit				
Current Owner					
Current Use	Residence

Front Orientation	W	Number of Stories	2
Style/Detailing	Four Square		
Wall Material(s)	stucco		
Storefront			
Other Windows	vinyl		
Visible Roof Materials	asphalt shingles		
Overall Condition	good		
Notable Features	Front bay windows

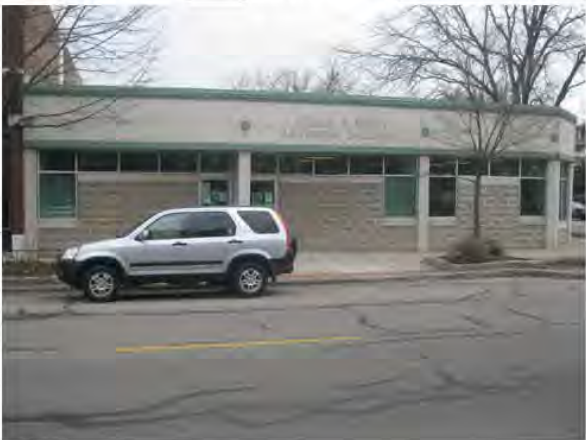
Address	328-332 Harrison St.	Map ID Number	37	PIN Number	
Significance	No merit				
Current Owner					
Current Use	Julius and Betty Levinson Building

Front Orientation	S	Number of Stories	1
Style/Detailing	modern		
Wall Material(s)	tapestry brick		
	concrete block		
	cast-stone	dryvit	
Storefront			
Other Windows	Steel		
Visible Roof Materials			
Overall Condition	Good

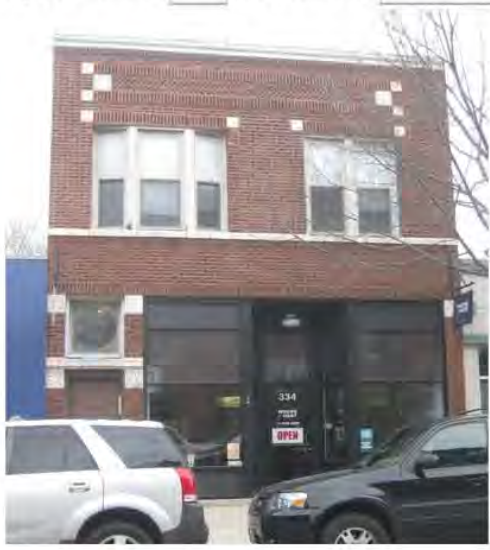
Address	334 Harrison St.	Map ID Number	38	PIN Number	
Significance	With Merit				
Current Owner					
Current Use	House of Heat; Stone Brook Capital Management

Front Orientation	S	Number of Stories	2
Style/Detailing			
Wall Material(s)	brick		
	terra cotta		
	concrete foundation		
Storefront	steel		
Other Windows	vinyl		
Visible Roof Materials			
Overall Condition	Good

Terra cotta details;
art glass transom;
diamond-patterned door;
floor masiacs at entrance

Date or Approx. Decade	1921	Original or Prior Uses	
Architect	M. Eisenberg	Additions/Alterations	Storefront replaced; poor repointing
Contractor	H. Cook & Co.		
Original Owner	Sam Sachs

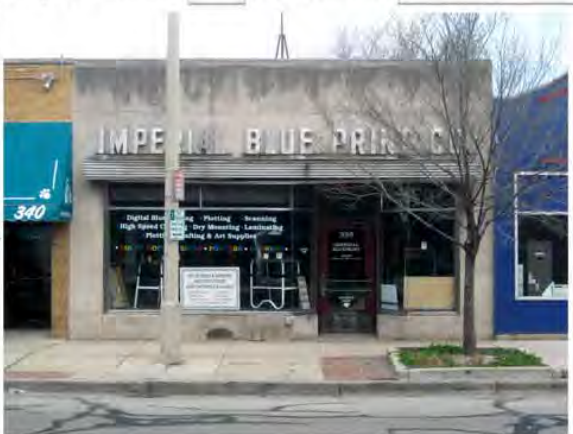
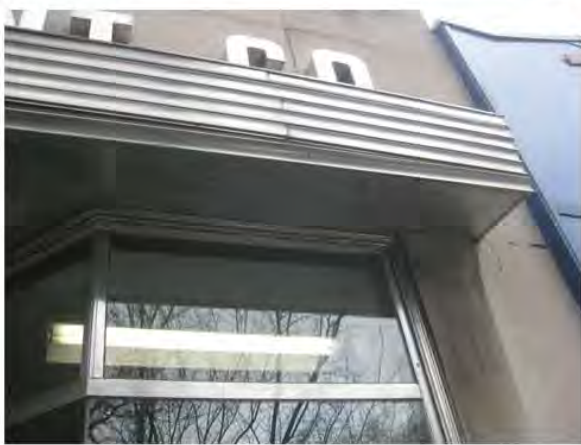
Front Orientation	S	Number of Stories	1
Style/Detailing			
Wall Material(s)	limestone		
Storefront	chrome		
Other Windows			
Visible Roof Materials			
Overall Condition	fair		
Notable Features

Corrugated chrome awning;
metal pin letters;
storefront joints and frames;
entrance door

Date or Approx. Decade	1947	Original or Prior Uses	
Architect	Robert H. Maiwurm	Additions/Alterations	
Contractor	Northern Builders		
Original Owner	Ed Isaachsen & George Gorski

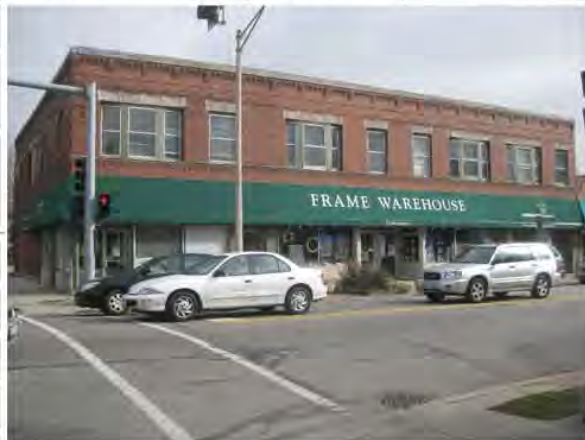
Map ID Number 42 PIN Number

Front Orientation S Number of Stories 2
 Style/Detailing
 Wall Material(s) brick
 shingles limestone
 Permastone wood
 Storefront aluminum
 Other Windows wood
 Visible Roof Materials
 Overall Condition fair

Notable Features
 Corbelled brick at parapet;
 limestone lintel;
 iron corner column;
 bay windows

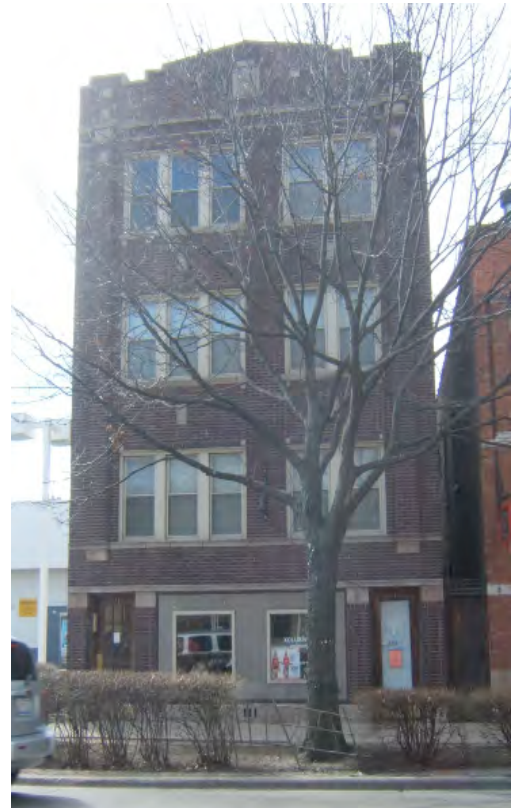
Map Number 45

Overall Condition Good

Notable Features Profile of parapet, wood doors and frames intact

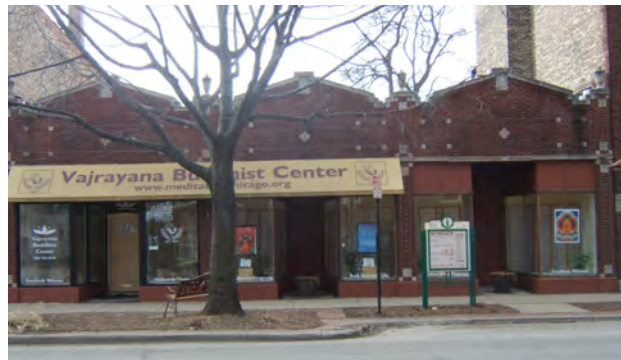
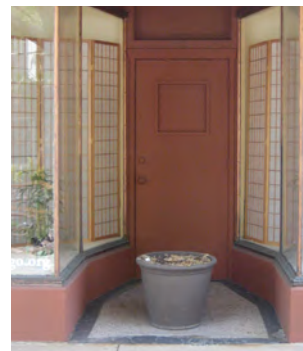
Overall Condition good

Notable Features limestone bulkhead, 13 - replacement window frame, transom glass remains, 15-17 - plate glass with copper frames, transoms boarded up, recessed entrances with tile flooring, painted pressed metal ceiling, repeating parapet profiles

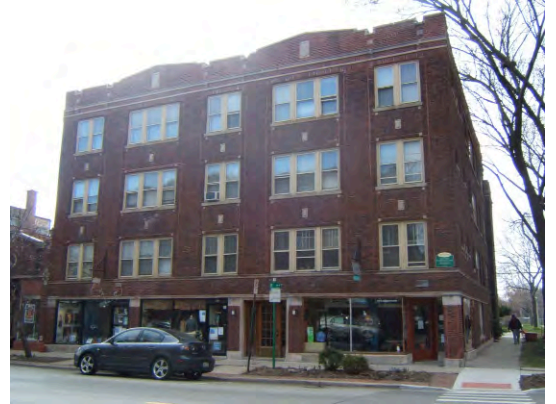
Address	17-21 Harrison	Map Number	48
Significance	Structure with merit		
Current Owner/business	Ridge Art, Harrison Works, Art Gecko		
Current Use	Apartments/retail		
Front Orientation	North	Number of Stories	4
Style/Detailing	Masonry apartment building		
Wall Materials	Red brick, limestone detail		
Storefront	Altered		
Other Windows	Wood frames with metal storms		
Visible Roof Materials	NA		
Overall Condition	Good		
Notable Features	Pedimented parapet with limestone detail

Date or approx decade	1924	Original or prior use	Stores/apartments
Architect	A.V. Capraro		
Contractor	H.C. Jensen		
Original Owner	Joseph Montenegro	Additions/Alterations	Replacement light fixtures, 17-19 ent. have replacement windows/doors, limestone bulkheads 21 ent. multi-paned wood door with side lights Corner display windows - copper framed plate glass
Field Notes		History Notes	
X	English basement retail space

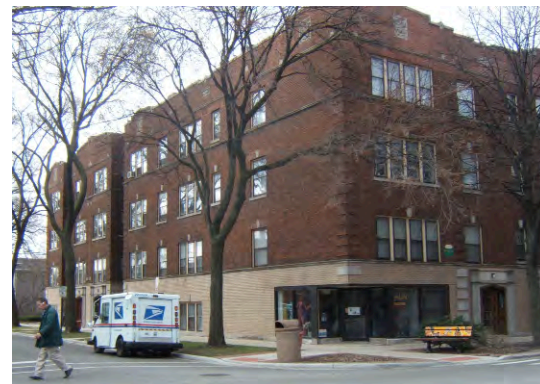
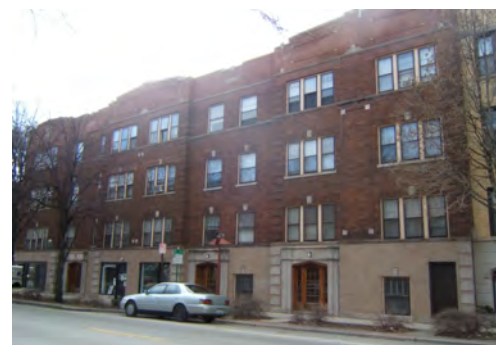
Address	25-35 Harrison	Map Number	49
Significance	Structure with merit		
Current Owner/business	Studio Light		
Current Use	Apartments/retail		
Front Orientation	North	Number of Stories	4
Style/Detailing	Masonry apartment building		
Wall Materials	First story has smooth buff colored brick with limestone quoins, red textured brick on floors 2-4, limestone keystones and detail		
Storefront	Replacement windows		
Other Windows	Wood frames with metal storms		
Visible Roof Materials	NA		
Overall Condition	Good		
Notable Features	Pedimented parapet, limestone entrances with multi-paned wood doors

Date or approx decade	1925	Original or prior use	Apartments/stores
Architect	A.L. Himmelblau	Additions/Alterations	Missing corner support column? Wood panel infill and new window for corner business. Replacement light fixtures
Contractor	Freevol & Smedburg	History Notes	
Original Owner	Victor Rootberg		
Field Notes

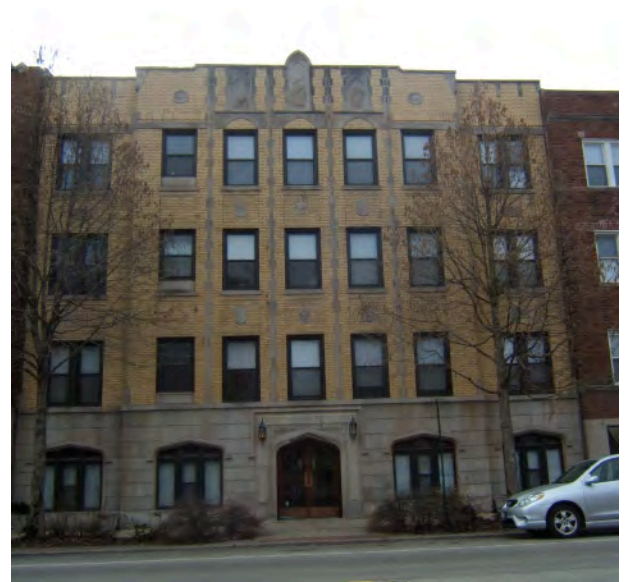
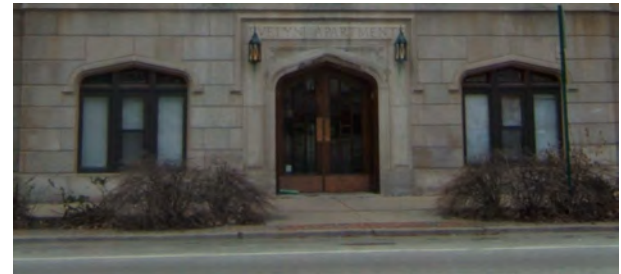
Overall Condition Good

Notable Features First floor windows and doorways have gothic arches with multi-paned wood doors. Transom leaded lights in first floor windows remain. Rest of window openings have replacement windows. Carved name of building above entrance.

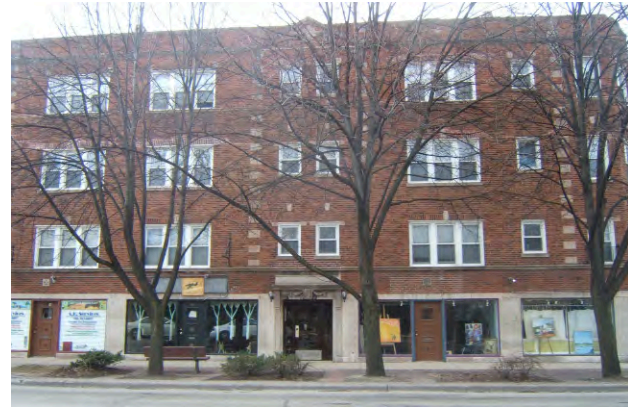
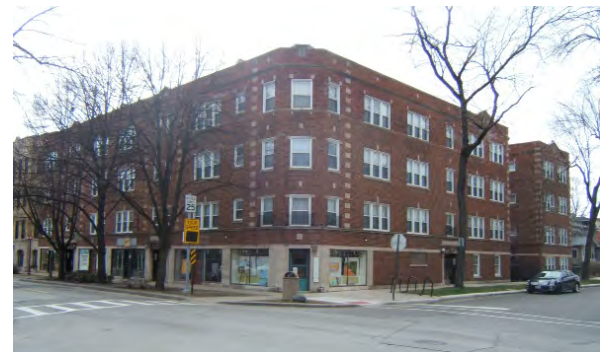
Map Number 51

Overall Condition Good

Notable Features 3 cast iron railings on second floor corner windows, one cast iron railing on west elevation. Carved limestone entrance with multi-paned wood doors with side lights.

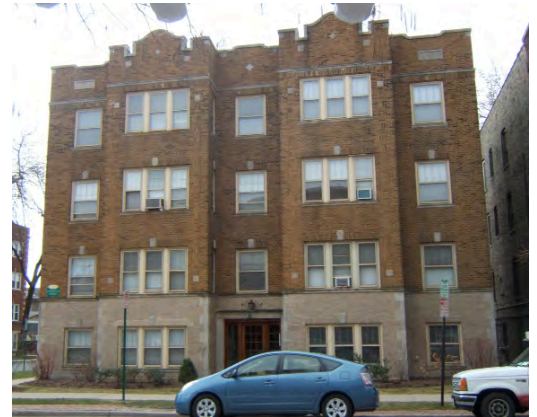
Overall Condition Good

Notable Features Spanish colonial style parapet profile. Multi-paned wood doors with side lights.

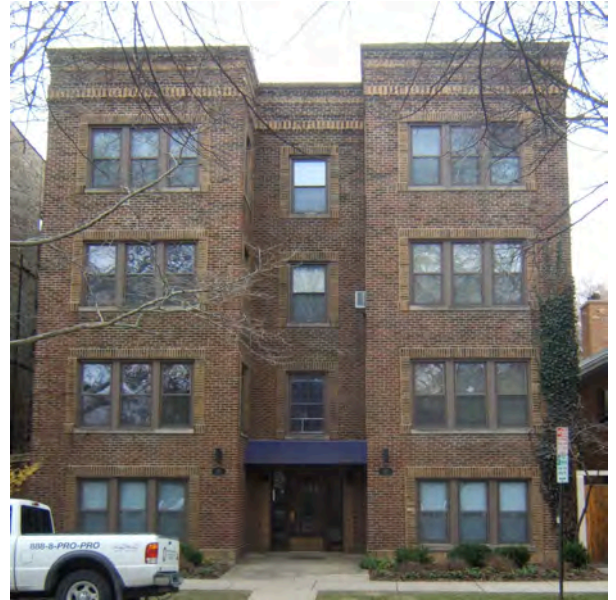
Address	115-117 Harrison	Map Number	55
Significance	Structure with merit		
Current Owner			
Current Use	Apartments		
Front Orientation	North	Number of Stories	4
Style/Detailing	Masonry apartment building with brickwork detail		
Wall Materials	Red textured brick, buff brick		
Storefront	NA		
Other Windows	Replacement		
Visible Roof Materials	NA		
Overall Condition	Good		
Notable Features	Multi-paned wood doors with sidelights.

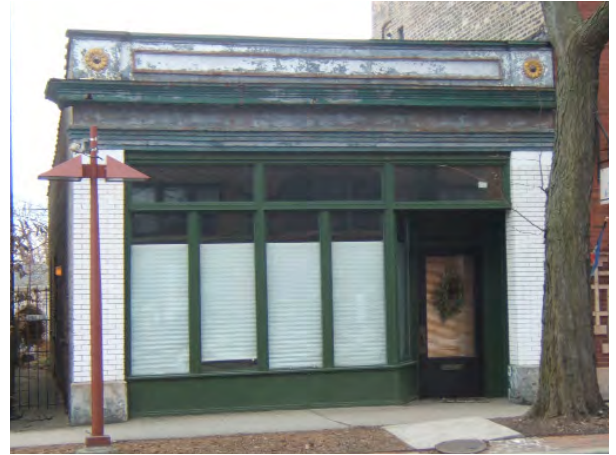
Overall Condition Metal cornice - poor

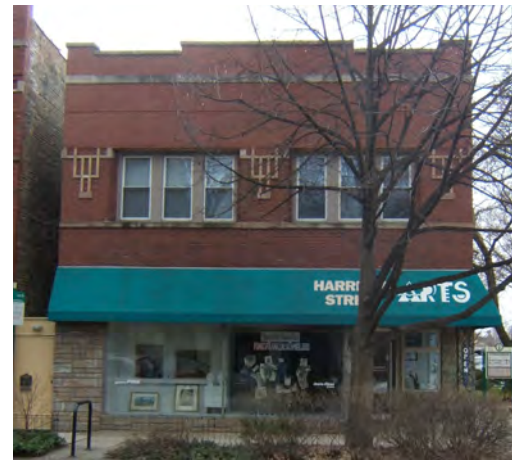
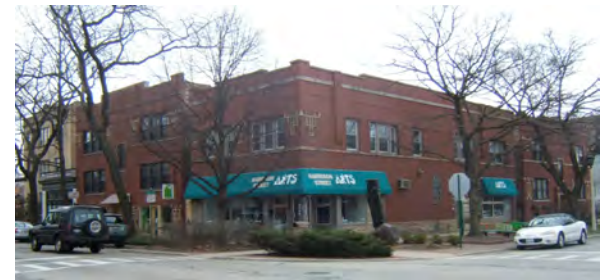
Map Number 60

Overall Condition Fair

Notable Features Uneven roof-line, brickwork designs

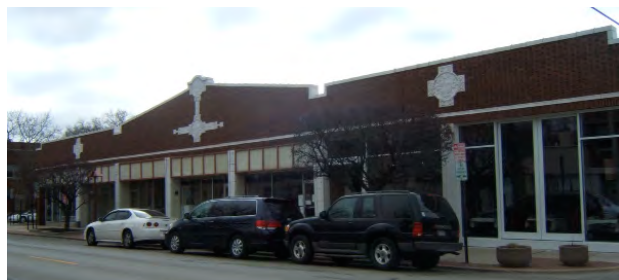
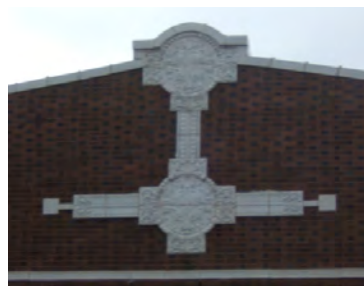
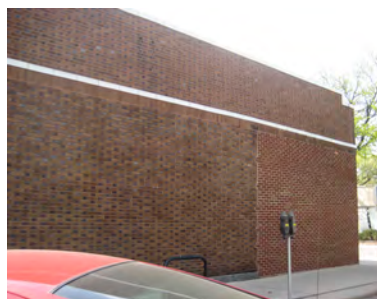
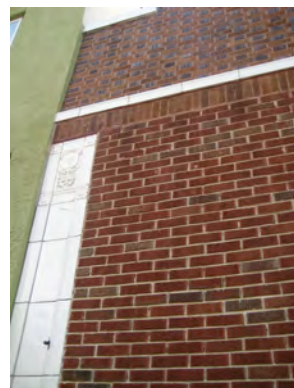
Address	201-211 Harrison	Map Number	62
Significance	Structure with merit		
Current Owner	Vacant and Briejo Restaurant		
Current Use	Vacant and Briejo Restaurant		
Front Orientation	North	Number of Stories	1
Style/Detailing	Commercial building		
Wall Materials	Textured red brick, terra cotta details and columns		
Storefront	Aluminum framed plate glass, limestone bulkhead, covered transom windows, some business entrances		
Other Windows	NA		
Visible Roof Materials	NA		
Overall Condition	Good		
Notable Features	Sullivanesque terra cotta. Contrasting textured brick header pattern.

Date or approx decade	1922	Original or prior use	Stores
Architect	A.L. Himmelblau	Original or prior use	Stores
Contractor	Berger & Cohen	Additions/Alterations	Storefronts
Original Owner	M. Nidetz	Additions/Alterations	Storefronts
Field Notes	Evidence of former storefront on east elevation with brick infill and remaining terra cotta pier.	Additions/Alterations	Storefronts

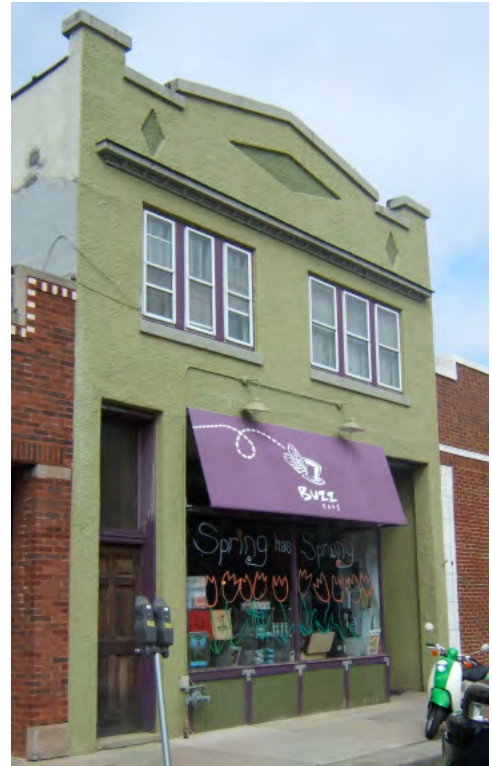
Map Number 63

Build up of stucco material compared to neighboring building

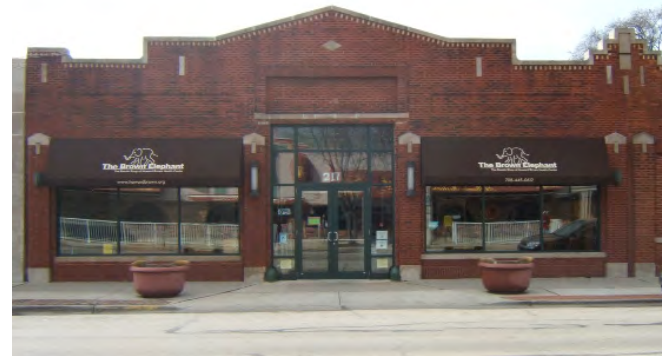
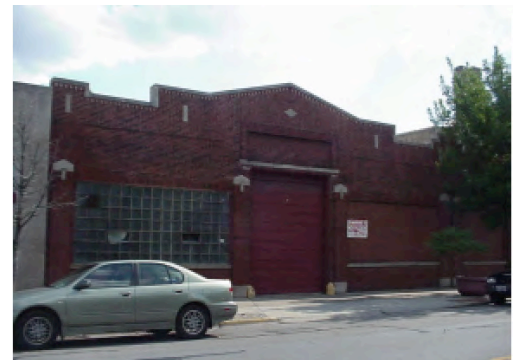
Map Number 66

Notable Features Metal truss roof system

Building before adaptive reuse renovation

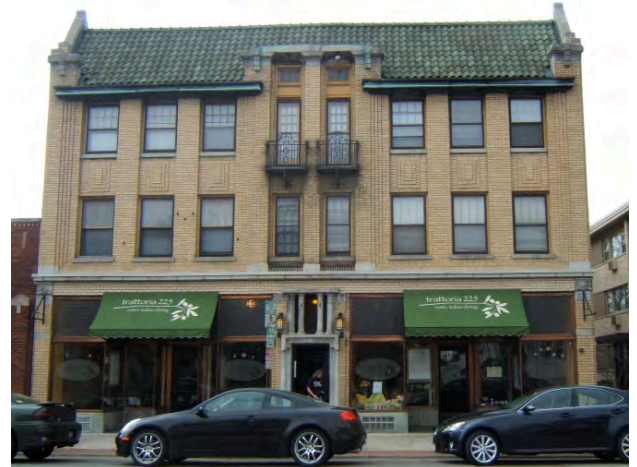
Overall Condition Excellent

Notable Features Iron railings, copper cornice, limestone detailing, limestone columns over central entrance, tile roof, copper gutter on primary facade

Field Notes Some of the limestone details around the center entrance seem to be replaced with cast stone

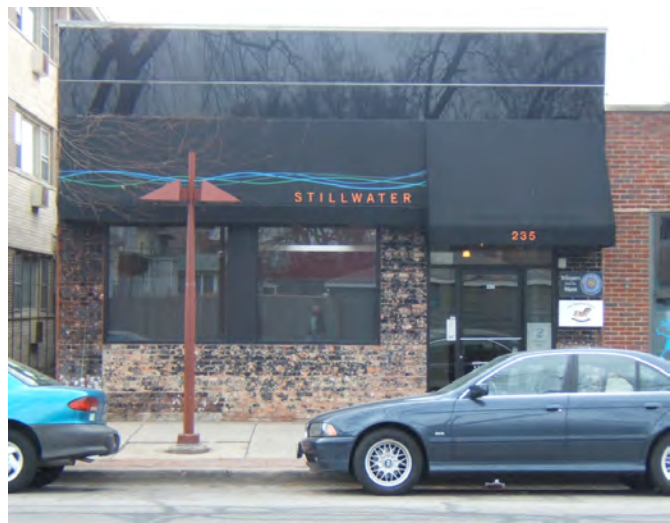
Map Number 70

Overall Condition poor

Notable Features Could have been a structure with merit if all the vitrolite remained.

1930 addition noted in permits (vitrolite?)

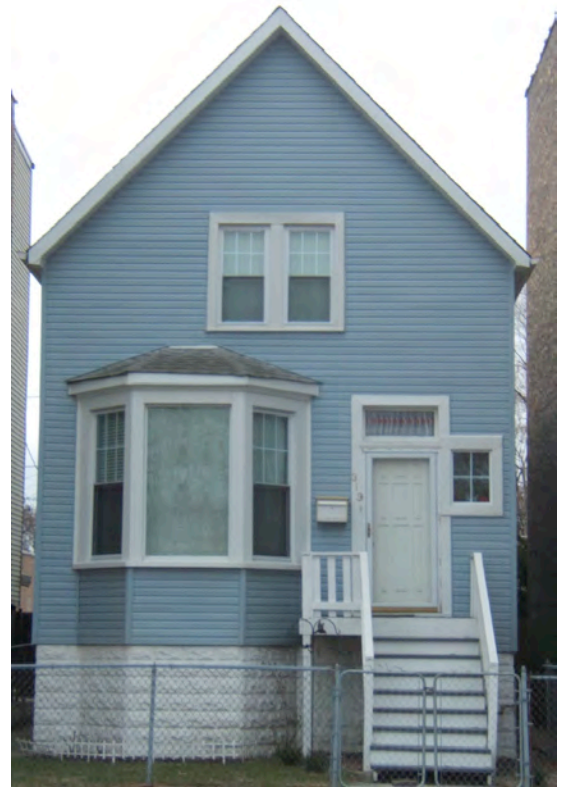
Address	313 Harrison	Map Number	78
Significance	Structure without merit		
Current Owner			
Current Use	SFH		
Front Orientation	North	Number of Stories	2
Style/Detailing	Front gable wood frame SFH		
Wall Materials	Vinyl siding		
Storefront	NA		
Other Windows	Replacement		
Visible Roof Materials	NA		
Overall Condition	Good		
Notable Features

Date or approx decade	ca. 1900	Original or prior use	
Architect		SFH	
Contractor			
Original Owner		Additions/Alterations	
Field Notes	SNM because it doesn't fit into the overall theme of the district.

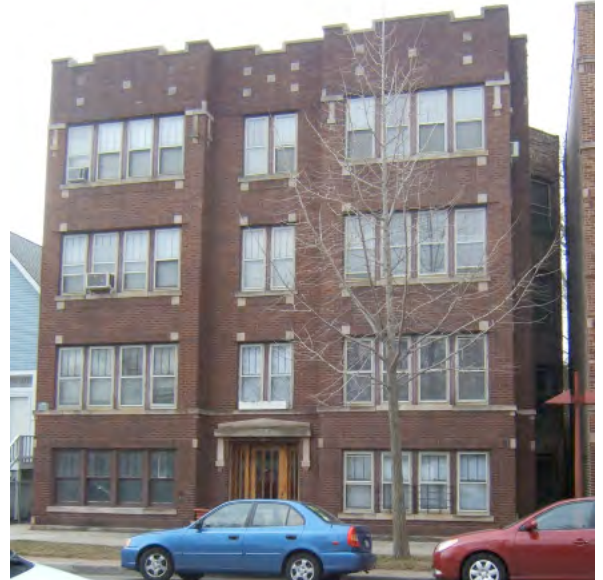
Overall Condition Good

Notable Features Uneven roof-line.

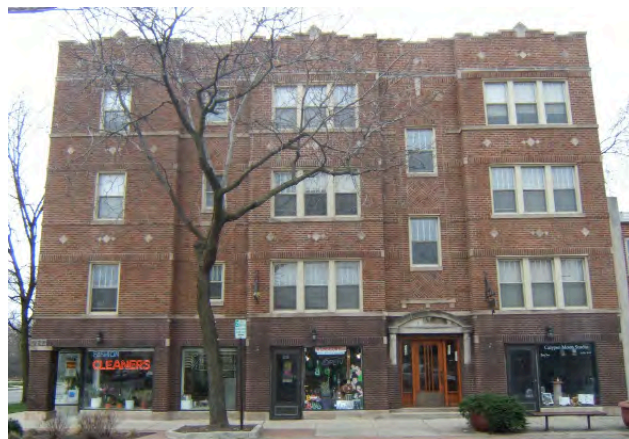
Harrison St. elevation

Style/Detailing Masonry mixed-use building

Wall Materials textured red brick with limestone details

Overall Condition poor
