Harrison Street Arts District Architectural Survey

Developed by the Historic Preservation Program at the School of the Art Institute of Chicago, under Prof. Vince Michael.

Spring 2010

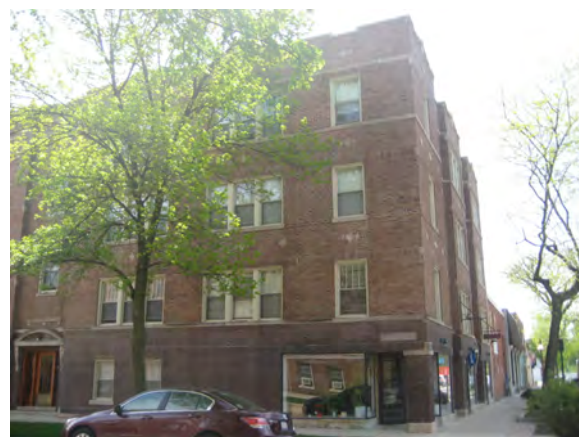
Cuyler St. elevation

Other Windows Replacement and glass block

Overall Condition poor

Notable Features Carved limestone "Supreme Juices" signs.
Service garage door facing Harrison street

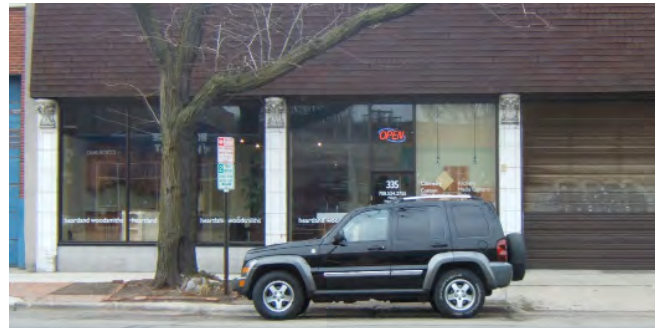
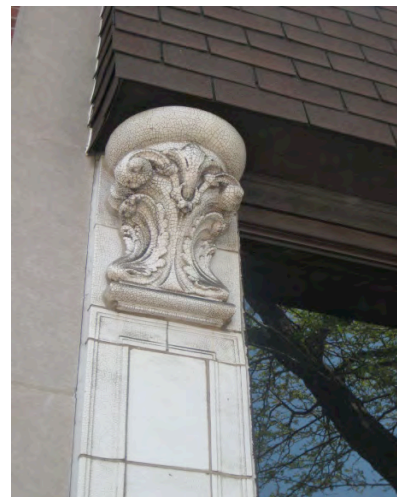
Overall Condition Good

Notable Features Terra cotta piers

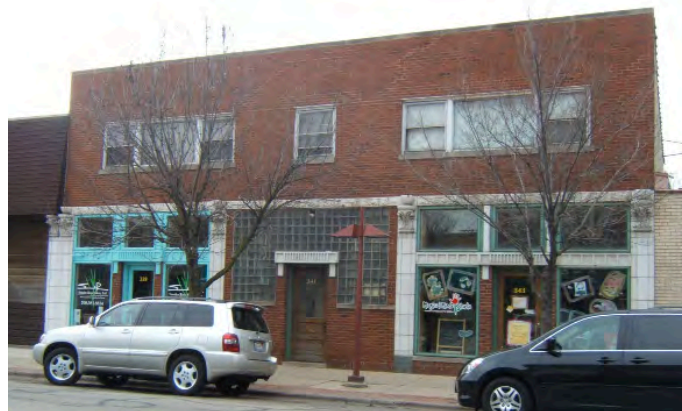
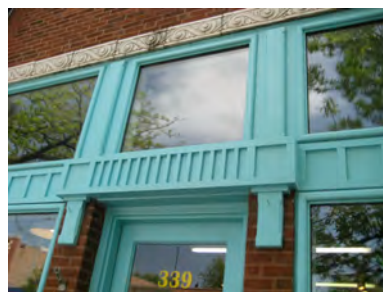
Map Number 84

Overall Condition Good

Notable Features Terra cotta elements on storefront

Built at same time by same architect as building to the east. Presume both were single story.

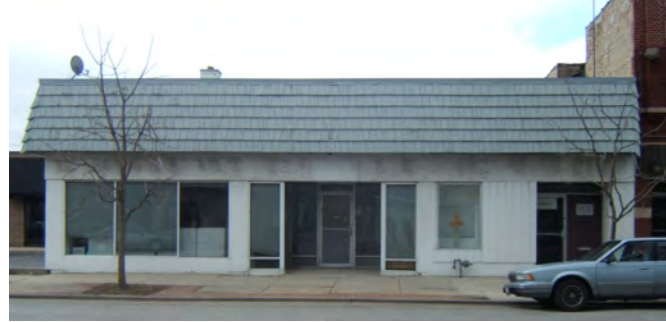
Overall Condition Fair

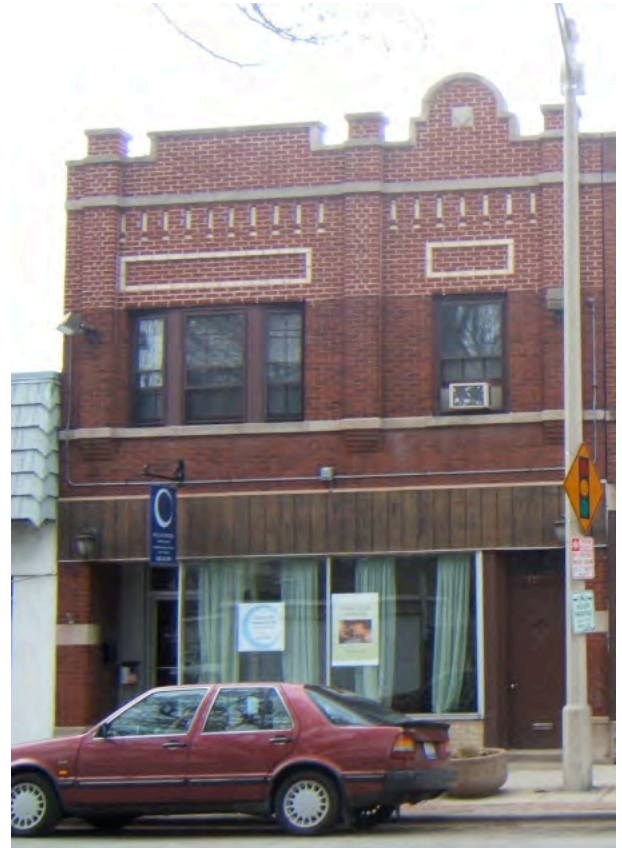
Overall Condition good

Notable Features Distinctive roof line with limestone details.

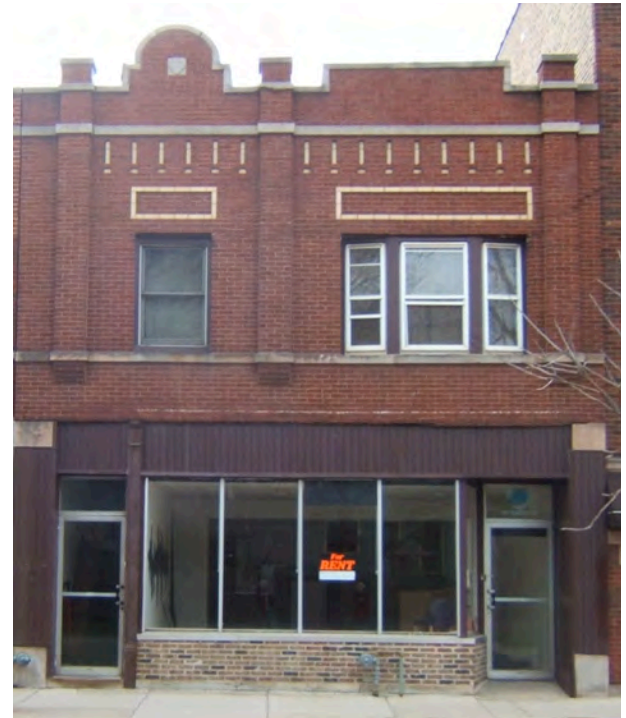
Poor tuckpointing job above second story windows, storefront-replacement windows, bulkhead and paneling above storefront
