Village of Oak Park

Lake Street Corridor

Architectural Historical Survey

Prepared by:
Wiss, Janney, Elstner Associates, Inc.
330 Pfingsten Road
Northbrook, Illinois 60062
(847) 272-7400
WJE Project No. 2005.4108

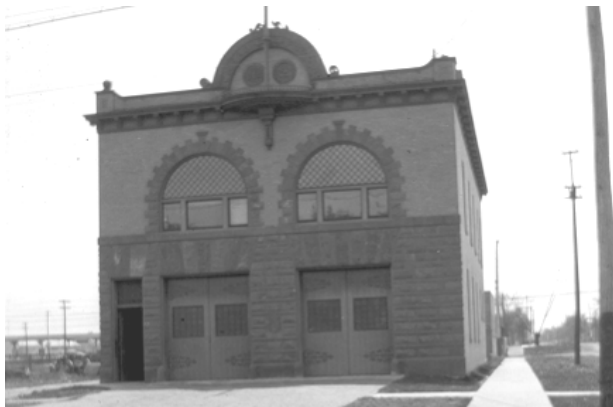
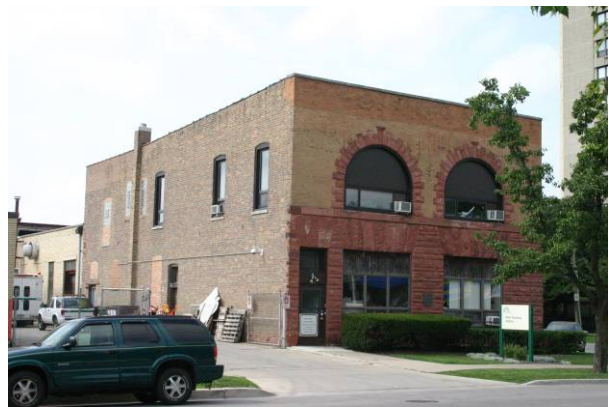
Left: The Cicero Township Fire Company No. 2 building, 1902 photograph courtesy of Historical Society of Oak Park and River Forest (Philander Barclay collection). Right: The building today, which now houses the Oak Park main water pumping station.

In 1886, Cicero Township Fire Company No. 2 was established in Ridgeland, and a wooden station house was built on Lake Street between Ridgeland and Cuyler Avenues (a location with the present-day address 322–324 Lake). This station was replaced by a large brick and stone structure on the south side of Lake Street at Lombard Avenue in 1898. The use of the building as a firehouse was discontinued in 1916. Oak Park had agreed to buy Lake Michigan water from Chicago in 1908, and a pumping station was established behind this building in 1912 to increase water pressure. This use of the building continues today.

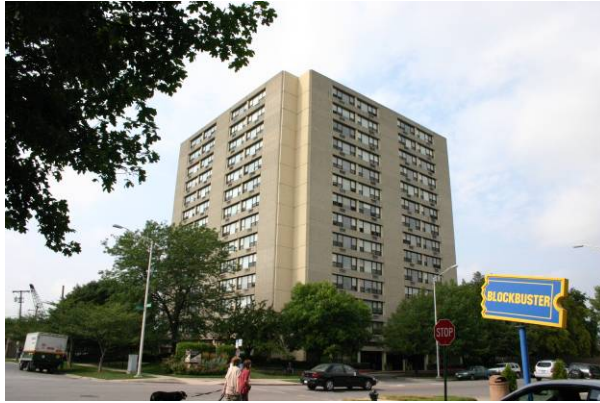
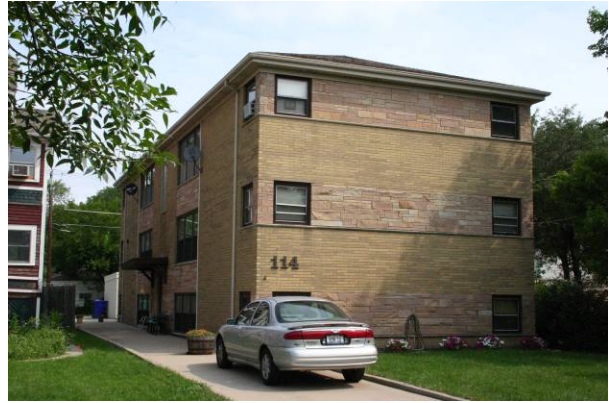
Left: The fourteen story Heritage House was constructed in 1979. Right: The infill apartment building at 114 Lake Street was constructed in 1961.

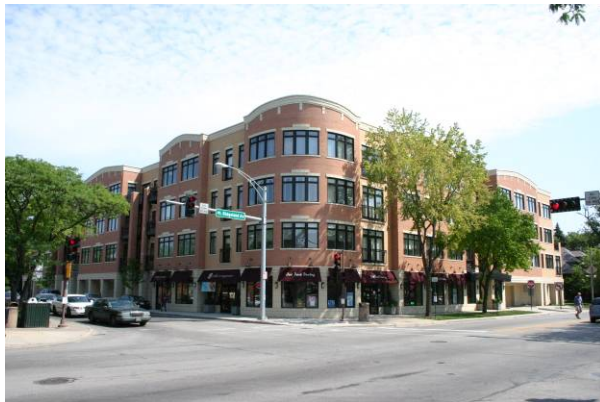
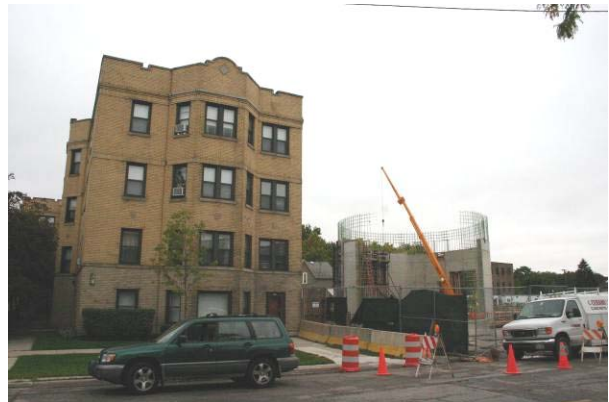
Left: Twenty-first century development in the corridor has included multi-unit residential and mixed use buildings, such as this recently completed four story building at the corner of South Boulevard and Ridgeland Avenue. Right: A new Oak Park Public Works Facility is now under construction on South Boulevard, with completion scheduled for mid-2007.

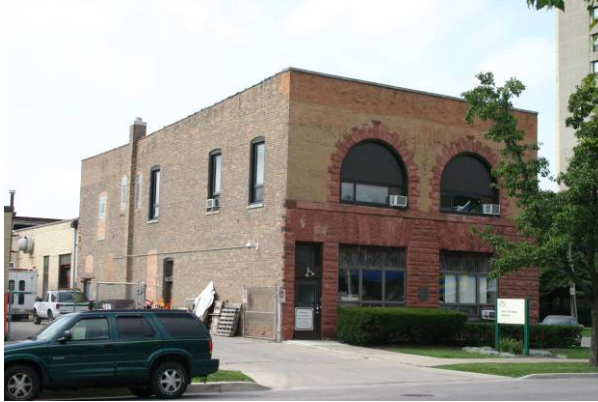
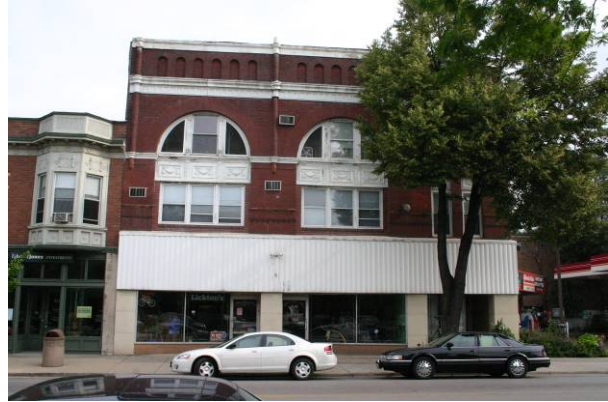
Two properties considered National Register-eligible as part of this study: left, the former Cicero Township Fire Company No. 2 (1898); right, the former Ridgeland Hall (1890).

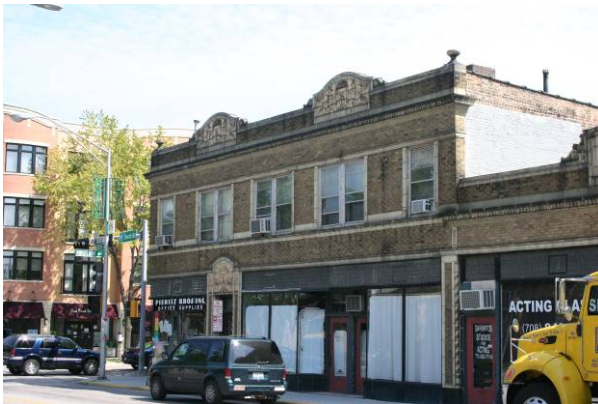
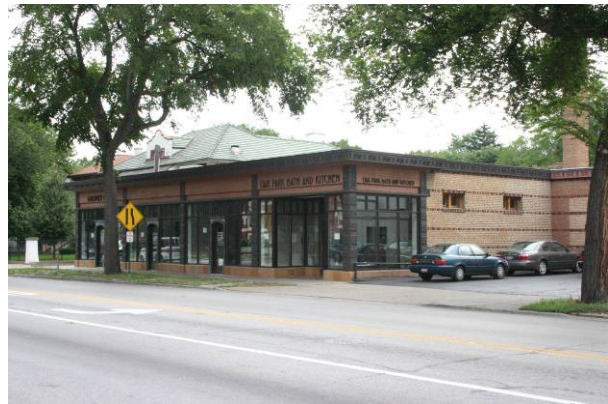
Examples of buildings designated Significant as part of this study: left, the retail/apartment building at South Boulevard and Ridgeland Avenue; right, the retail building at 128-136 North Ridgeland Avenue.

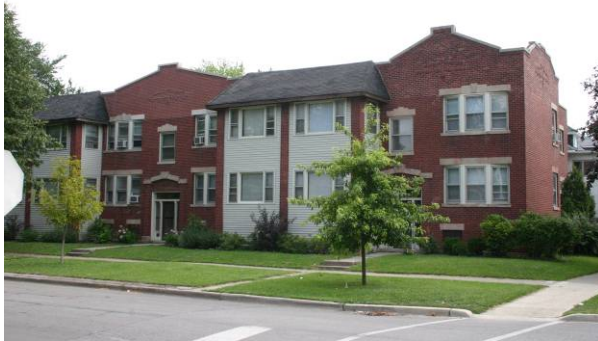
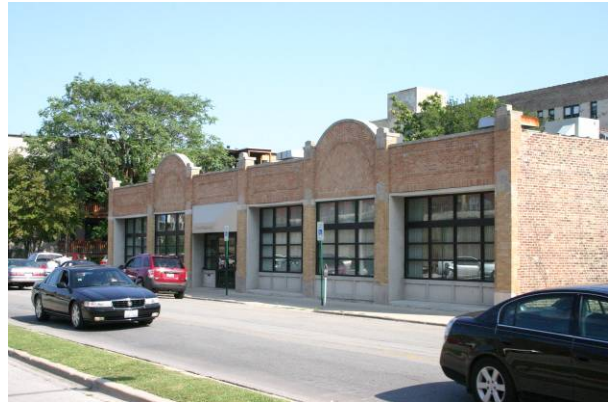
Left: The apartment building at 118–126 North Taylor Avenue, although somewhat altered, still retains a noteworthy historic character. Right: The former garage building at 21 South Boulevard, now used as offices, retains its basic simple historic character. Both of these buildings are designated Contributing.

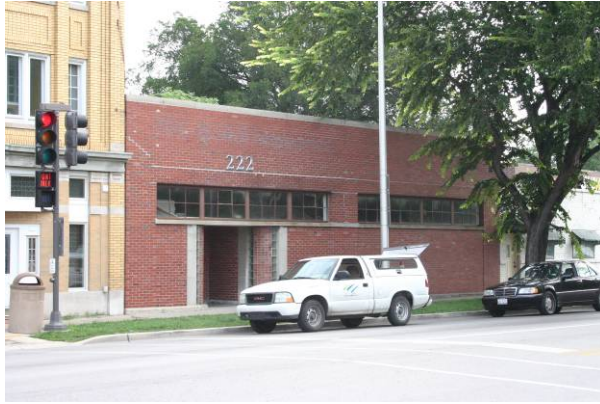
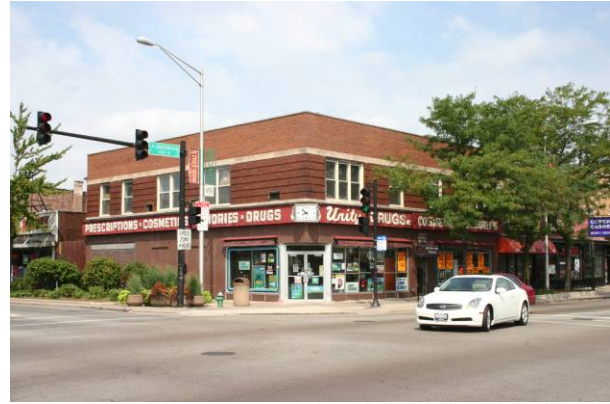
Non-contributing buildings include mainly post-World War II buildings like 222 Lake Street, as well as a small number of drastically altered older buildings, such as the retail building at the corner of Lake Street and Austin Boulevard.

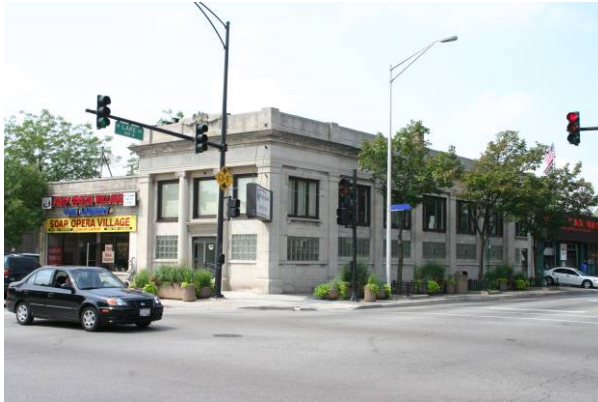
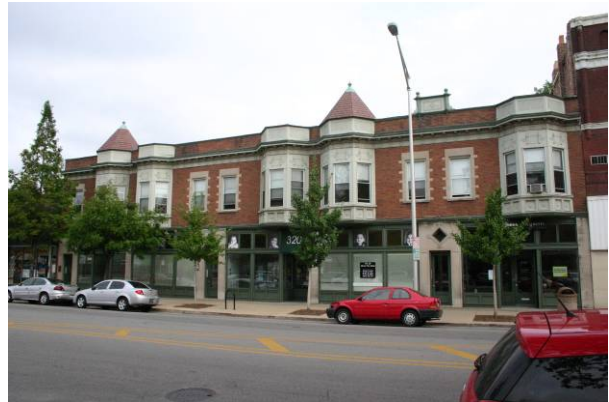
Left: The former First National Bank building anchors the commercial strip at the corner of Austin Boulevard and Lake Street. Right: Part of the commercial strip on Lake Street near Ridgeland Avenue.

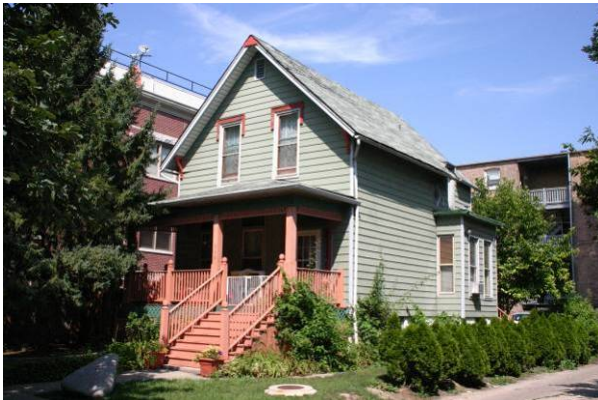
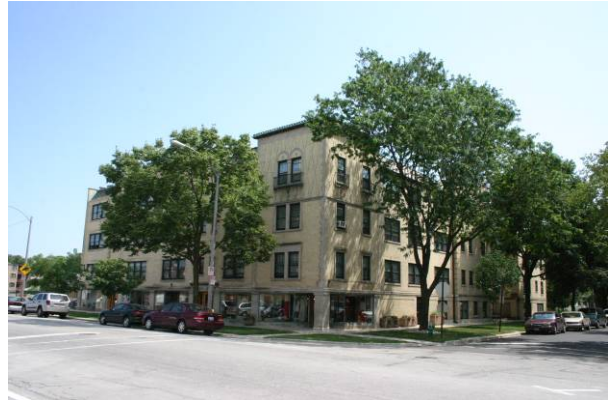
Left: The survey included some single family houses that date back to the earliest development of Ridgeland in the 1870s, such as this house on South Elmwood Avenue. Right: Other residential properties include 1920s apartment buildings such as this building at Harvey Avenue and South Boulevard.

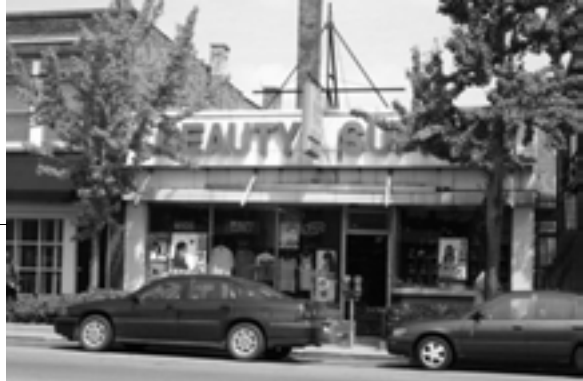
8 – Lake Street	Map ID Number	87	PIN Number	16-08-123-026
Significance	No Merit				
Current Owner	Hae S. Kim				
Current Use	Lake Beauty Supply				
Front Orientation	S	Number of Stories	1		
Style/Detailing	Commercial				
Wall Material(s)	Enamel Metal Panel				
	Ceramic Tile				
Storefront	Aluminum				
Other Windows					
Visible Roof Materials					
Overall Condition	Fair				
Notable Features	<div style="border: 1px solid black; height: 60px; width: 100%;"></div>

Date or Approx. Decade	1915	Original or Prior Uses	1915: John W. Cherry restaurant 1920s: Densby-Parsons Bakery 1970s: Ebert Studio (photography)
Architect		Additions/Alterations	Entire facade covered with enameled metal panels.
Contractor	Guy & McClintock		
Original Owner	Mrs. C. F. Miller	History Notes	From permit files: apparently reconstructed or greatly remodelled, 1927.
Field Notes	<div style="border: 1px solid black; height: 100px; width: 100%;"></div>

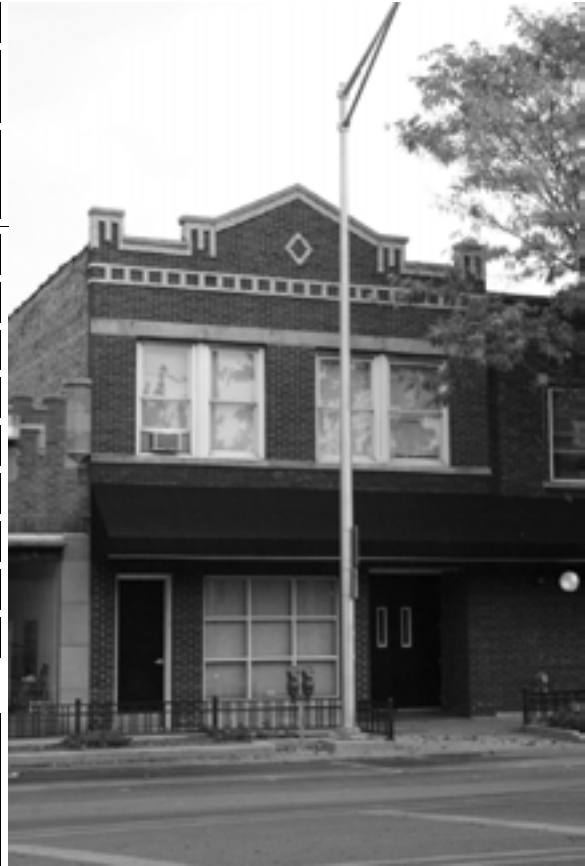
Front Orientation	<input type="text" value="S"/>	Number of Stories	<input type="text" value="2"/>
Style/Detailing	Commercial		
Wall Material(s)	Brick		
	Limestone		
Storefront	Aluminum		
Other Windows	Vinyl Double Hung		
Visible Roof Materials			
Overall Condition	Fair		
Notable Features

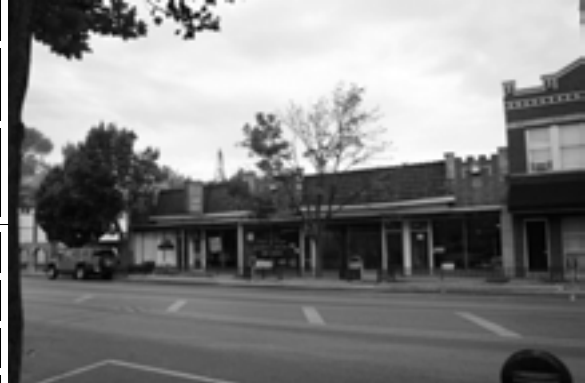
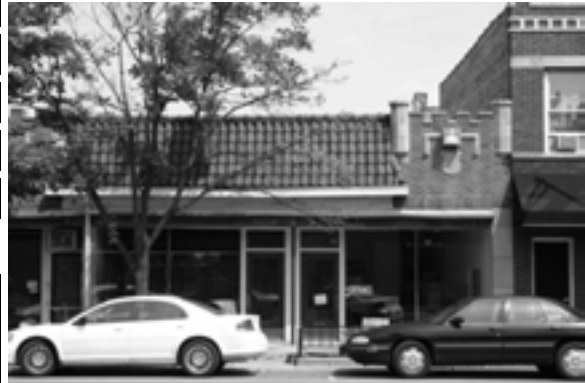
Significance	Structure of Merit
Current Owner	S.P.A. Inc.
Current Use	PCC Community Wellness Center House of Vogue Salo

Front Orientation	<input type="text" value="S"/>	Number of Stories	<input type="text" value="1"/>
Style/Detailing	Commercial		
Wall Material(s)	Brick		
	Limestone		
	Enamel Metal		
Storefront	Aluminum		
Other Windows			
Visible Roof Materials	Clay Tile		
Overall Condition	Fair		
Notable Features	<div style="border: 1px solid black; height: 60px; width: 100%;"></div>

Date or Approx. Decade	<input type="text" value="1922"/>	Original or Prior Uses	Various small shops
Architect	B. J. Bruns		
Contractor	Ben Friedman		
Original Owner		Additions/Alterations	<div style="border: 1px solid black; height: 40px; width: 100%;"></div>

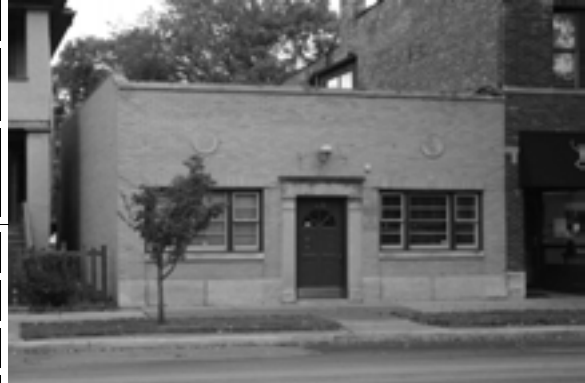
Significance	<input type="text" value="Contributing"/>
Current Owner	<input type="text" value="Oak Park Real Estate Inc."/>
Current Use	<input type="text" value="Oak Park Real Estate"/>

Front Orientation	<input type="text" value="S"/>	Number of Stories	<input type="text" value="1"/>
Style/Detailing	<input type="text" value="Art Moderne"/>		
Wall Material(s)	<input type="text" value="Brick"/>		
	<input type="text" value="Limestone"/>		
Storefront	<input type="text"/>		
Other Windows	<input type="text" value="Wood Double Hung"/>		
Visible Roof Materials	<input type="text"/>		
Overall Condition	<input type="text" value="Fair"/>

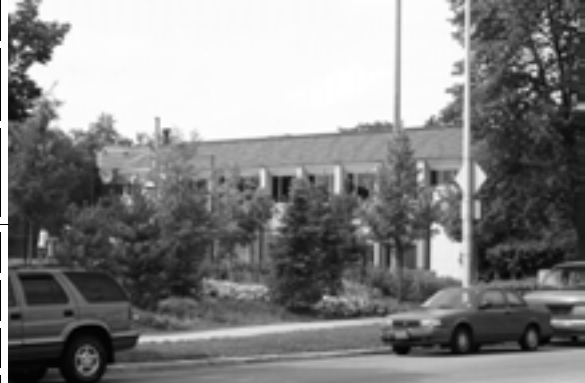
Significance	<input type="text" value="No Merit"/>
Current Owner	<input type="text" value="Park District of Oak Park"/>
Current Use	<input type="text" value="Stevenson Park fieldhouse"/>

Front Orientation	<input type="text" value="N"/>	Number of Stories	<input type="text" value="2"/>
Style/Detailing	<input type="text" value="Contemporary"/>		
Wall Material(s)	<input type="text" value="Brick"/>		
	<input type="text"/>		
Storefront	<input type="text"/>		
Other Windows	<input type="text" value="Aluminum Fixed"/>		
Visible Roof Materials	<input type="text" value="Asphalt shingle"/>		
Overall Condition	<input type="text" value="Good"/>		
Notable Features	<input type="text"/>

This building replaced the first Stevenson Park fieldhouse, constructed in 1927.

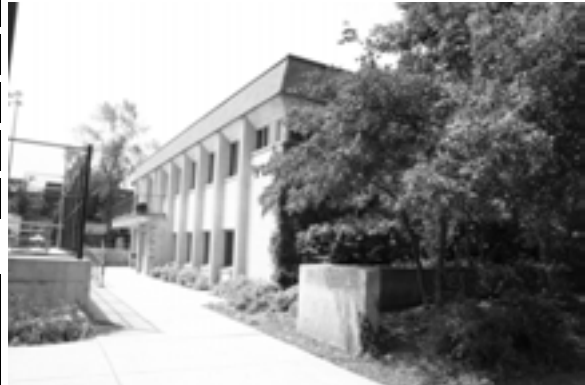
Date or Approx. Decade	<input type="text" value="1966"/>	Original or Prior Uses	<input type="text"/>
Architect	<input type="text"/>	Additions/Alterations	<input type="text"/>
Contractor	<input type="text"/>		
Original Owner	<input type="text"/>

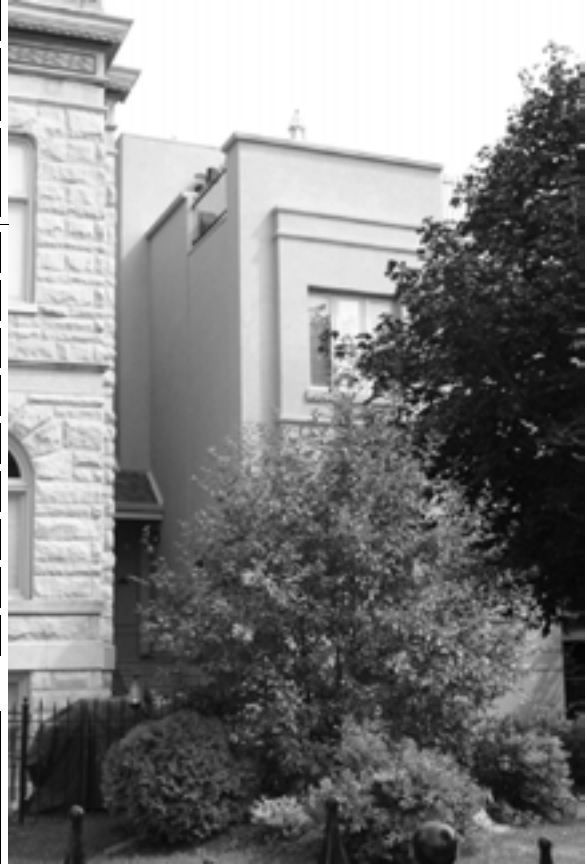
Map ID Number PIN Number

Significance	<input type="text" value="Non-contributing"/>
Current Owner	<input type="text" value="various"/>
Current Use	<input type="text" value="Condominium"/>

Front Orientation	<input type="text" value="S"/>	Number of Stories	<input type="text" value="3"/>
Style/Detailing	<input type="text" value="Contemporary"/>		
Wall Material(s)	<input type="text" value="EIFS"/>		
	<input type="text"/>		
Storefront	<input type="text"/>		
Other Windows	<input type="text" value="Aluminum Casement"/>		
Visible Roof Materials	<input type="text"/>		
Overall Condition	<input type="text" value="Good"/>		
Notable Features	<input type="text"/>

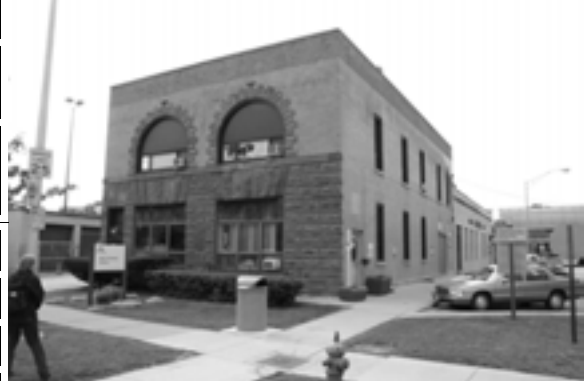
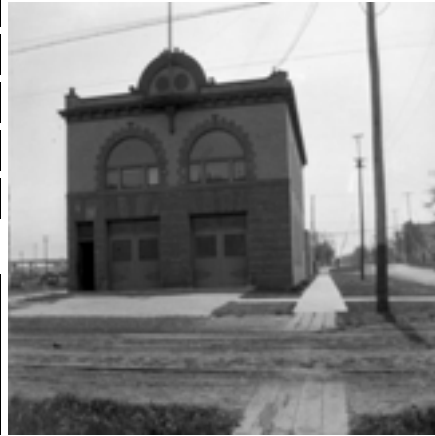
Map ID Number PIN Number

Significance	Significant (National Register eligible)
Current Owner	Village of Oak Park
Current Use	Oak Park Pumping Station

Front Orientation	<input type="text" value="N"/>	Number of Stories	<input type="text" value="2"/>
Style/Detailing	Romanesque Revival		
Wall Material(s)	Brick		
	Stone		
Storefront	Altered		
Other Windows	Aluminum Casement		
Visible Roof Materials			
Overall Condition	Fair		
Notable Features	Original interior wood floor

Date or Approx. Decade	<input type="text" value="1898"/>	Original or Prior Uses	Firehouse
Architect	<input type="text"/>	Additions/Alterations	Cornice removed
Contractor	<input type="text"/>		
Original Owner	Cicero Township	History Notes

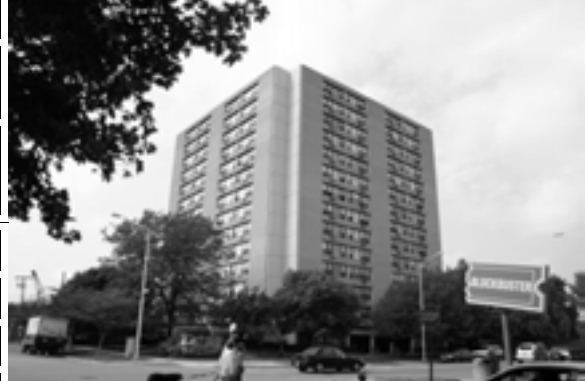
Map ID Number PIN Number

Significance	<input type="text" value="No Merit"/>
Current Owner	<input type="text" value="New Frontier Management"/>
Current Use	<input type="text" value="Heritage House apartments"/>

Front Orientation	<input type="text" value="N"/>	Number of Stories	<input type="text" value="14"/>
Style/Detailing	<input type="text" value="Contemporary"/>		
Wall Material(s)	<input type="text" value="Concrete"/>		
	<input type="text"/>		
	<input type="text"/>		
Storefront	<input type="text" value="Aluminum"/>		
Other Windows	<input type="text" value="Double Hung"/>		
Visible Roof Materials	<input type="text"/>		
Overall Condition	<input type="text" value="Good"/>

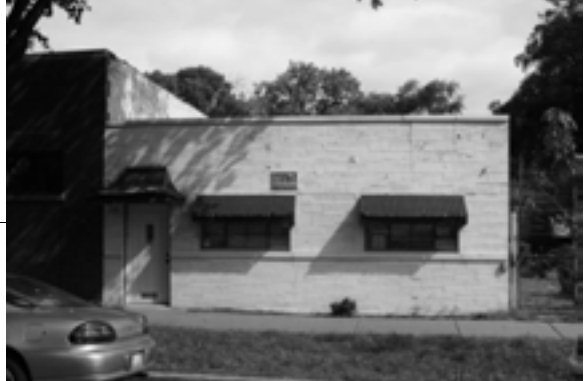
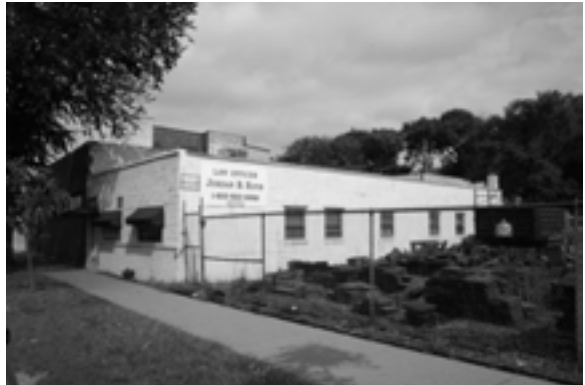
Current Owner Charice Phillips

Current Use Law Offices of Jordan B. Rifis

Front Orientation S Number of Stories 1

Style/Detailing Contemporary

Overall Condition Poor

Date or Approx. Decade 1948 Original or Prior Uses doctors' offices

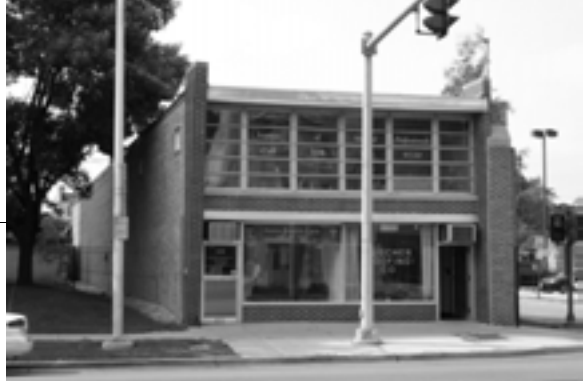
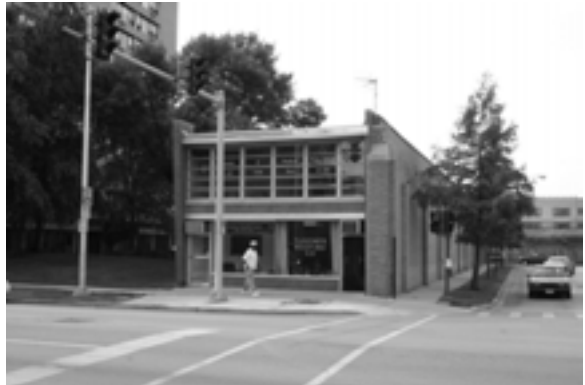
Map ID Number PIN Number

Significance	<input type="text" value="No Merit"/>
Current Owner	<input type="text" value="219-221 Lake LLC"/>
Current Use	<input type="text" value="Tuscher Roofing Co. / Home Healthcare"/>

Front Orientation	<input type="text" value="N"/>	Number of Stories	<input type="text" value="2"/>
-------------------	--------------------------------	-------------------	--------------------------------

Style/Detailing	<input type="text" value="Modernist"/>
-----------------	--

Overall Condition	<input type="text" value="Good"/>
-------------------	-----------------------------------

Date or Approx. Decade	<input type="text" value="1920s"/>
------------------------	------------------------------------

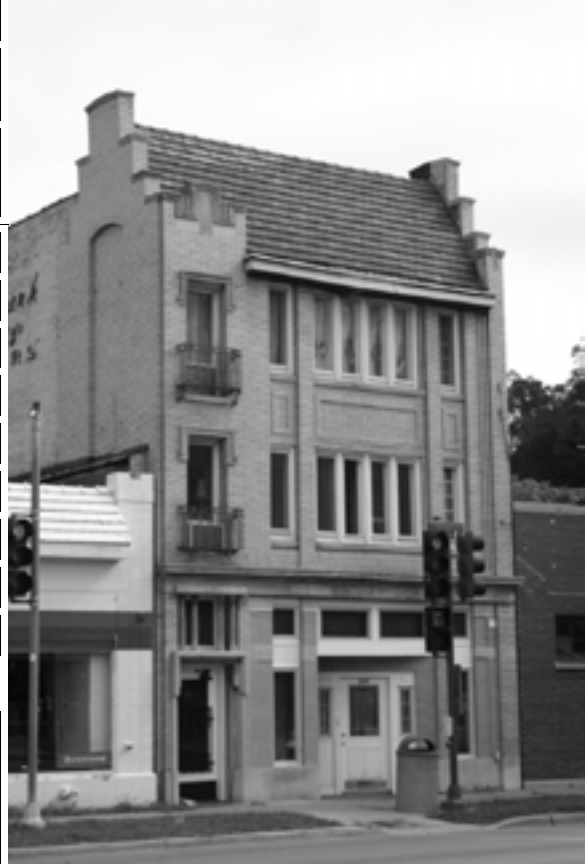
Significance	Significant (Local landmark eligible)
Current Owner	Charice Phillips
Current Use	Three-flat

Front Orientation	<input type="text" value="S"/>	Number of Stories	<input type="text" value="3"/>
Style/Detailing	Commercial		
Wall Material(s)	Brick		
	Limestone		
	Copper		
Storefront	None/Not Applicable		
Other Windows	Wood Casement		
Visible Roof Materials	Clay Tile		
Overall Condition	Good		
Notable Features			
Prism glass transoms, iron grilles

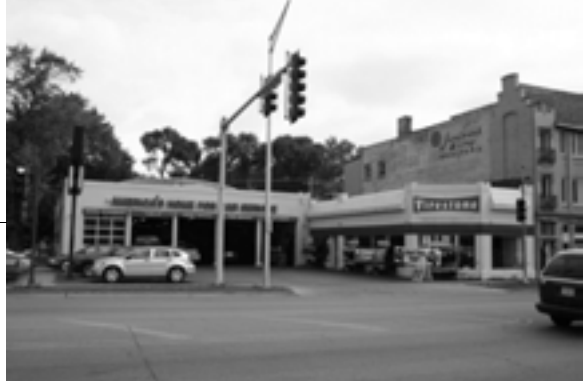
226 – Lake Street

Significance	<input type="text" value="Structure of Merit"/>
Current Owner	<input type="text" value="BFS Retail"/>
Current Use	<input type="text" value="Firestone Service Station"/>

Front Orientation	<input type="text" value="SW"/>	Number of Stories	<input type="text" value="1"/>
Style/Detailing	<input type="text" value="Commercial"/>		
Wall Material(s)	<input type="text" value="Brick"/>		
	<input type="text" value="Limestone"/>		
Storefront	<input type="text" value="Aluminum"/>		
Other Windows	<input type="text" value="Aluminum Fixed"/>		
Visible Roof Materials	<input type="text" value="Clay Tile"/>		
Overall Condition	<input type="text" value="Fair"/>

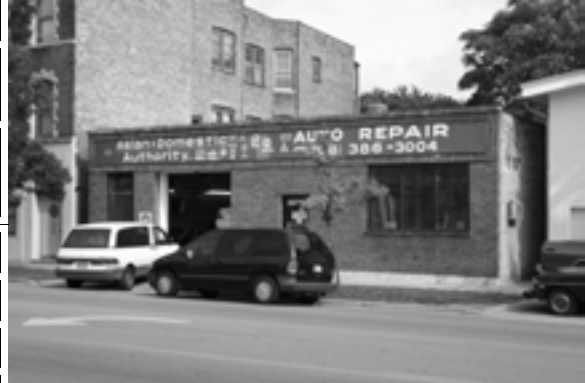
Map ID Number PIN Number

Significance	<input type="text" value="Non-contributing"/>
Current Owner	<input type="text" value="-"/>
Current Use	<input type="text" value="Asian Domestic Auto Repair"/>

Front Orientation	<input type="text" value="S"/>	Number of Stories	<input type="text" value="1"/>
Style/Detailing	<input type="text" value="Commercial"/>		
Wall Material(s)	<input type="text" value="Brick"/>		
	<input type="text" value="Limestone"/>		
Storefront	<input type="text"/>		
Other Windows	<input type="text" value="Aluminum Fixed"/>		
Visible Roof Materials	<input type="text"/>		
Overall Condition	<input type="text"/>

Date or Approx. Decade	<input type="text" value="1915"/>	Original or Prior Uses	<input type="text" value="1923: Universal Auto Repair Shop"/>
Architect	<input type="text"/>	Additions/Alterations	<input type="text"/>
Contractor	<input type="text" value="Guy & McClintock"/>		
Original Owner	<input type="text" value="Guy & McClintock"/>

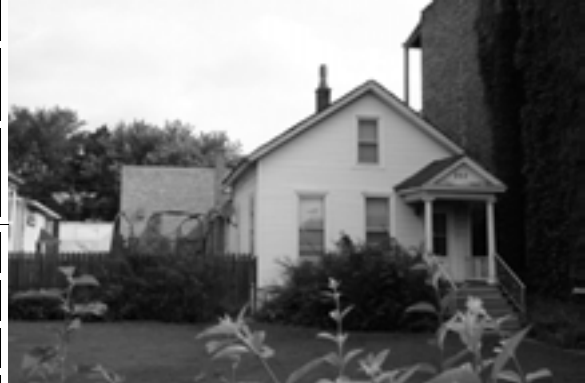
Map ID Number 138 PIN Number 16-08-119-028

Significance	Non-contributing
Current Owner	John R. Gilchrist
Current Use	unknown

Front Orientation	S	Number of Stories	1-1/2
Style/Detailing			
Wall Material(s)	Vinyl Siding		
	Brick		
Storefront	None/Not Applicable		
Other Windows	Wood Double Hung		
Visible Roof Materials	Asphalt shingle		
Overall Condition	Fair

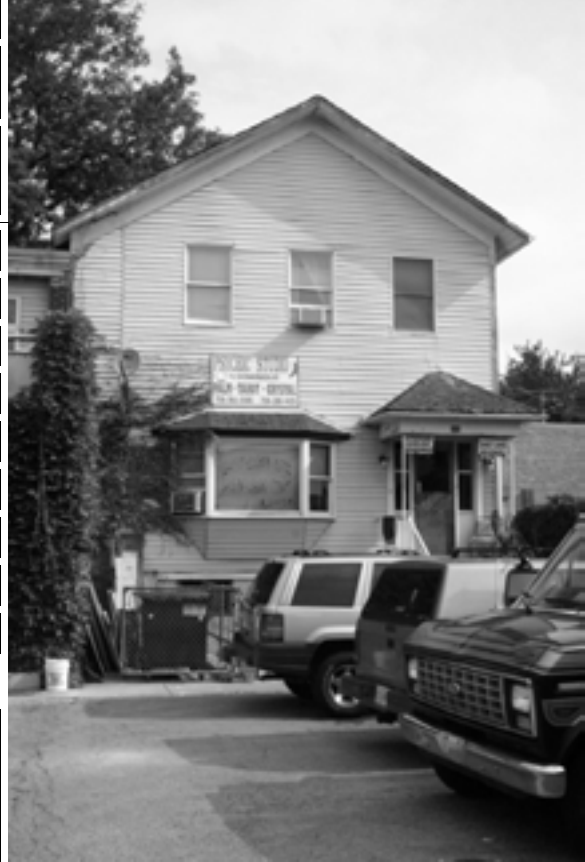
Significance	Non-contributing
Current Owner	Robert Patel
Current Use	Dominique Psychic Studio

Front Orientation	S	Number of Stories	2
Style/Detailing	Italianate		
Wall Material(s)	Vinyl Siding		
Storefront			
Other Windows	Aluminum Double Hung		
Visible Roof Materials	Asphalt Shingle		
Overall Condition	Poor		
Notable Features	<p>Limestone foundation. Italianate style detailing at east side bay window.</p>

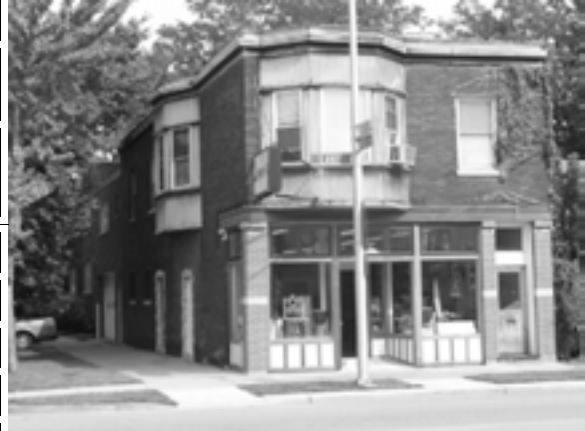
Significance	Contributing
Current Owner	John R. Gilchrist
Current Use	Joyce's

Front Orientation	S	Number of Stories	2
Style/Detailing	Commercial		
Wall Material(s)	Brick		
	Copper		
	Limestone		
Storefront	Wood		
Other Windows	Vinyl Double Hung		
Visible Roof Materials			
Overall Condition	Poor		
Notable Features	Copper cladding at second floor bay windows

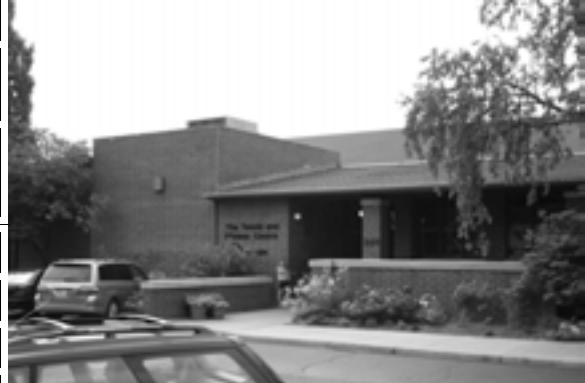
301 – Lake Street

Front Orientation	<input type="text" value="N"/>	Number of Stories	<input type="text" value="1"/>
Style/Detailing	<input type="text"/>		
Wall Material(s)	<input type="text" value="Brick"/>		
	<input type="text" value="Limestone"/>		
	<input type="text" value="Cmu"/>		
Storefront	<input type="text"/>		
Other Windows	<input type="text" value="Aluminum Fixed"/>		
Visible Roof Materials	<input type="text" value="Asphalt Shingle"/>		
Overall Condition	<input type="text" value="Good"/>

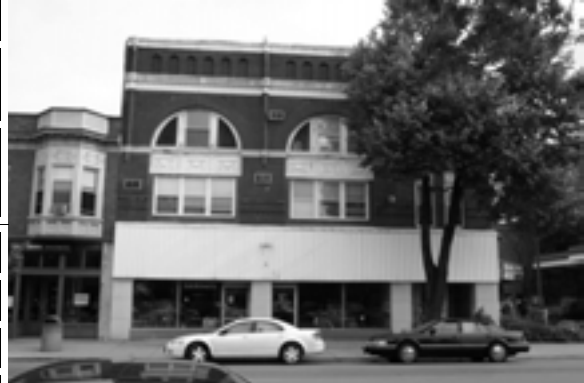
Front Orientation	<input type="text" value="S"/>	Number of Stories	<input type="text" value="3"/>
Style/Detailing	<input type="text"/>		
Wall Material(s)	<input type="text" value="Brick"/>		
	<input type="text" value="Wood"/>		
	<input type="text" value="Enamel Metal Panel"/>		
Storefront	<input type="text" value="Aluminum"/>		
Other Windows	<input type="text" value="Vinyl Double Hung"/>		
Visible Roof Materials	<input type="text"/>		
Overall Condition	<input type="text" value="Poor"/>		
Notable Features	<input type="text" value="Skylight"/>

Date or Approx. Decade	<input type="text" value="1890"/>	Original or Prior Uses	<input type="text" value="Ridgeland Hall owned by Lickton family since 1920s."/>
Architect	<input type="text"/>	Additions/Alterations	<input type="text" value="First floor greatly altered; windows replaced; original tower at southeast corner removed."/>
Contractor	<input type="text"/>		
Original Owner	<input type="text" value="Ridgeland Hall Association"/>	History Notes	<input type="text" value="Constructed as a community hall for Ridgeland, 1888-1890. [OAK LEAVES, 5/19/1928, p. 62]"/>

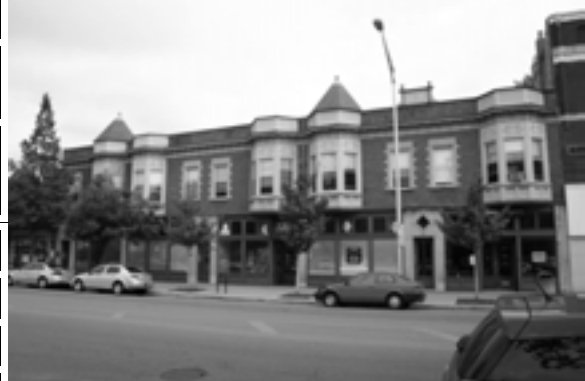
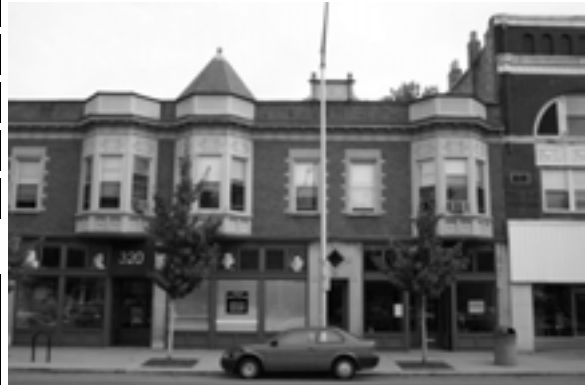
316 – 324 Lake Street

Front Orientation	<input type="text" value="S"/>	Number of Stories	<input type="text" value="2"/>
Style/Detailing	Commercial		
Wall Material(s)	Brick		
	Limestone		
	Sheet Metal		
Storefront	Aluminum		
Other Windows	Vinyl Double Hung		
Visible Roof Materials	Slate, Copper		
Overall Condition	Good

projecting bay windows 2nd floor

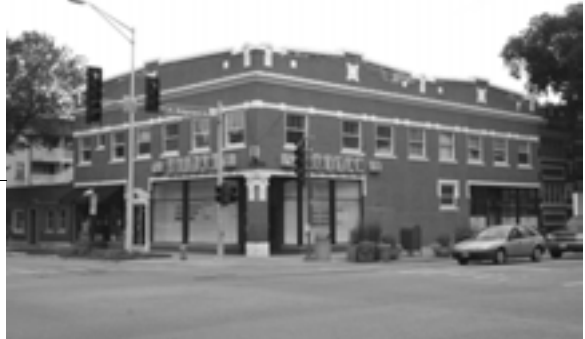
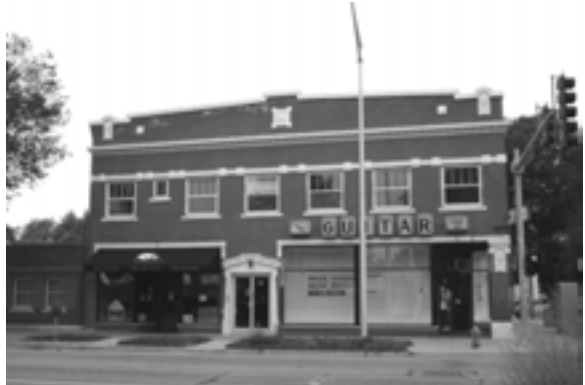
Front Orientation	<input type="text" value="SE"/>	Number of Stories	<input type="text" value="2"/>
Style/Detailing	<input type="text" value="Commercial"/>		
Wall Material(s)	<input type="text" value="Brick"/>		
	<input type="text" value="Terra Cotta"/>		
Storefront	<input type="text" value="Aluminum"/>		
Other Windows	<input type="text" value="Wood Double Hung"/>		
Visible Roof Materials	<input type="text"/>		
Overall Condition	<input type="text" value="Fair"/>

Date or Approx. Decade	<input type="text" value="1911"/>	Original or Prior Uses	<input type="text" value="W.J.B. Gram's drugstore; professional offices"/>
Architect	<input type="text" value="Frederick R. Schock"/>	Additions/Alterations	<input type="text" value="Some windows replaced"/>
Contractor	<input type="text" value="Guy & McClintock"/>		
Original Owner	<input type="text" value="E. A. Cummings"/>	History Notes	<input type="text"/>

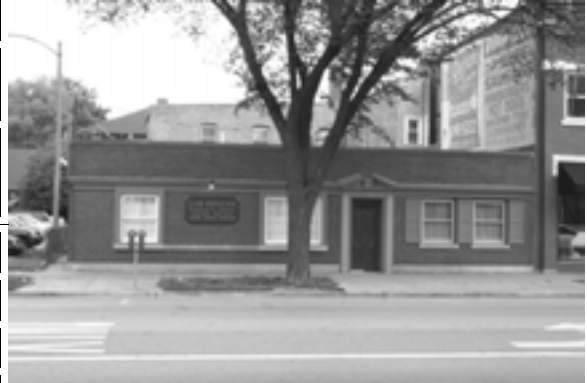
410 – Lake Street

Front Orientation	<input type="text" value="S"/>	Number of Stories	<input type="text" value="1"/>
Style/Detailing	<input type="text" value="Colonial Revival"/>		
Wall Material(s)	<input type="text" value="Brick"/>		
	<input type="text" value="Limestone"/>		
	<input type="text" value="Wood Siding"/>		
Storefront	<input type="text" value="None/Not Applicable"/>		
Other Windows	<input type="text" value="Aluminum Double Hung"/>		
Visible Roof Materials	<input type="text"/>		
Overall Condition	<input type="text" value="Good"/>

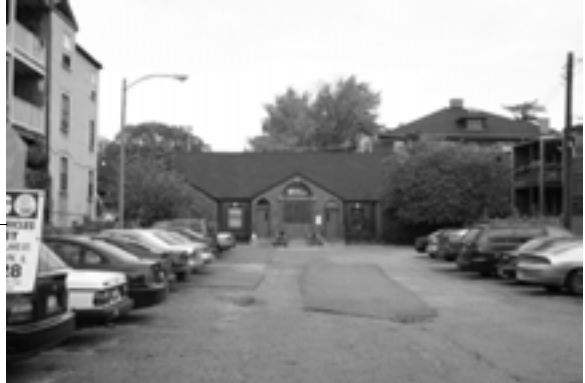
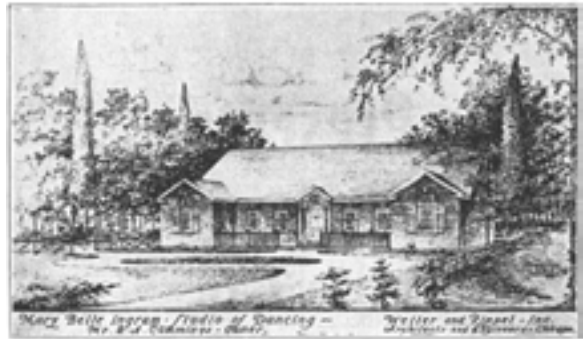
Front Orientation	S	Number of Stories	1
Style/Detailing	Colonial Revival		
Wall Material(s)	Brick		
Storefront	None/Not Applicable		
Other Windows	Double Hung		
Visible Roof Materials	Asphalt shingle		
Overall Condition	Fair		
Notable Features	<div style="border: 1px solid black; height: 60px; width: 100%;"></div>

Date or Approx. Decade	1922	Original or Prior Uses
Architect	Weller and Rippel, Inc.	Mrs. Mary Belle Ingram's Dance Hall West Suburban Jewish Center (1940s) American Legion Post (1950s)
Contractor	Guy & McClintock	
Original Owner	E. A. Cummings	Additions/Alterations
		Somewhat remodelled, but this is the historic dance hall building.

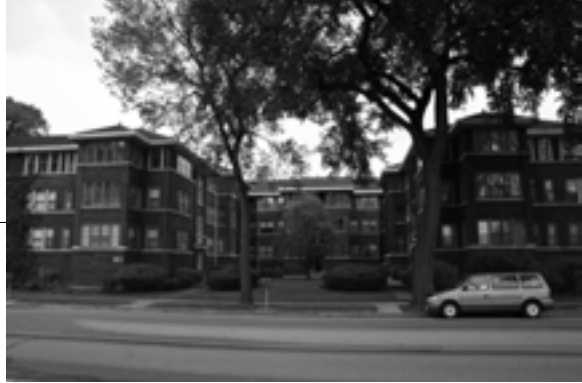
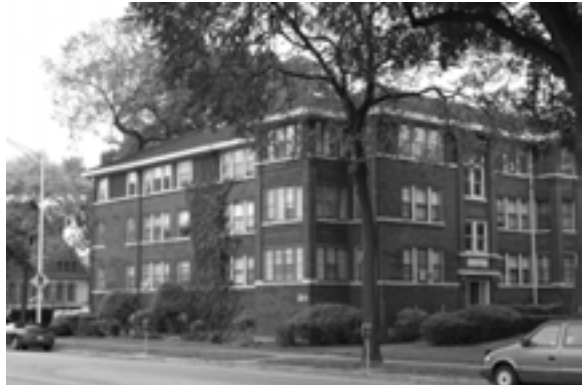
Front Orientation	<input type="text" value="S"/>	Number of Stories	<input type="text" value="3"/>
Style/Detailing	<input type="text"/>		
Wall Material(s)	<input type="text" value="Brick"/>		
	<input type="text" value="Limestone"/>		
Storefront	<input type="text"/>		
Other Windows	<input type="text"/>		
Visible Roof Materials	<input type="text" value="Clay tile"/>		
Overall Condition	<input type="text" value="Good"/>		
Notable Features	<input type="text"/>

Date or Approx. Decade	<input type="text" value="1913"/>	Original or Prior Uses	<input type="text"/>
Architect	<input type="text"/>	Additions/Alterations	<input type="text"/>
Contractor	<input type="text" value="H. Hogans"/>		
Original Owner	<input type="text" value="H. Hogans"/>

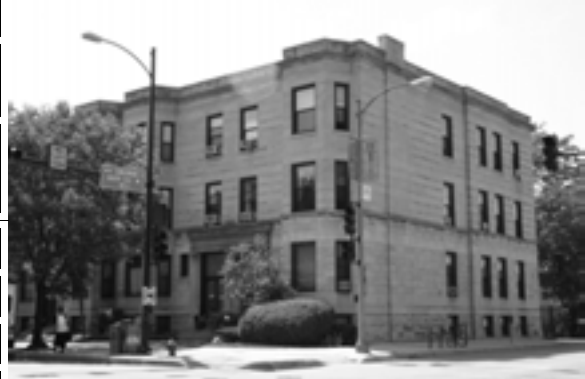
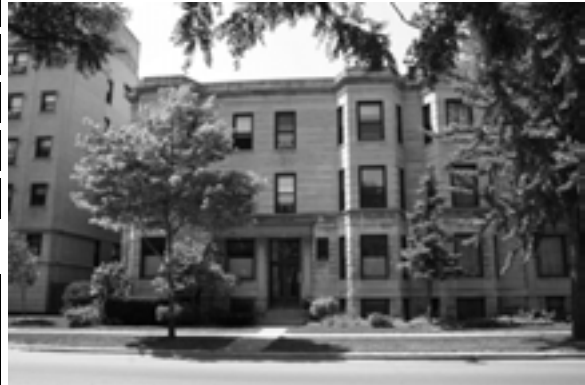
Front Orientation	E	Number of Stories	3
Style/Detailing	Neo-Classical Revival		
Wall Material(s)	Limestone		
Storefront			
Other Windows	Aluminum Double Hung		
Visible Roof Materials			
Overall Condition	Good

Limestone detailing is concentrated near entrances.

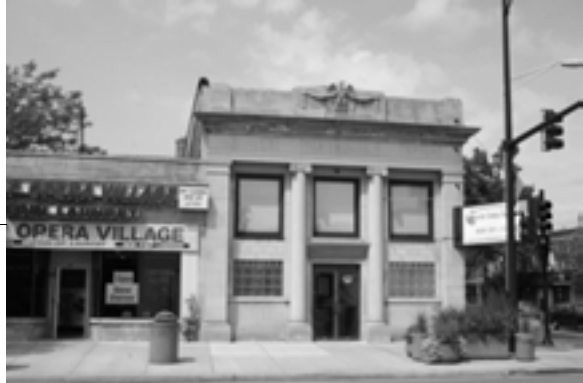
Front Orientation	E	Number of Stories	2
Style/Detailing	Neo-Classical Revival		
Wall Material(s)	Limestone		
Storefront	Glass block		
Other Windows	Wood Fixed		
Visible Roof Materials			
Overall Condition	Fair		
Notable Features	Limestone Ornament

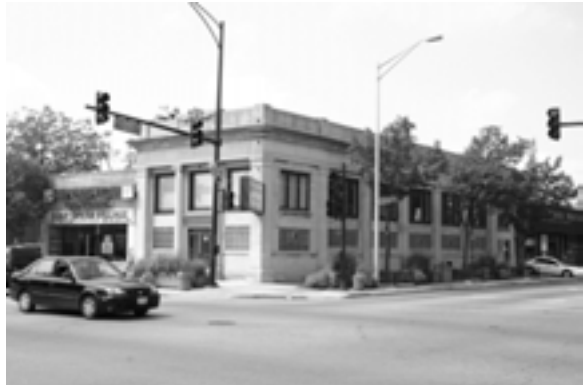
Date or Approx. Decade	1920	Original or Prior Uses	bank
Architect	William C. Miller	Additions/Alterations	
Contractor	W. A. Pillinger		
Original Owner	First National Bank of Oak Park

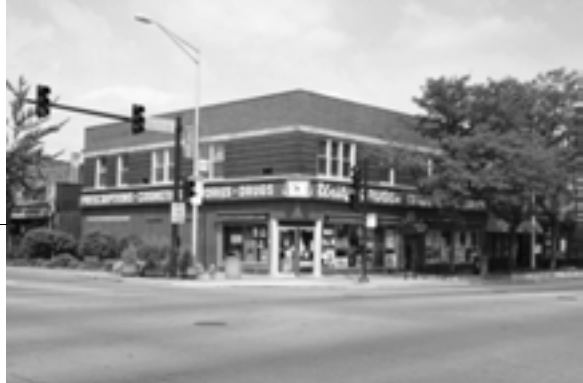
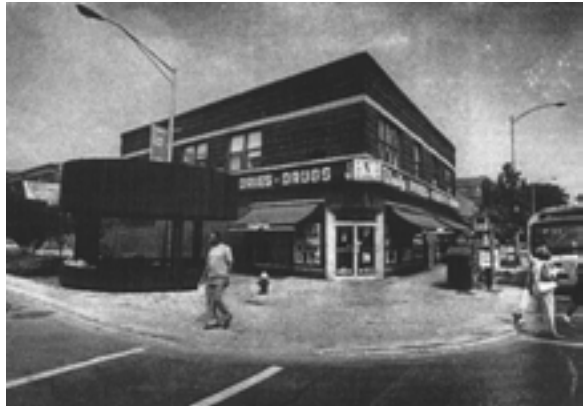
Front Orientation	<input type="text" value="SE"/>	Number of Stories	<input type="text" value="2"/>
Style/Detailing	<input type="text" value="Commercial"/>		
Wall Material(s)	<input type="text" value="Brick"/>		
	<input type="text" value="Limestone"/>		
	<input type="text" value="Granite"/>		
Storefront	<input type="text" value="Aluminum"/>		
Other Windows	<input type="text" value="Vinyl Double Hung"/>		
Visible Roof Materials	<input type="text"/>		
Overall Condition	<input type="text" value="Fair"/>		
Notable Features	<input type="text" value="Horizontal emphasis from recessed brick coursing of second floor."/>

Date or Approx. Decade	<input type="text" value="1907"/>	Original or Prior Uses	<input type="text"/>
Architect	<input type="text"/>	Additions/Alterations	<input type="text" value="Original parapet wall removed since 1983; ground floor drastically altered."/>
Contractor	<input type="text" value="W. A. Pillinger"/>		
Original Owner	<input type="text" value="C. Miller"/>	History Notes	<input type="text" value="[THE WORLD, 4/13/1975, p.3, photograph; and WEDNESDAY JOURNAL, 9/7/1983, p.5, photograph, included on this survey form]"/>

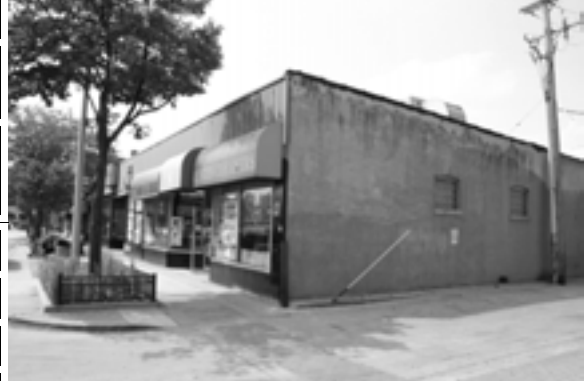
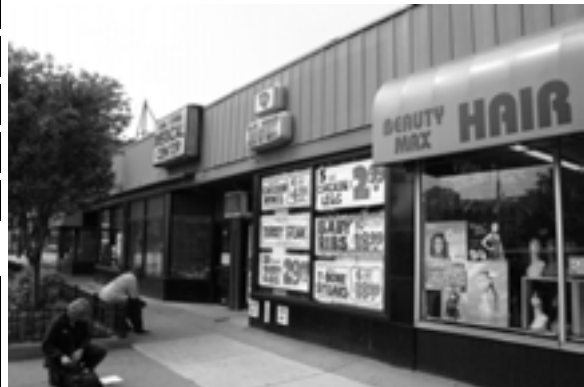
420 – 430 N. Austin Boulevard

Front Orientation E **Number of Stories** 1

Overall Condition Fair

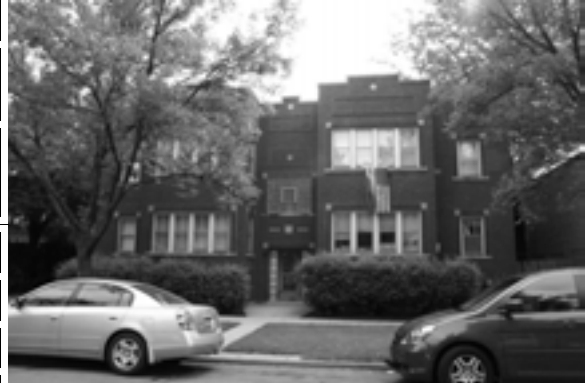
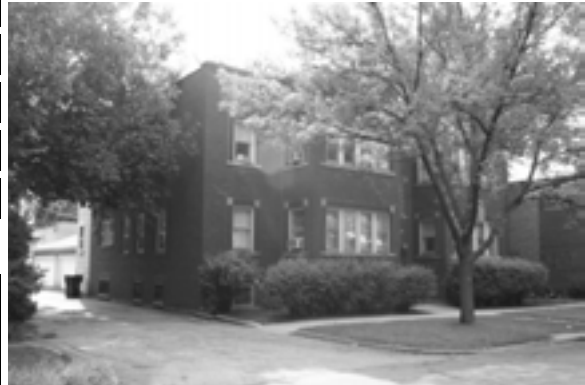
Front Orientation	W	Number of Stories	2
-------------------	---	-------------------	---

Overall Condition	Fair
-------------------	------

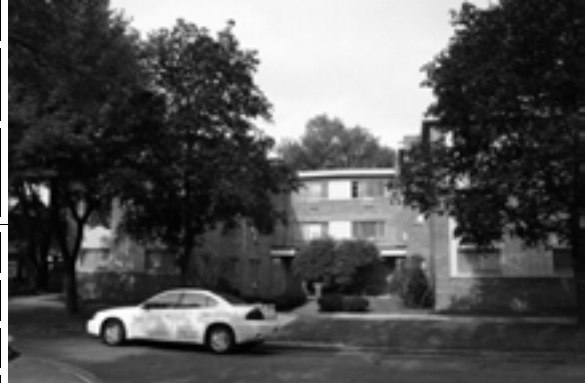
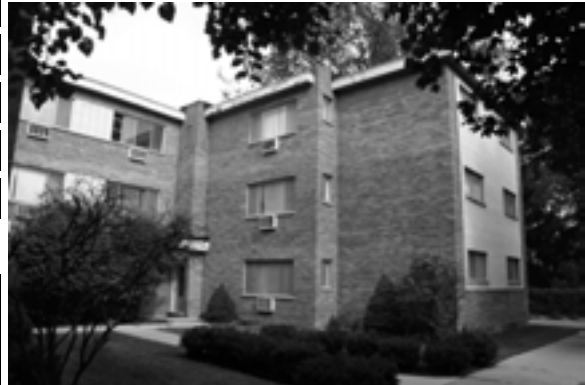
Front Orientation	E	Number of Stories	3
Style/Detailing	Contemporary		
Wall Material(s)	Brick		
	Wood		
Storefront			
Other Windows	Aluminum Sliding		
Visible Roof Materials			
Overall Condition	Fair		
Notable Features

Date or Approx. Decade	1962	Original or Prior Uses	"Cuyler Courts" Apartments
Architect	Ronald Handler	Additions/Alterations	
Contractor			
Original Owner		Field Notes

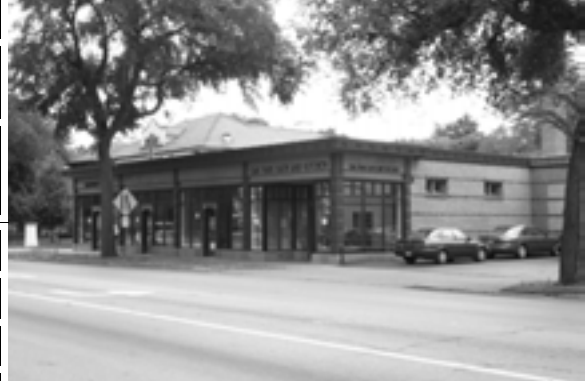
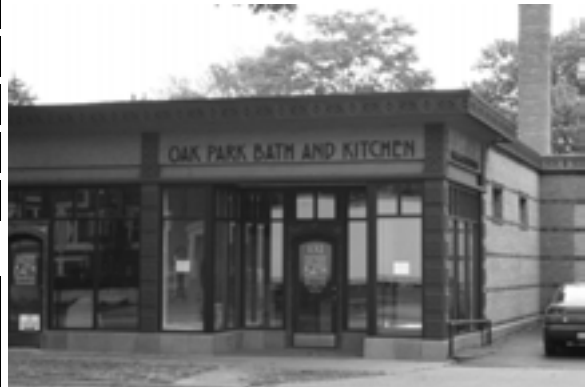
Front Orientation	<input type="text" value="W"/>	Number of Stories	<input type="text" value="1"/>
Style/Detailing	<input type="text" value="Prairie"/>		
Wall Material(s)	<input type="text" value="Terra Cotta"/>		
	<input type="text" value="Brick"/>		
	<input type="text" value="Stucco"/>		
Storefront	<input type="text" value="Bronze/Aluminum"/>		
Other Windows	<input type="text" value="Casement"/>		
Visible Roof Materials	<input type="text"/>		
Overall Condition	<input type="text" value="Good"/>

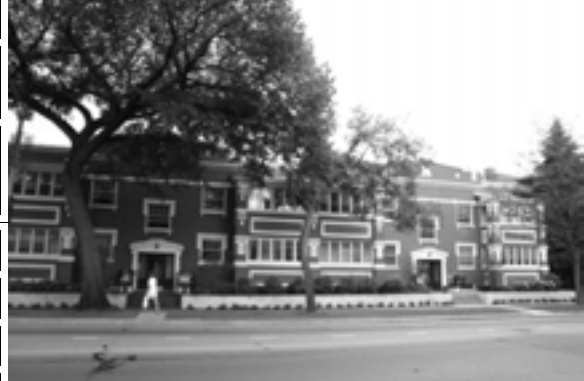
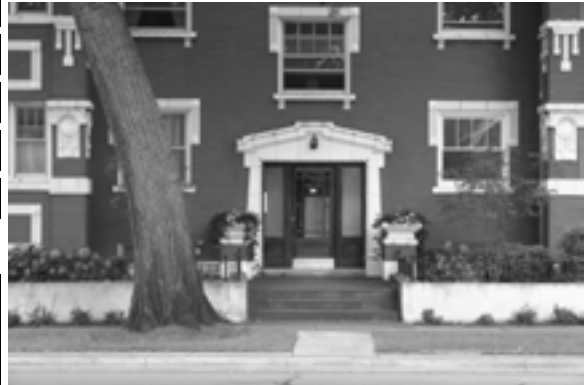
135 – 141 N. Ridgeland Avenue

Front Orientation	E	Number of Stories	2
Style/Detailing	Craftsman/Arts and Crafts		
Wall Material(s)	Brick		
	Terra Cotta		
Storefront			
Other Windows	Wood Double Hung		
Visible Roof Materials			
Overall Condition	Good		
Notable Features	Terra cotta ornament matches 400-404 Lake Street

Date or Approx. Decade	1913	Original or Prior Uses	apartments
Architect	Frederick R. Schock	Additions/Alterations	
Contractor	Guy & McClintock		
Original Owner	E. A. Cummings	History Notes
