Village of Oak Park

Lake Street Corridor

Architectural Historical Survey

Prepared by:
Wiss, Janney, Elstner Associates, Inc.
330 Pfingsten Road
Northbrook, Illinois 60062
(847) 272-7400
WJE Project No. 2005.4108

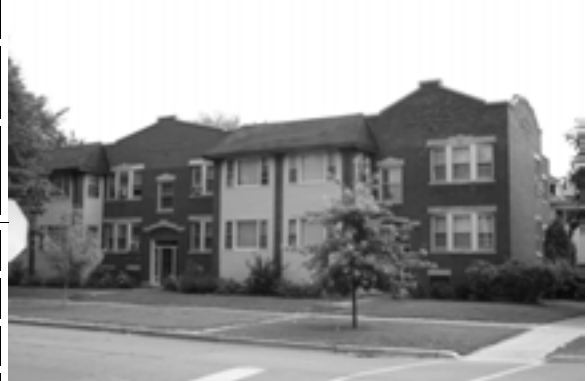
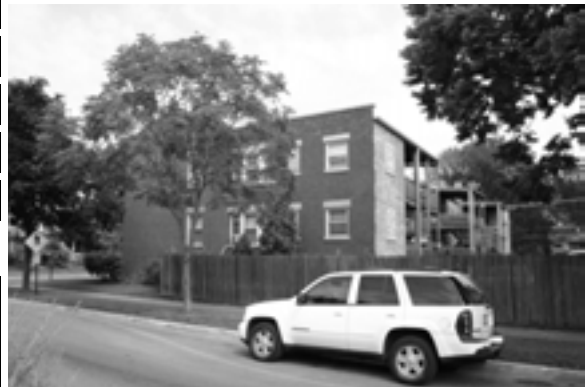
118 – 126 N. Taylor Avenue

Front Orientation	<input type="text" value="W"/>	Number of Stories	<input type="text" value="2"/>
Style/Detailing	<input type="text"/>		
Wall Material(s)	<input type="text" value="Brick"/>		
	<input type="text" value="Vinyl Siding"/>		
	<input type="text" value="Limestone"/>		
Storefront	<input type="text"/>		
Other Windows	<input type="text" value="Wood Double Hung"/>		
Visible Roof Materials	<input type="text" value="Asphalt Shingle"/>		
Overall Condition	<input type="text" value="Good"/>		
Notable Features	<input type="text"/>

Date or Approx. Decade	<input type="text" value="1913"/>	Original or Prior Uses	<input type="text" value="apartments"/>
Architect	<input type="text"/>	Additions/Alterations	<input type="text" value="Porches enclosed"/>
Contractor	<input type="text" value="Johson Earle"/>		
Original Owner	<input type="text" value="R. M. Pray"/>	History Notes

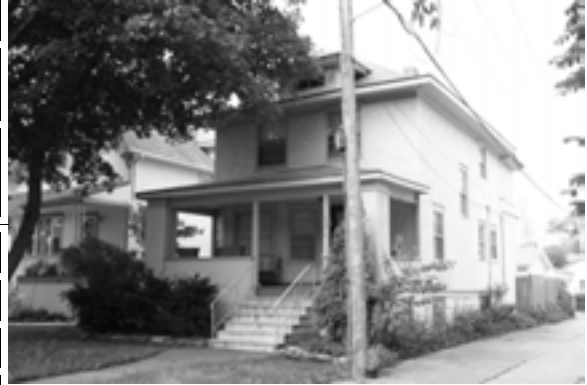
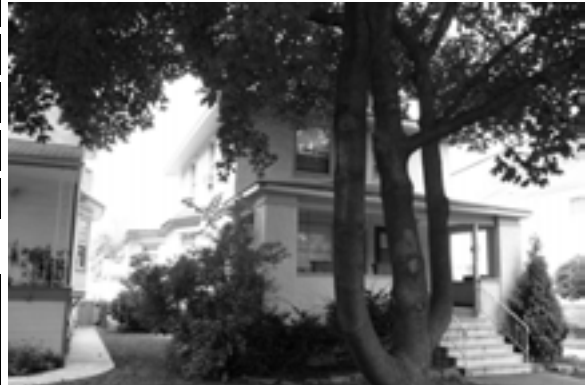
Map ID Number 113 PIN Number 16-08-121-047

Front Orientation	E	Number of Stories	2
Style/Detailing	Craftsman/Arts and Crafts		
Wall Material(s)	Stucco		
	Wood		
Storefront			
Other Windows	Wood Double Hung		
Visible Roof Materials	Asphalt Shingle		
Overall Condition	Good

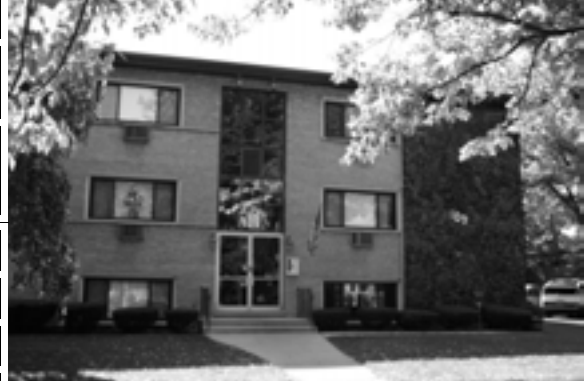
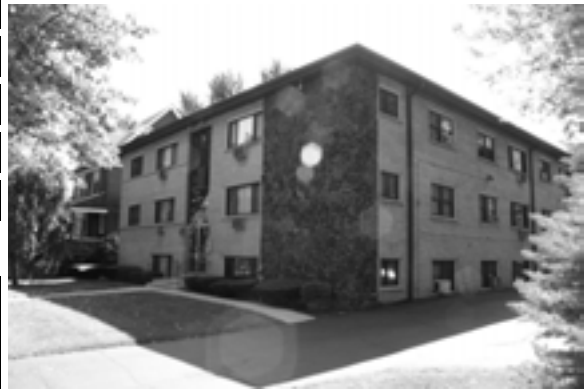
16-07-404-032

Front Orientation	E	Number of Stories	3
Style/Detailing	Contemporary		
Wall Material(s)	Brick		
	Stone		
Storefront	Aluminum		
Other Windows	Aluminum Double Hung		
Visible Roof Materials			
Overall Condition	Good		
Notable Features	<div style="border: 1px solid black; height: 60px; width: 100%;"></div>

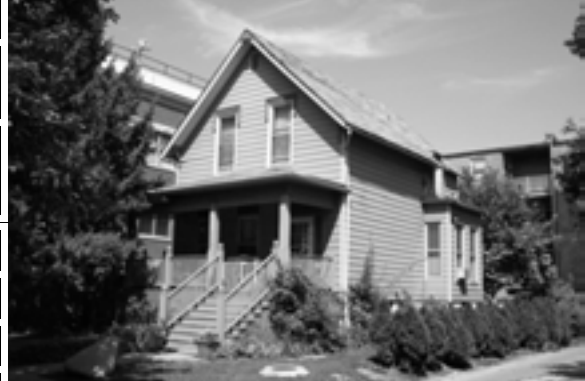
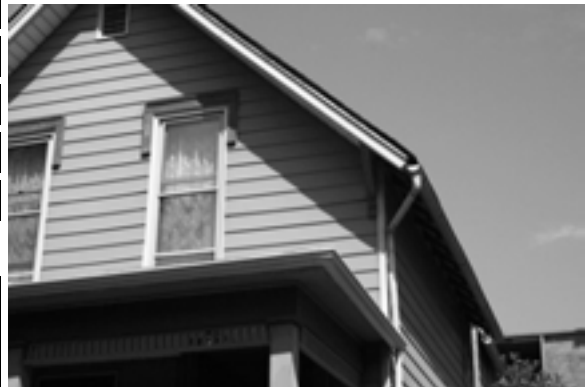
Front Orientation	<input type="text" value="W"/>	Number of Stories	<input type="text" value="2"/>
-------------------	--------------------------------	-------------------	--------------------------------

Overall Condition	<input type="text" value="Fair"/>
-------------------	-----------------------------------

<input type="text" value="Wood brackets at eaves, window hoods"/>

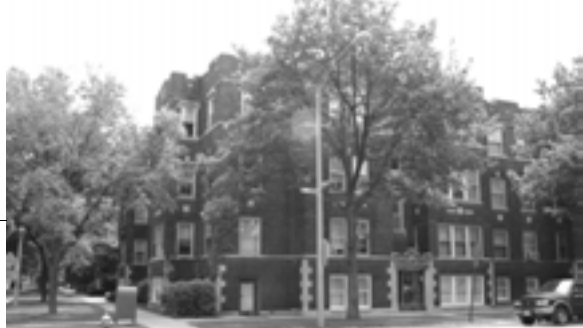
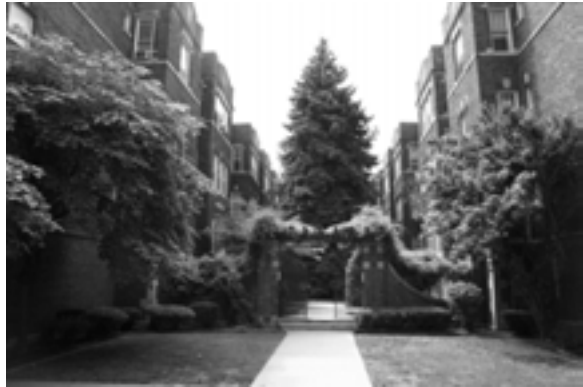
16-08-301-002

Front Orientation	NE	Number of Stories	3
-------------------	----	-------------------	---

Overall Condition	Fair
-------------------	------

Entrance surrounds	
--------------------	--

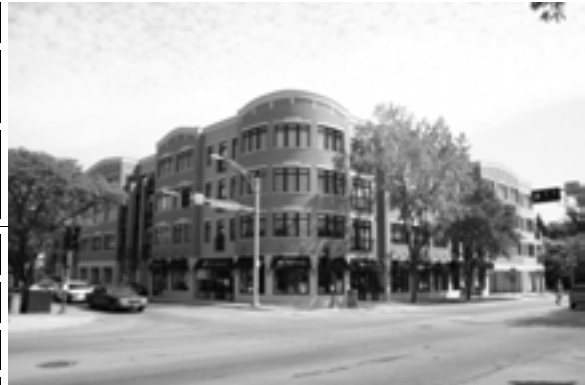
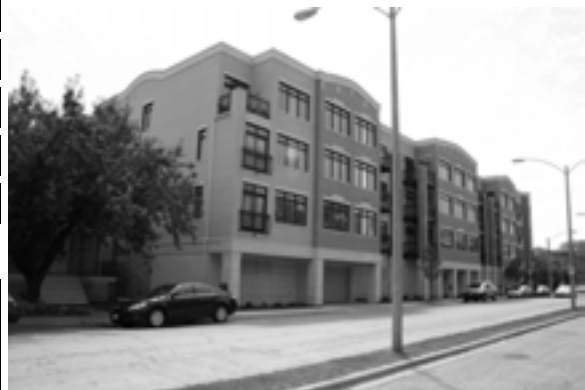
Front Orientation	<input type="text" value="NW"/>	Number of Stories	<input type="text" value="4"/>
Style/Detailing	<input type="text" value="Contemporary"/>		
Wall Material(s)	<input type="text" value="Brick"/>		
	<input type="text" value="Cast Stone"/>		
Storefront	<input type="text" value="Aluminum"/>		
Other Windows	<input type="text" value="Aluminum Casement"/>		
Visible Roof Materials	<input type="text"/>		
Overall Condition	<input type="text" value="Good"/>		
Notable Features	<input type="text"/>

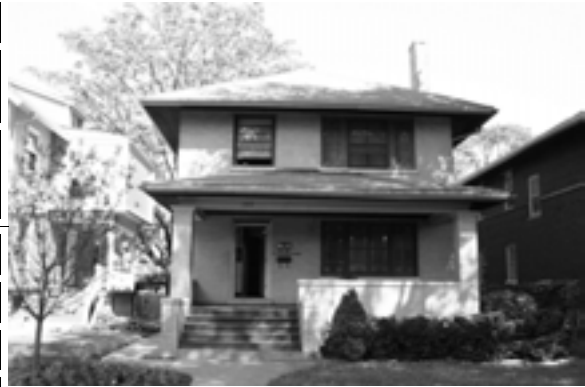
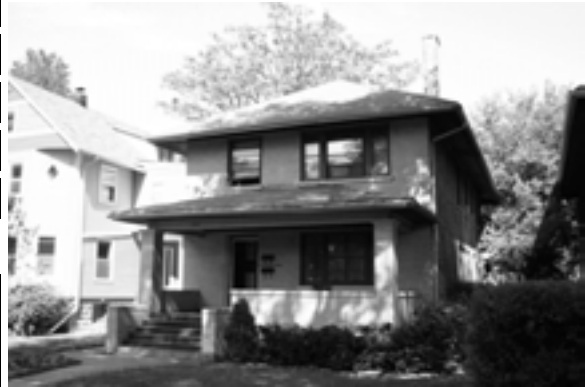
Front Orientation	<input type="text" value="W"/>	Number of Stories	<input type="text" value="2"/>
Style/Detailing	<input type="text" value="Craftsman/Arts and Crafts"/>		
Wall Material(s)	<input type="text" value="Brick"/>		
	<input type="text" value="Limestone"/>		
	<input type="text" value="Wood Siding"/>		
Storefront	<input type="text"/>		
Other Windows	<input type="text" value="Wood Casement"/>		
Visible Roof Materials	<input type="text" value="Asphalt Shingle"/>		
Overall Condition	<input type="text" value="Good"/>

Date or Approx. Decade	<input type="text" value="1908"/>	Original or Prior Uses	<input type="text" value="Two-flat"/>
Architect	<input type="text"/>	Additions/Alterations	<input type="text" value="generally unaltered, a few windows replaced"/>
Contractor	<input type="text" value="Henry Hogans"/>		
Original Owner	<input type="text" value="Thomas and Minnie Woods (?)"/>	History Notes

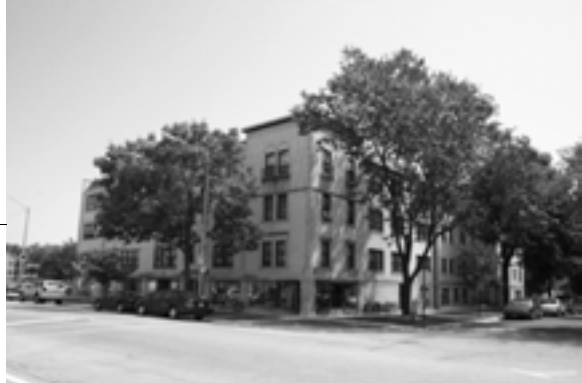
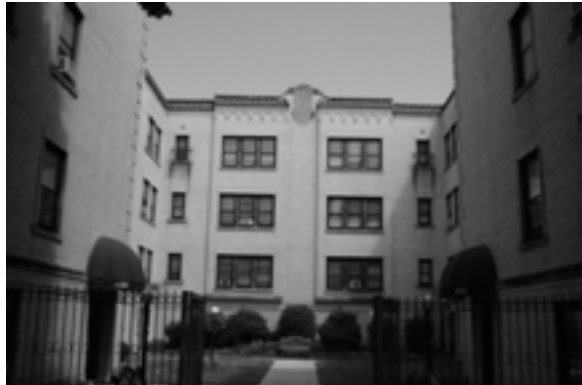
Front Orientation	<input type="text" value="NW"/>	Number of Stories	<input type="text" value="4"/>
Style/Detailing	Mission		
Wall Material(s)	Brick		
	Limestone		
Storefront	Steel		
Other Windows	Wood Double Hung		
Visible Roof Materials	Clay Tile		
Overall Condition	Good

Brick details
Iron "balconies" and brackets

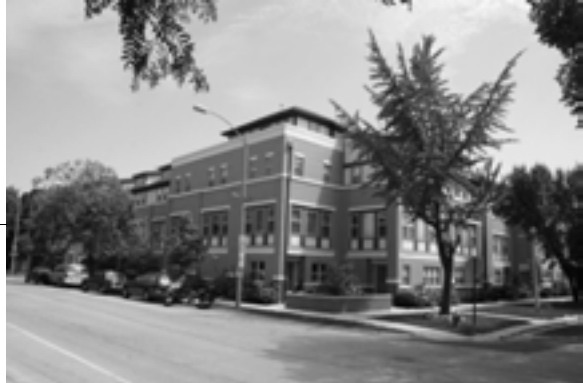
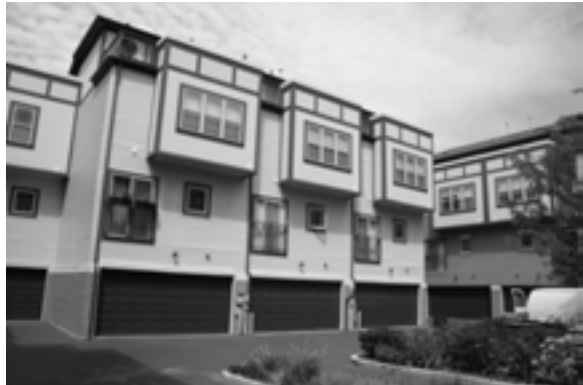
255 – South Boulevard

Front Orientation	<input type="text" value="NW"/>	Number of Stories	<input type="text" value="4"/>
Style/Detailing	<input type="text" value="Contemporary"/>		
Wall Material(s)	<input type="text" value="Brick"/>		
	<input type="text" value="Cast Stone"/>		
	<input type="text" value="Vinyl Siding"/>		
Storefront	<input type="text"/>		
Other Windows	<input type="text" value="Aluminum Double Hung"/>		
Visible Roof Materials	<input type="text" value="Asphalt Shingle"/>		
Overall Condition	<input type="text" value="Good"/>

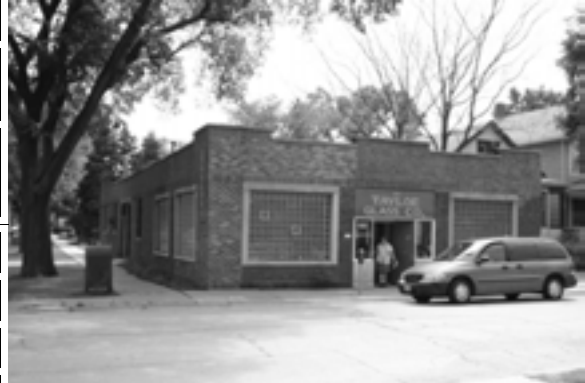
16-08-300-009

Front Orientation	N	Number of Stories	1
Style/Detailing			
Wall Material(s)	Brick		
	Limestone		
Storefront	Glass Block		
Other Windows			
Visible Roof Materials			
Overall Condition	Fair

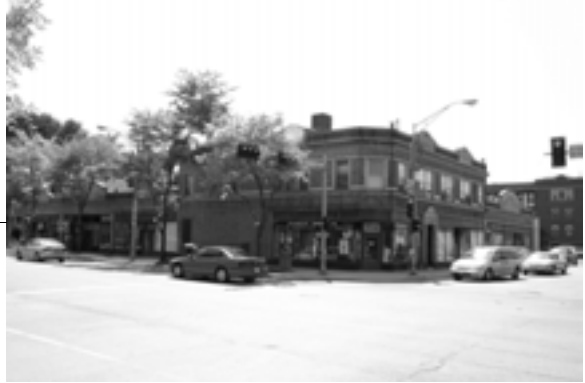
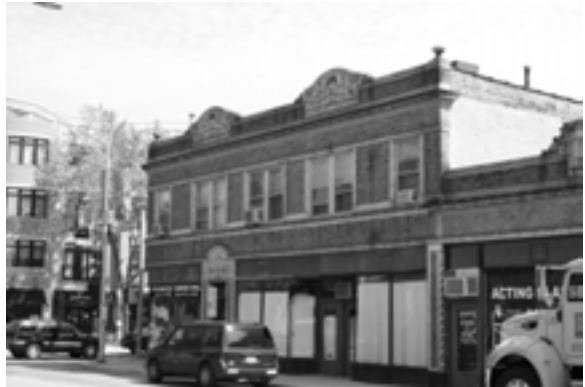
Front Orientation	<input type="text" value="NE"/>	Number of Stories	<input type="text" value="2"/>
Style/Detailing	<input type="text" value="Commercial"/>		
Wall Material(s)	<input type="text" value="Brick"/>		
	<input type="text" value="Terra Cotta"/>		
	<input type="text"/>		
Storefront	<input type="text" value="Steel"/>		
Other Windows	<input type="text" value="Wood Double Hung"/>		
Visible Roof Materials	<input type="text"/>		
Overall Condition	<input type="text" value="Good"/>

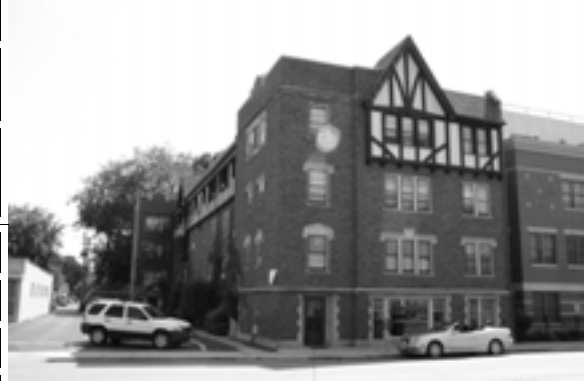
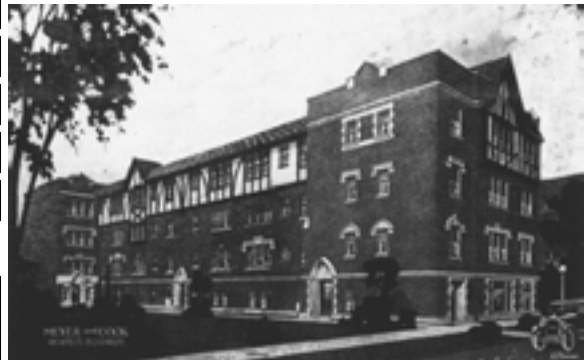
Map ID Number 155 PIN Number 16-07-405-005

Front Orientation	NE	Number of Stories	4
Style/Detailing	Tudor Revival		
Wall Material(s)	Brick		
	Limestone		
	Stucco		
Storefront	Steel		
Other Windows	Wood Double Hung		
Visible Roof Materials	Asphalt Shingle		
Overall Condition	Good

Nicely detailed half-timber at projecting side bay and north elevation.

Exterior is generally unaltered from original design. Slate roof was replaced with asphalt shingles in 2002.

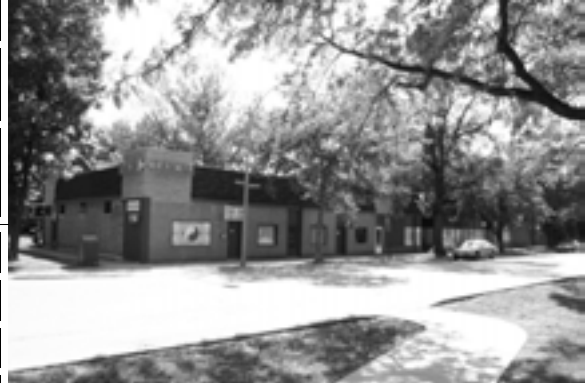
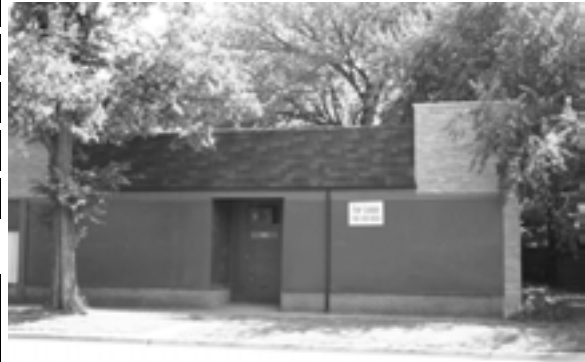
Front Orientation	<input type="text" value="N"/>	Number of Stories	<input type="text" value="1"/>
Style/Detailing	<input type="text" value="Commercial"/>		
Wall Material(s)	<input type="text" value="Brick"/>		
	<input type="text"/>		
	<input type="text"/>		
Storefront	<input type="text" value="Filled in/Aluminum"/>		
Other Windows	<input type="text" value="Aluminum Fixed"/>		
Visible Roof Materials	<input type="text" value="Asphalt Shingles"/>		
Overall Condition	<input type="text" value="Fair"/>

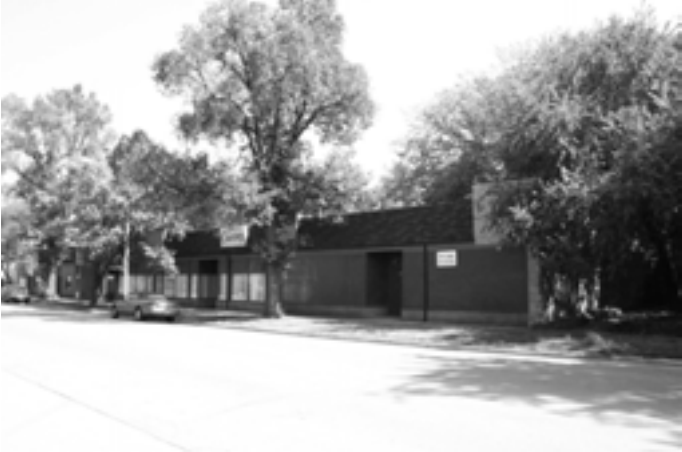
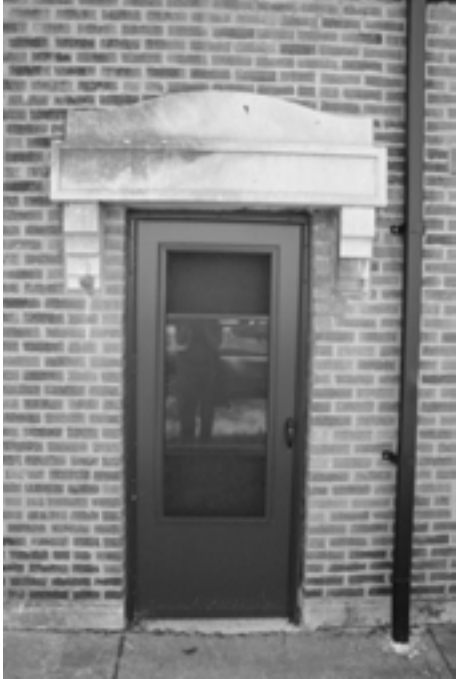
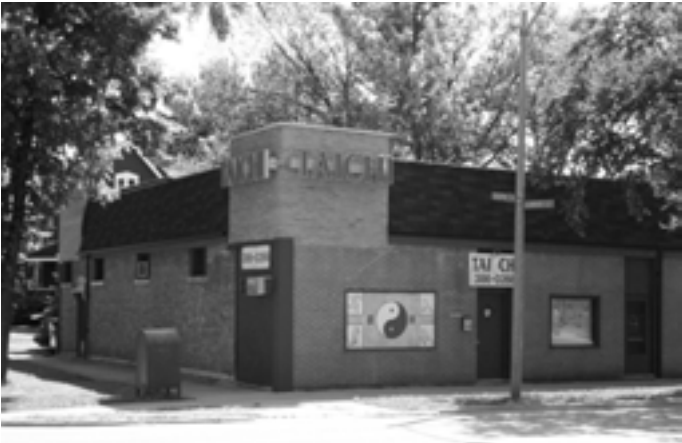
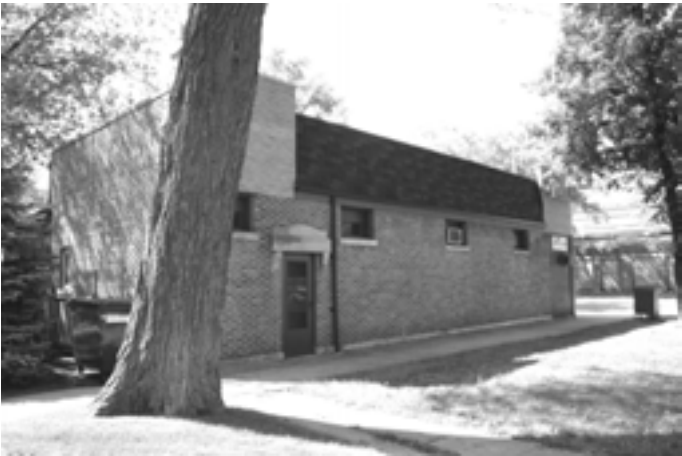
433 – 451 South Boulevard

Map ID Number 158 PIN Number 16-07-404-004
