OAK PARK POLICE DEPARTMENT

SPACE NEEDS ASSESSMENT

November 25, 2019
FGM # 19-2639.01

Existing Condition Analysis

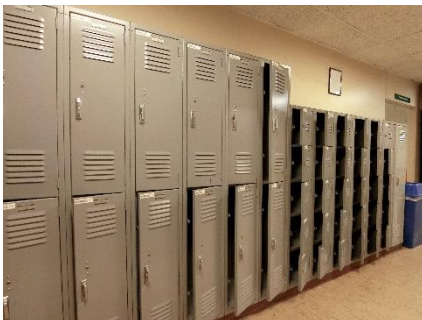
Evidence lockers located in hallway

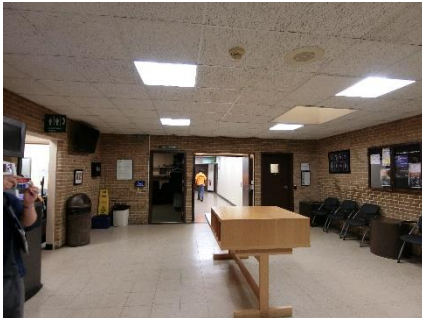
Unsupervised public corridor to elevator

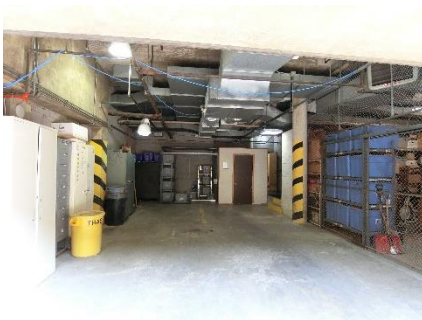
Unsecured access from Sally port to building storage

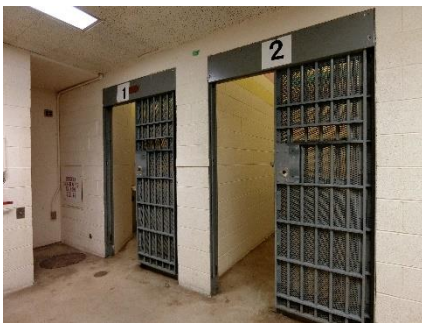
Holding Cells

- Cells fronts and doors are older style bars that have been covered with wire mesh to reduce hazards and ligature (hanging) issues. They do not provide any sound separation.

- Steel bunks are not anti-ligature (anti-hanging) design.
- The emergency eyewash is located directly in the main cell corridor and could be a tripping hazard.

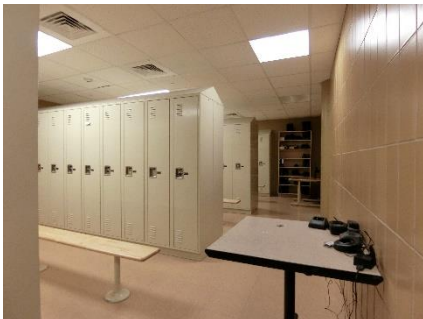
Men's Locker Room

- Locker Rooms:** Since the building was constructed, the amount of gear issued to police officers has increased. Lockers now must store a multitude of items, including training manuals, bulletproof vests, specialized protective equipment, and weapons. This has necessitated a need for larger lockers. Today, the smallest locker typically provided for police officers is 24"wide x 24" deep.

The locker room lockers were originally 12"wide x12"deep. At some point, they were changed to 15"wide x12" deep, reducing the number of lockers and necessitating the creation of a male sergeant's locker room and a command locker area in other areas of the Police Station.

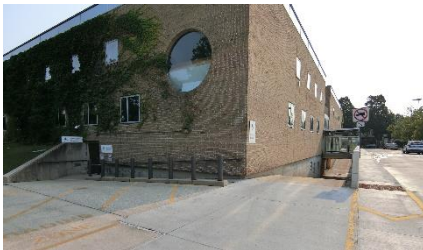
Non-compliant ADA ramp

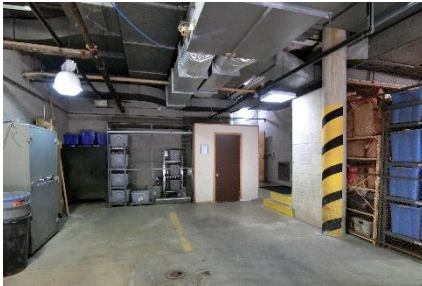
No ADA access to Sally Port

- Multiple doors throughout the station lack the required ADA push/pull door clearances.
- There is no ADA access to the Sally Port. There is a landing approximately 14" above the Sally Port floor with two steps. There is no guardrail or handrail at the stairs or landing.

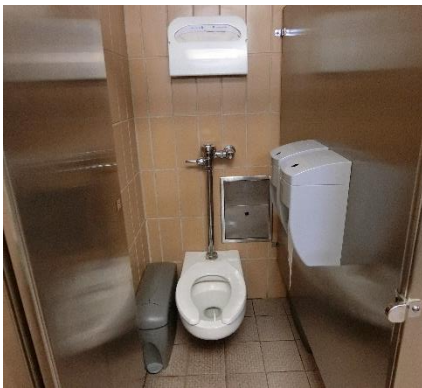
Inaccessible toilets in locker rooms

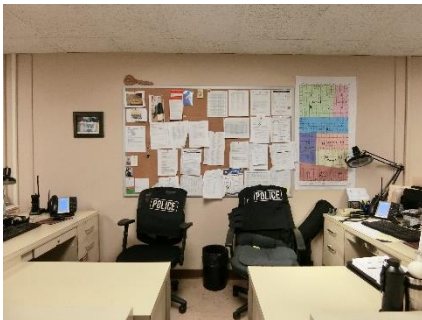
Inaccessible workstation

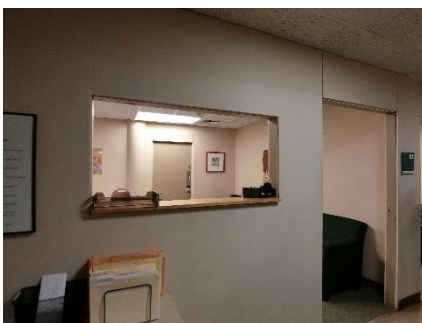
Non-ADA compliant service window

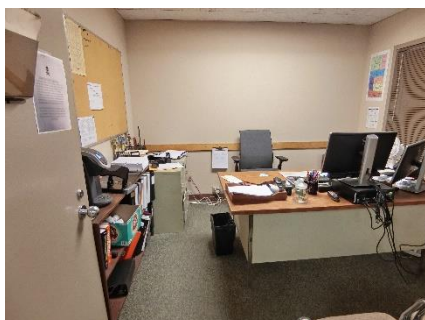
Extension cords laying on floor due to insufficient electrical outlets

- Due to age of building there is a lack of electrical and data outlets, cords are draped over furniture and across cabinets throughout the building.
- Within the Administration Department extension cords are lying across walkways creating a tripping hazard.
- Within the lobby conference room, temporary partition walls have been added to the west and south walls creating mechanical and electrical closets. These closets lack the required signage and fire ratings.
- A mechanical closet is located within the Crime Analyst's Office. This equipment should be accessible from the main corridor and not require access through a private office.
- Files and boxes being stored within 24" of ceiling
- Lighting levels within the Building Maintenance Department are too low.
- There is no free exit from the Mechanical Room. This door requires free egress.

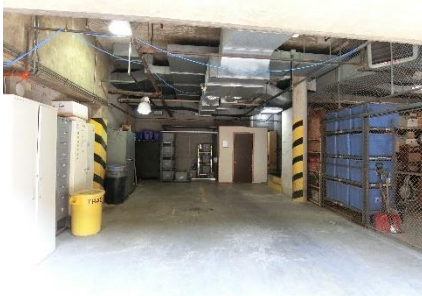
Walls within Sally Port lined with storage

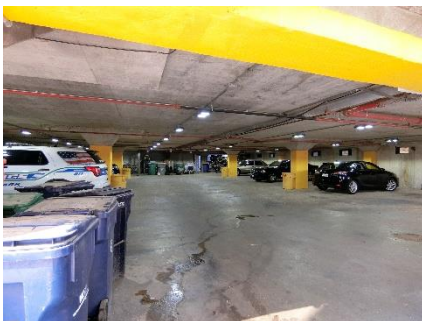
Steep slope and low head clearance at parking garage

- Snowplows and garbage trucks cannot access the bottom of the ramp and garage due to the steep slope and low headroom clearance.
- The floors and ceiling are showing signs of damage. The concrete around the trench drains is spalling and cracking. The concrete roof deck is spalling, exposing rebar which is rusting and corroding due to exposure to the elements.
- There is seepage in the garage which is likely caused by blocked or collapsed drain tile within the garage.
- The conduit surrounding the main data line connecting the communications tower to the building appears to be severely damaged and is exposing the cabling to water.

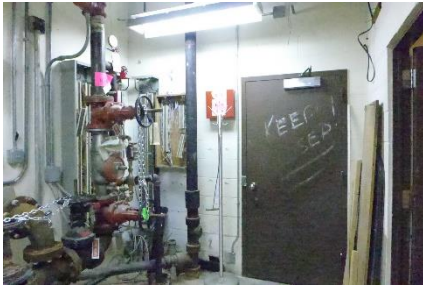
Unsecured door leading to detention area

- Currently loose ammunition is being stored within the range control room which is left unsecured.
- There is an unlocked door leading directly to the detention cell corridor.

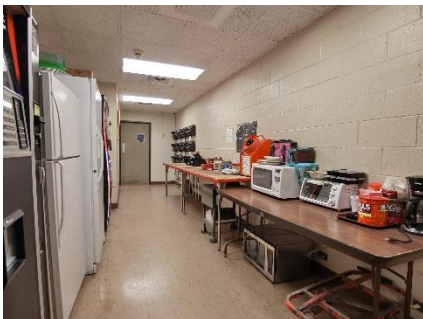
Staff break area shared with gun cleaning

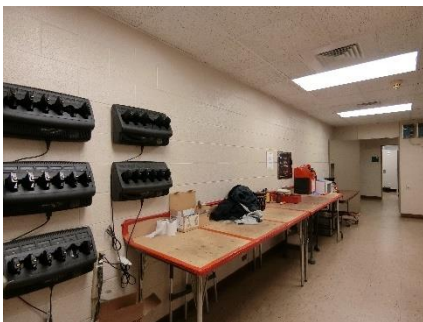
Lack of seating and natural daylight at staff break area

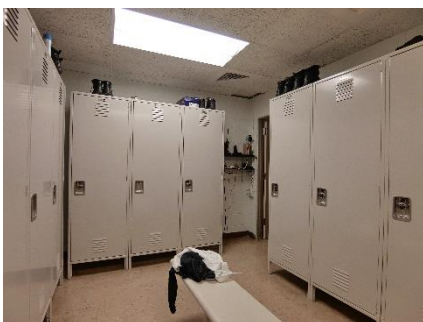
Lack of storage within sergeant's locker room

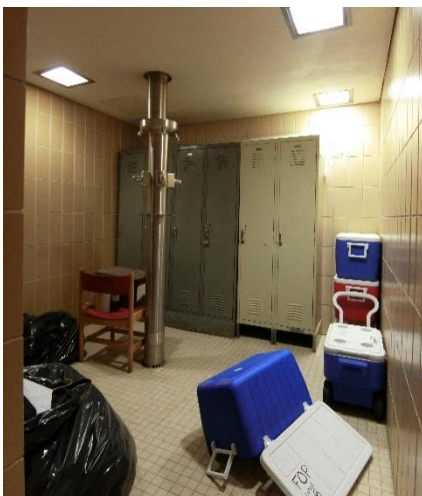
- In both the men's and women's locker rooms, the shower areas are being used for storage.
- The rooms are too small forcing the sergeants and administration lockers to be located elsewhere.
- The lockers are too small to provide proper boot storage and are insufficient in size for the officers.
- There is a lack of storage throughout for radios and equipment.

Men's shower being used for storage

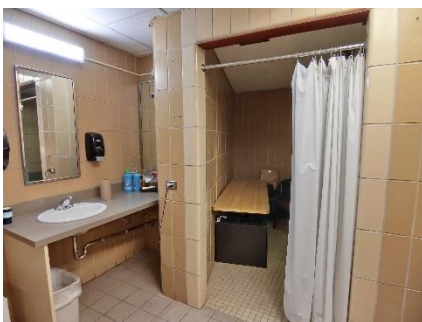
Poor layout at vanity within women's locker room

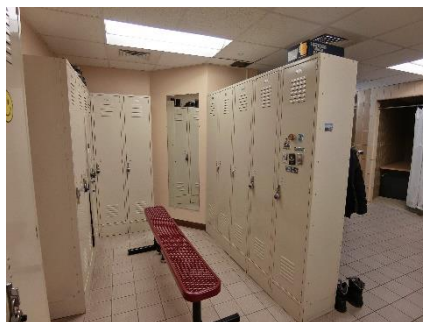
Insufficient space for storage and circulation

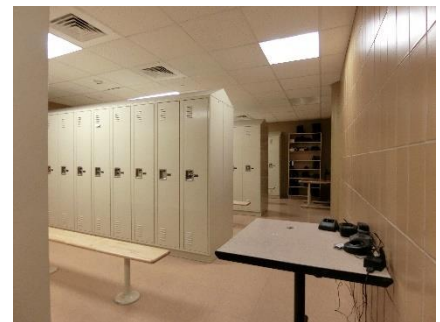
Lockers size is insufficient

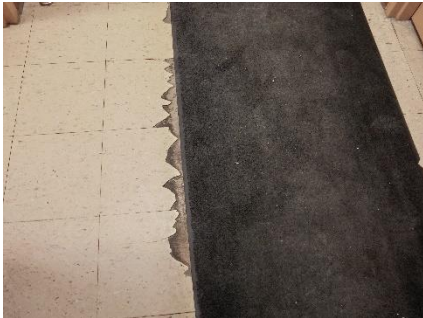
Chipped flooring outside conference room

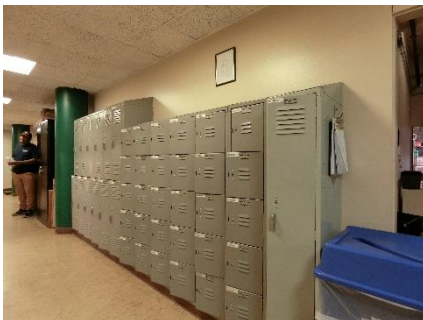
Evidence lockers located in the main corridor

- Due to overcrowding, the evidence lockers cannot be located near the bag and tag area and have been put in the main corridor. This location is not recommended as it requires moving evidence through the main circulation corridor.
- The bag and tag area is currently being shared with the evidence processing lab. The space is too small and does not allow for proper layout, circulation or processing space. There is insufficient space for storage and an overcrowding of equipment. In order to perform a task several items need to be relocated in order to access the required equipment.

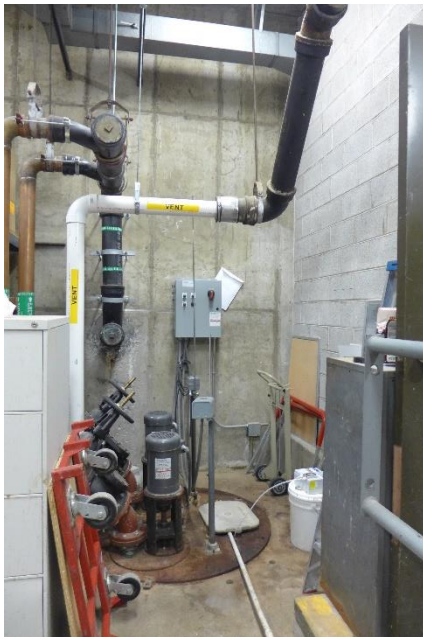
The existing ejector and sump pumps appear to have been replaced given their modern appearance. The condition of the main hot and cold water lines is unknown, but likely are galvanized pipe due to the age of the building. Over time the pipes will deteriorate. If the main lines have never been replaced, they will likely need replacement in the near future.

Existing ejector and sump pumps

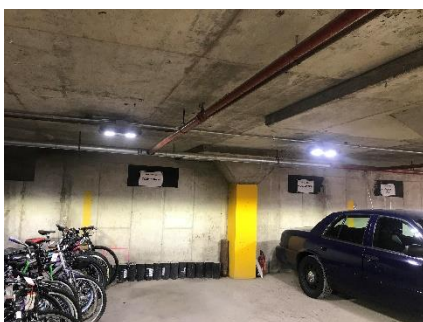
Fire protection throughout the Police Department seems nominal except where it is installed and visible within the squad parking garage. The garage is open to the outdoors and deterioration to the sprinkler piping is occurring. Sections of piping have recently been replaced but this will be an ongoing maintenance item.

Recently replaced sprinkler piping

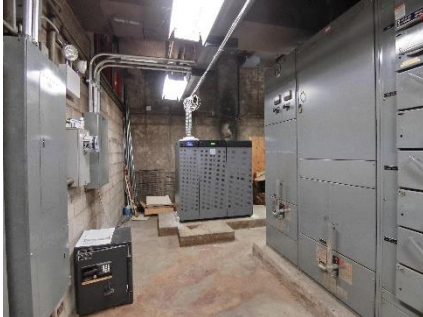
Main electrical room

The main switchboard is original to the building and is a Square D manufactured assembly labeled with a rating of 2000 amps, 208 volts, three-phase, four-wire. There are two main disconnect switches provided, one 800 amp three-pole switch supplying the facility chiller equipment and one 1200 amp three-pole switch supplying the rest of the building power. Each additional vertical switchboard section is rated for 1200 amps which limits the largest feed the board can supply to 1200 amps. The switchboard is in fair condition. The switchboard, excluding the cooling load, has recently been re-worked to feed through a full building transfer switch at the end of the switchboard lineup.

recommended. Typical expected useful service life of electrical service gear is approximately forty to fifty years. The existing service gear is nearing the end of its expected service life in approximately five years.

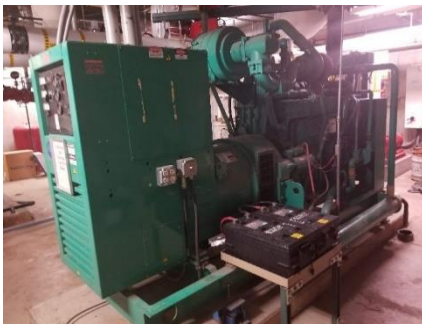
There is an 325kw/406kva natural gas fired Cummins Power Generation backup generator set installed in the basement northwest mechanical area. The generator has a start-up date of 11/99 listed on the control cabinet. The 1200 amp, 3-pole transfer switch in the main electrical room appears to be new and recently installed. The generator set is in fair condition at twenty years of age and has a typical expected service life of approximately thirty years. The back-up generator system appears to power the entire facility, excluding the chiller load. The output and loads supplied are adequate for a facility of this type and size.

Main gas-fired back-up generator set

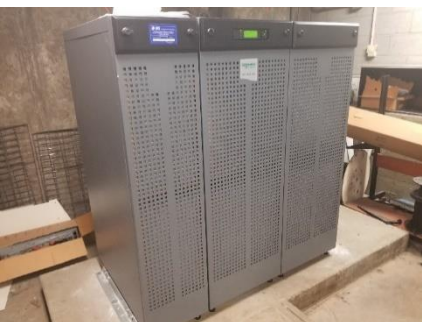
There is an MGE 3500 Schneider central UPS system located within the main electrical service room that provides battery back-up for the critical equipment. The UPS system is newer and in overall good condition. The output and loads supplied appear to be adequate for a facility of this type and size. Typical expected useful service life of electrical uninterrupted power supply systems is approximately 15 to 20 years.

UPS battery back-up system

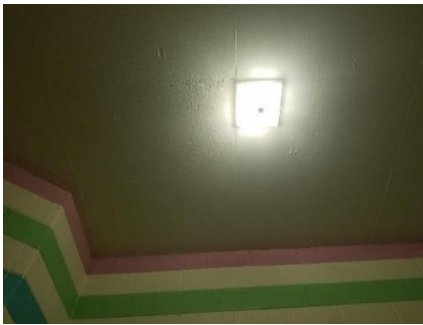
Typical detention cell lighting fixtures

The booking and detention areas of the police station do not have appropriately constructed vandal-proof detention rated light fixtures. The fixtures in the booking area are standard troffer fixtures and in the cells are exterior grade lights. The fixtures themselves are in fair condition.

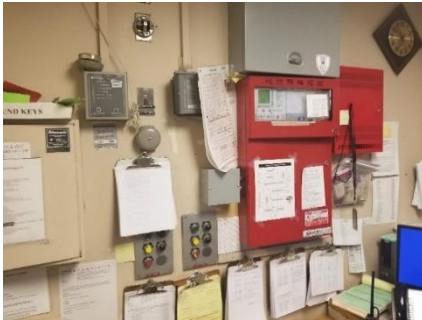
Fire alarm main control panel

The building has a complete addressable Quickstart electronic fire alarm detection and annunciation system, manufactured by Edwards Systems Technologies. Wireless alarm transmitter(s) were noted as well. The general coverage for detection and annunciation appear typical but minimal for a building of this age, type and use. The system is an older model with mixed manufacturer and age devices installed. The devices are in fair condition. The building does not have any fire sprinkler protection installed in the occupied spaces. Sprinkler protection was visible only within the garage areas so it could be monitored by the fire alarm system. Typical expected useful service life of electronic addressable fire alarm systems is approximately 15 to 20 years.

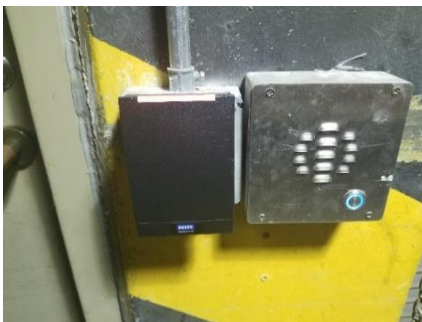
The building has a central sound/paging and intercom system with the head-end unit located at the front transaction counter. The system is quite old and in poor condition. Newer intercom devices, which may have taken the place of the old system devices, have been installed. There are modern card access devices and IP based security cameras installed throughout that are in fair condition. Typical expected useful service life of electronic telecommunications systems and equipment is approximately 7 to 10 years maximum.

Intercom call and electronic security reader
