## SOUTH TOWN DISTRICT SURVEY FINDINGS

May, 2010

# Survey Findings for the South Town District

School of the Art Institute  
Historic Preservation Program  
Professor Vincent L. Michael, PhD

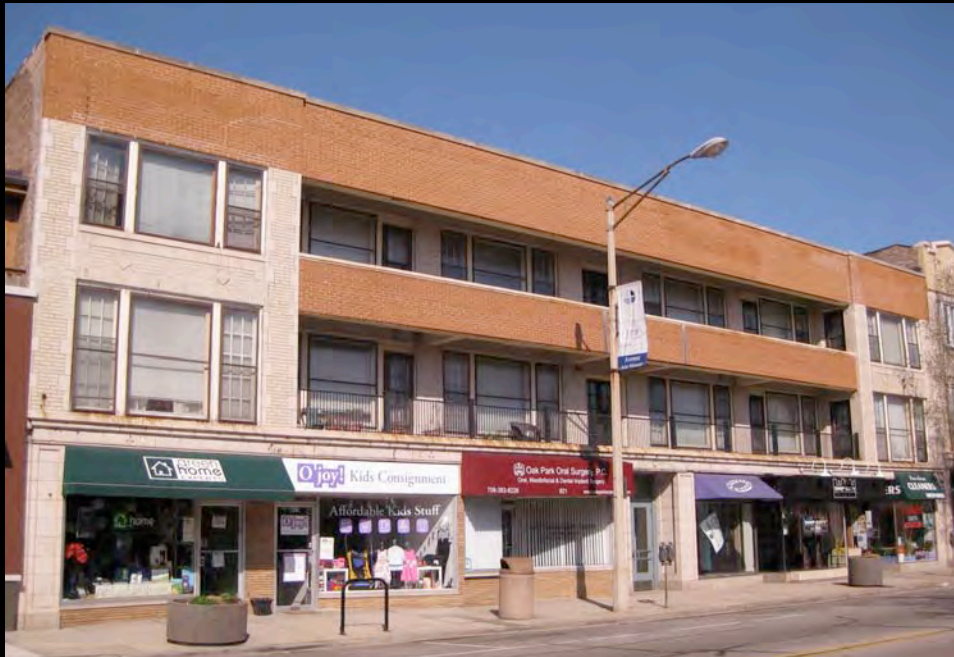
817 - 821 S. Oak Park

Built: 1922

Original use: mixed - The  
Community Arcade

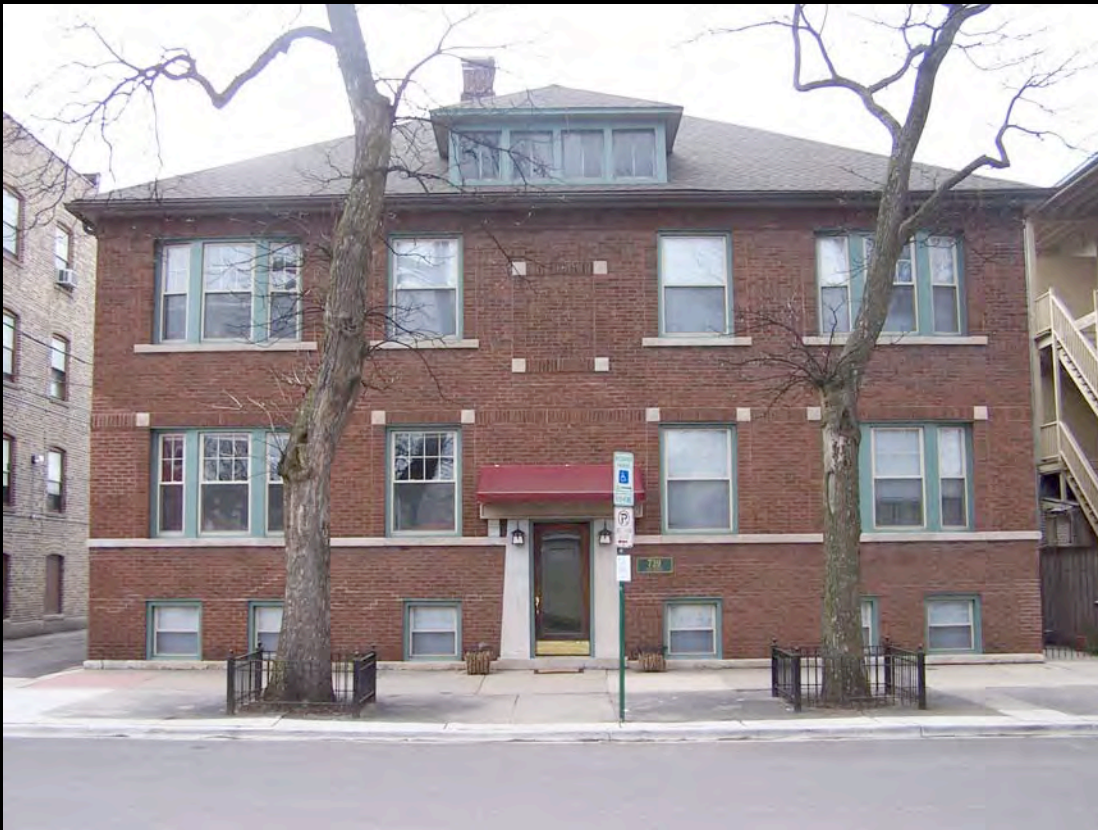
739 Van Buren

Built: 1910s

Serves original purpose as  
apartment building

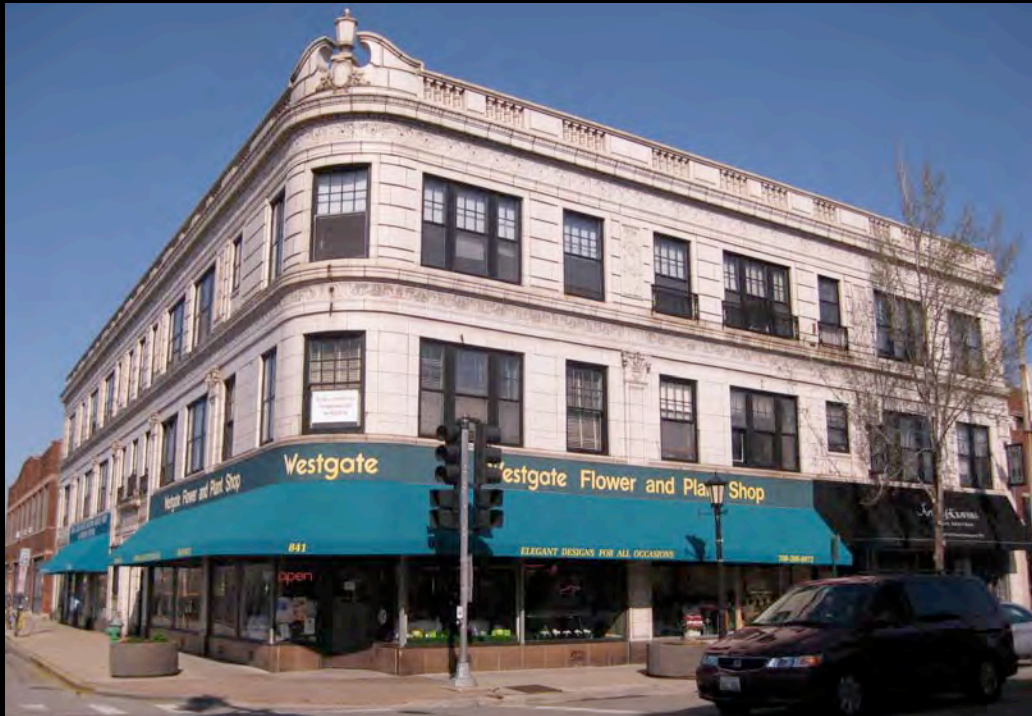
833-841 S. Oak Park

Built: 1928

Architect: Peter Nielsen

Original use: storefronts and  
"Suburban Apartments"

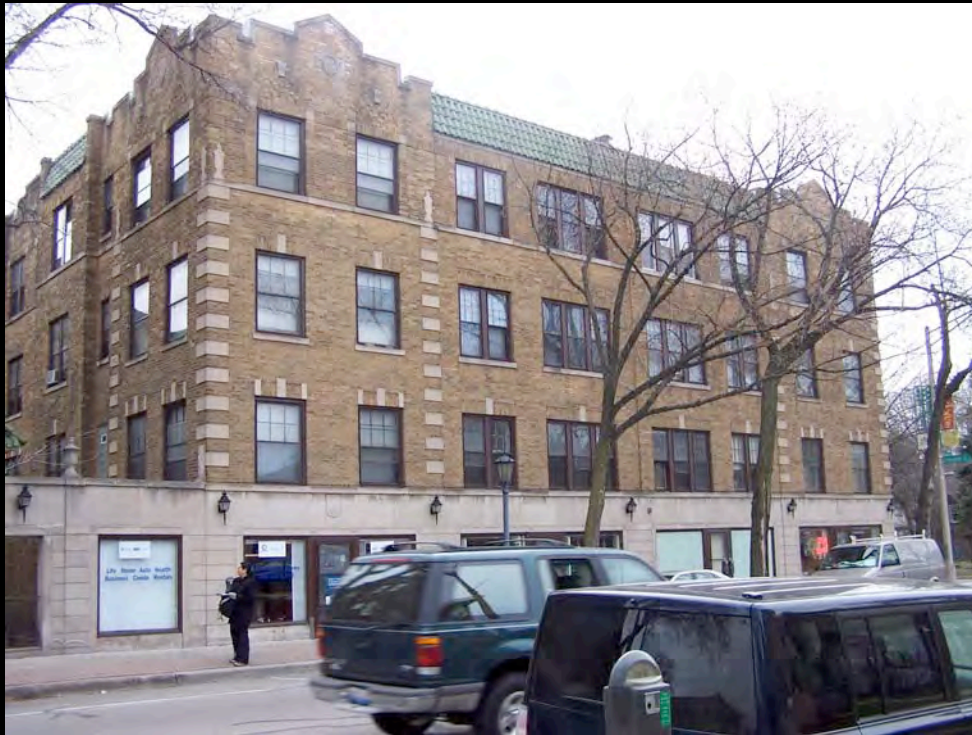
944-964 S. Oak Park  
Built: 1925  
Contractor: Sam Fishkin  
Client: Nathan Schoenbard  
Garden level store fronts

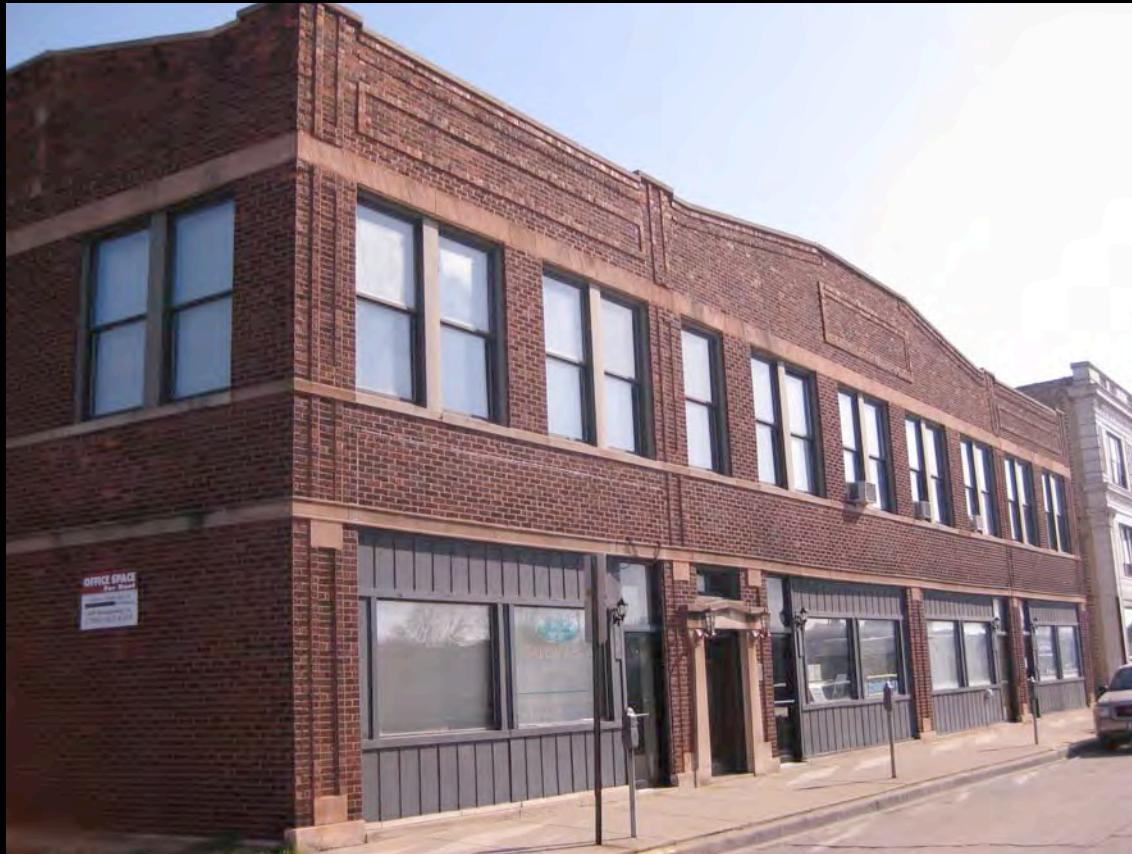
812 - 818 Harrison

Built: 1916

Original use: Oddfellows Hall

Builder: Harry Cotton

Designated Oak Park  
Landmark, 2003

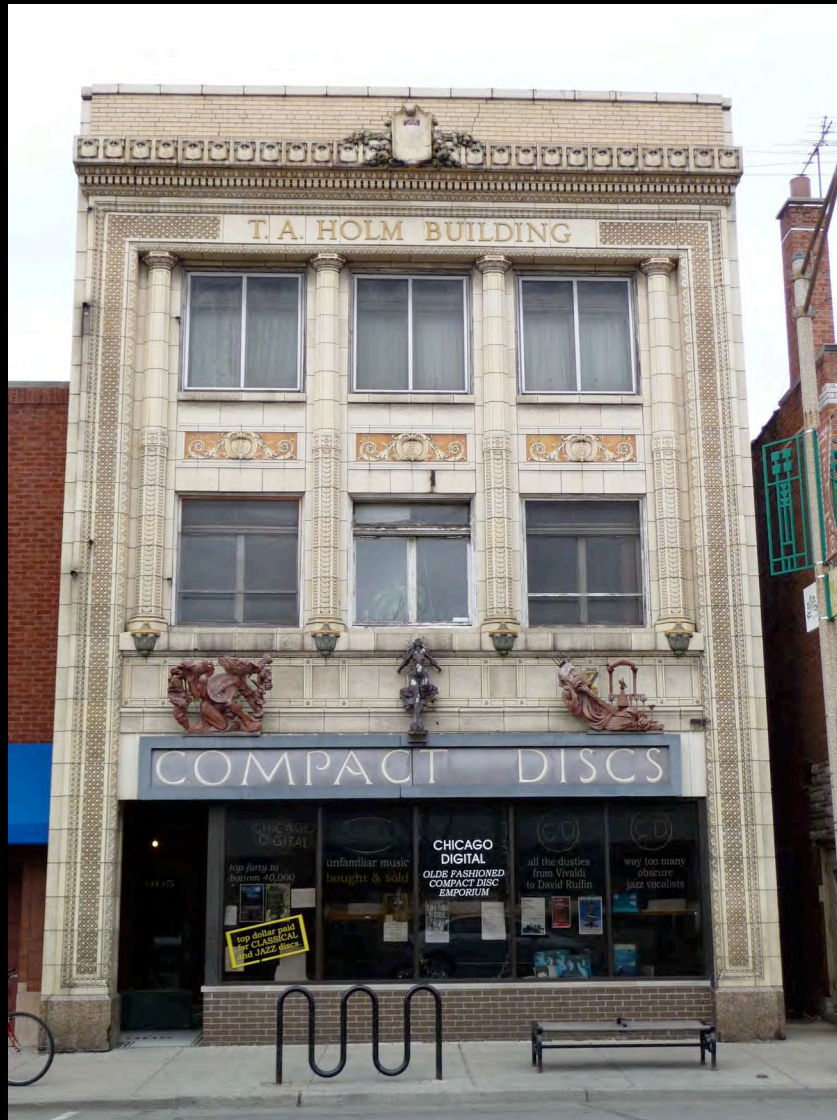
905 S. Oak Park

Built: 1926

Original owner: T.A. Holm

Original use: Real estate offices

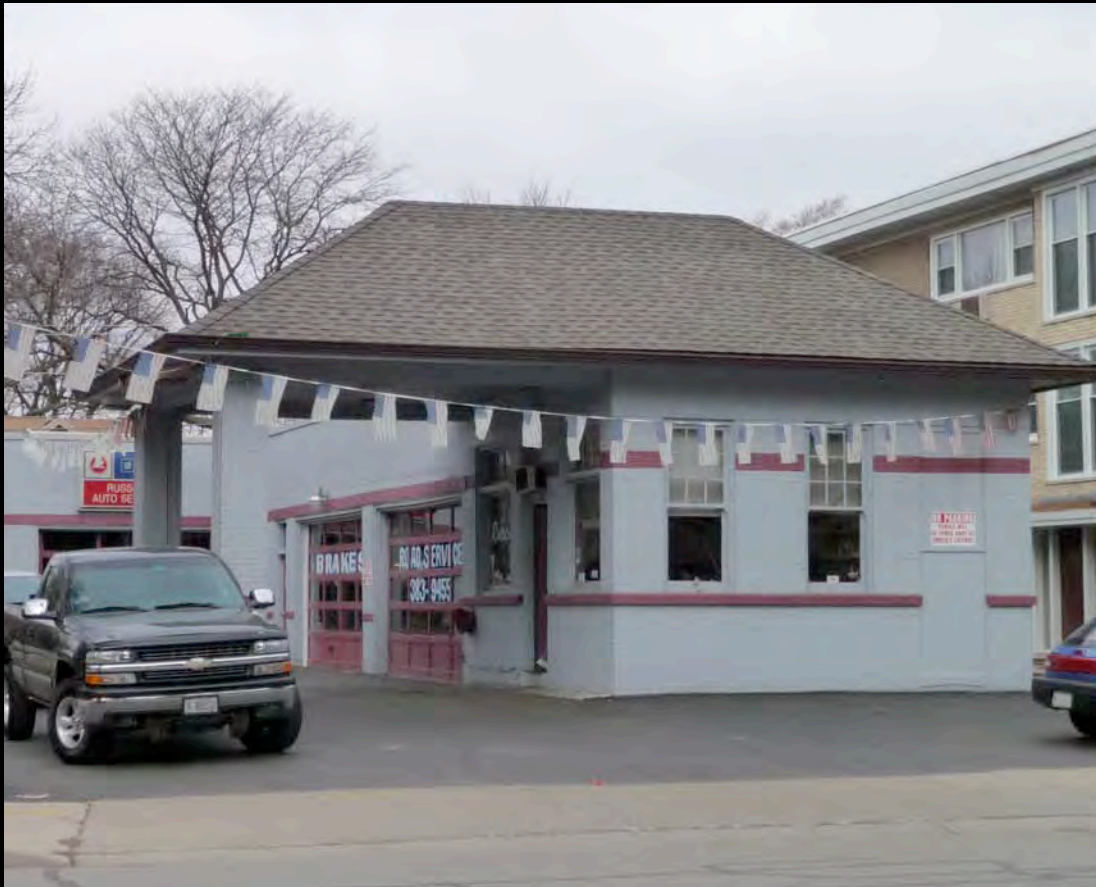
945 S. Oak Park

Built: 1926

Original owner: Mabel  
Sinclair

Original use: gas station

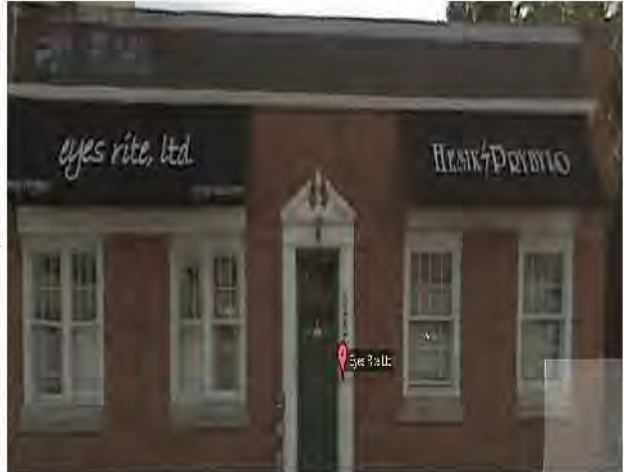
Address	821 Garfield	Map ID Number	W12	PIN Number	
Significance	No Merit				
Current Owner					
Current Use	Commercial

Front Orientation	N	Number of Stories	1
Style/Detailing			
Wall Material(s)	Brick		
Storefront			
Other Windows			
Visible Roof Materials			
Overall Condition			
Notable Features

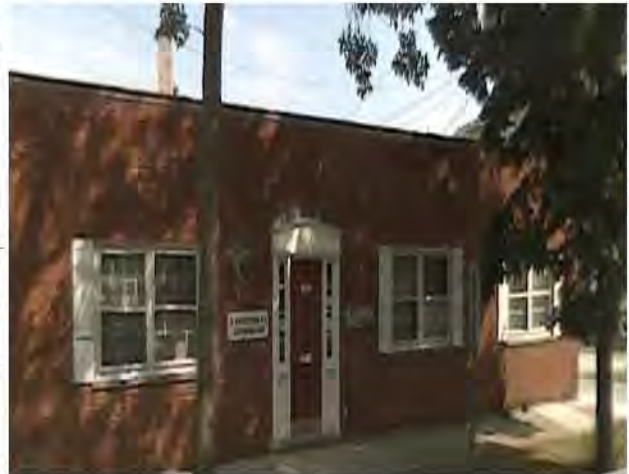
Address	914 S. Grove	Map ID Number	W13	PIN Number	
Significance	No Merit				
Current Owner					
Current Use	Commercial

Front Orientation	W	Number of Stories	1
Style/Detailing			
Wall Material(s)	Brick		
Storefront			
Other Windows			
Visible Roof Materials			
Overall Condition			
Notable Features

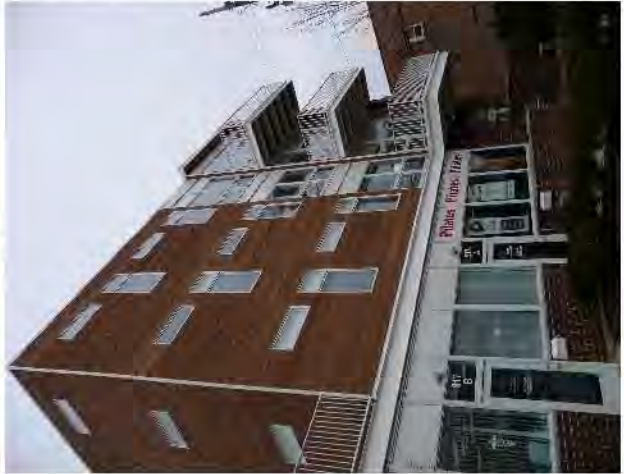
Address	917 S. Oak Park	Map ID Number	W5	PIN Number	
Significance	No merit				
Current Owner					
Current Use	commercial and residential

Front Orientation	E	Number of Stories	4
Style/Detailing			
Wall Material(s)	glass		
	brick		
	wood paneling		
Storefront			
Other Windows			
Visible Roof Materials			
Overall Condition			
Notable Features

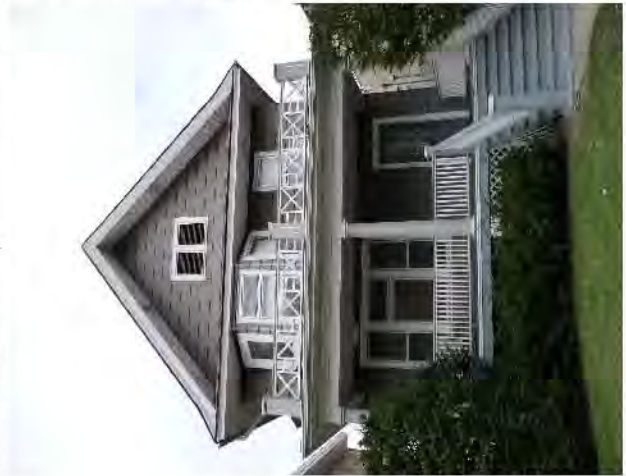
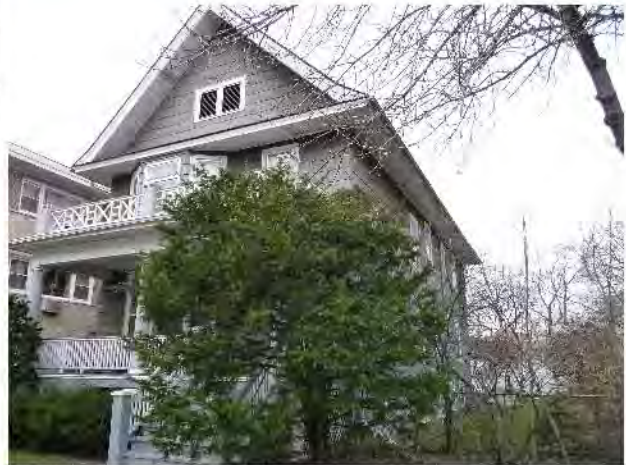
Overall Condition fair

Doric porch columns, some stained glass windows

cladding

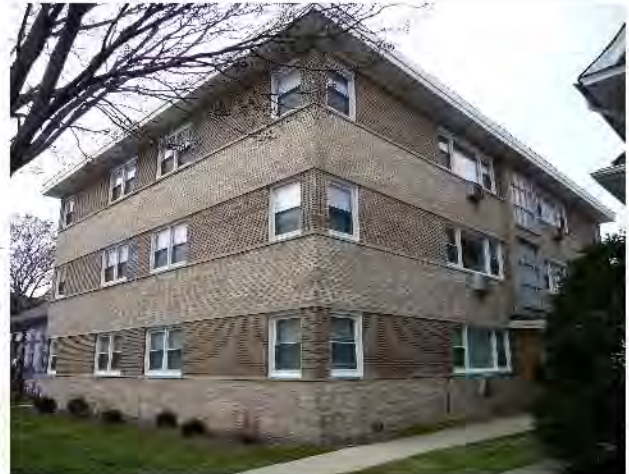
Address 929 S. Oak Park

Overall Condition good

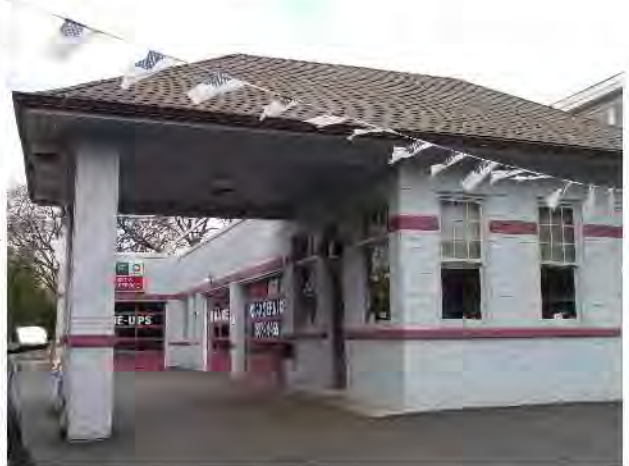
Map ID Number W1 PIN Number

Overall Condition good (restored)

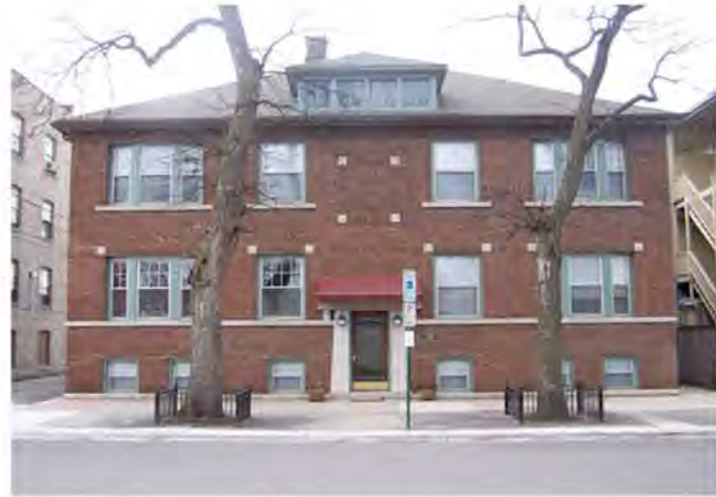
Address	739 Van Buren	Map ID Number	SE1	PIN Number	
Significance	Merit				
Current Owner					
Current Use	Residential - Apartment

Front Orientation	N	Number of Stories	3
Style/Detailing	1920s Eclectic		
Wall Material(s)	Brick, Limestone		
Storefront	N/A		
Other Windows	Vinyl		
Visible Roof Materials	Asphalt		
Overall Condition	Excellent

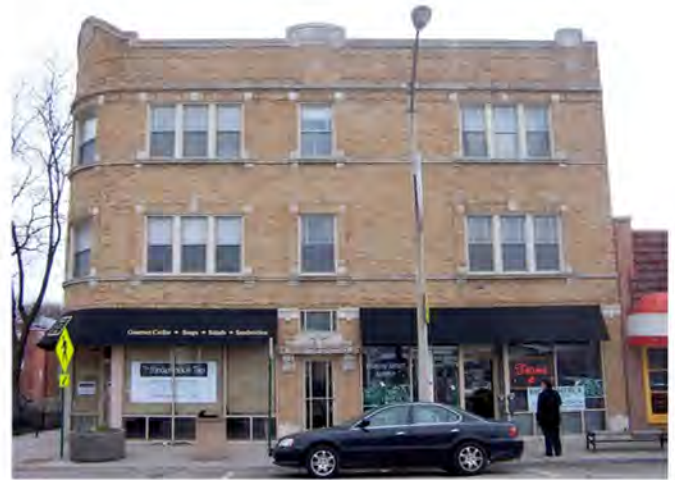
Address	800 Oak Park	Map ID Number	SE2	PIN Number	
Significance	Merit				
Current Owner					
Current Use	Mixed Use - Retail & Apartments

Front Orientation	W	Number of Stories	3
Style/Detailing	1920s Eclectic		
Wall Material(s)	Brick, Limestone		
Storefront	Aluminum		
Other Windows	Vinyl		
Visible Roof Materials	None - Parapet		
Overall Condition	Excellent

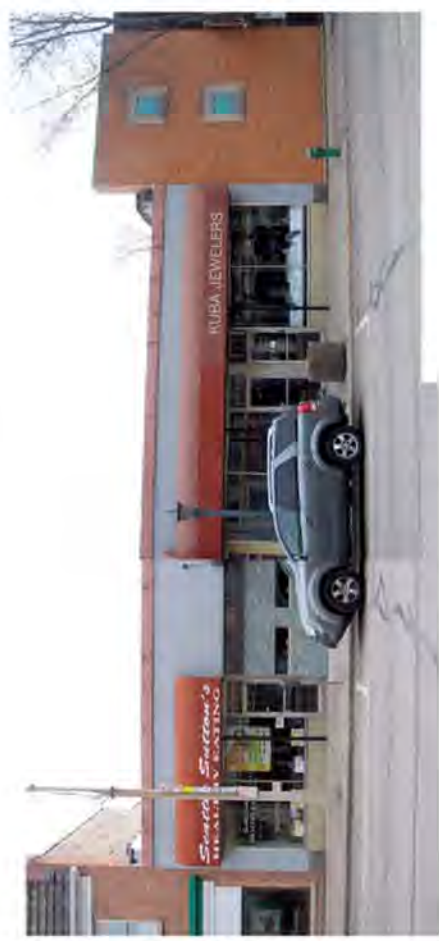
Original 1960s Beveled Storefront

814 - Slate Stone, Pebble, Wood, New Storefront Door, Aluminum Windows

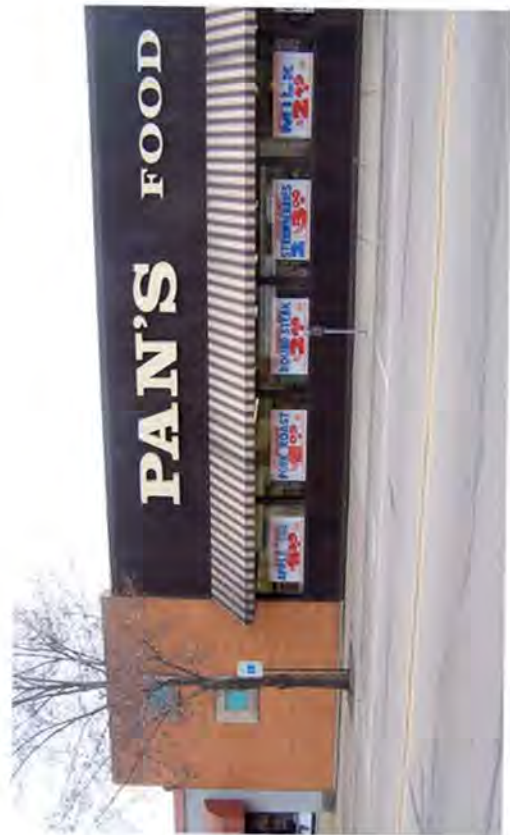
Address	824 Oak Park	Map ID Number	SE6	PIN Number	
Significance	Merit				
Current Owner	Pans Grocery				
Current Use	Pans Grocery

Front Orientation	W	Number of Stories	1
Style/Detailing	Mid Century Modern		
Wall Material(s)	Brick, Aluminum,		
Storefront	Aluminum		
Other Windows	None		
Visible Roof Materials	None		
Overall Condition	Excellent		
Notable Features

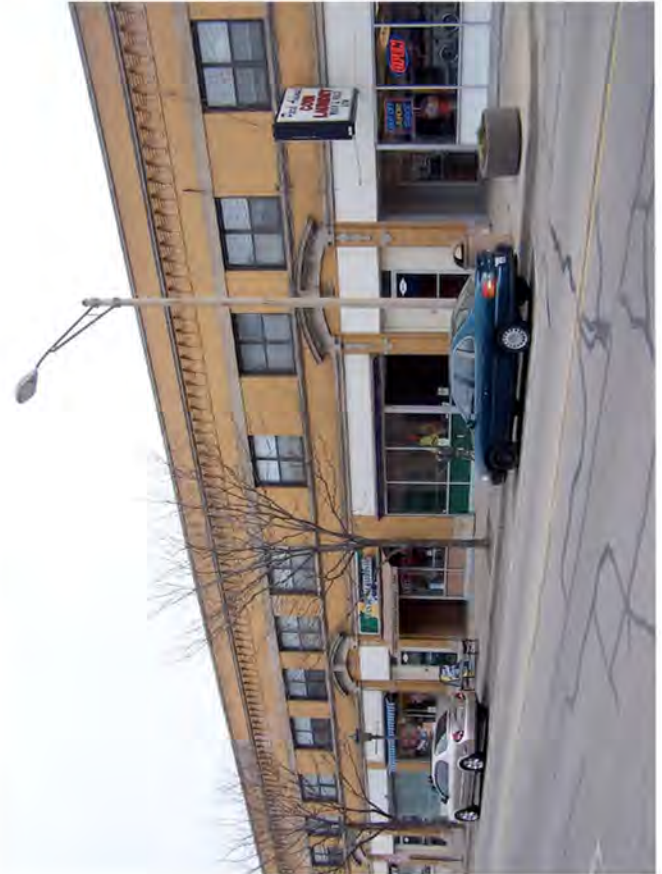
Front Orientation	<input type="text" value="W"/>	Number of Stories	<input type="text" value="2"/>
Style/Detailing	<input type="text" value="1960s Commercial"/>		
Wall Material(s)	<input type="text" value="Brick, Limestone, Mosaic Tile, Aluminum"/>		
Storefront	<input type="text" value="Aluminum"/>		
Other Windows	<input type="text" value="Vinyl"/>		
Visible Roof Materials	<input type="text" value="None"/>		
Overall Condition	<input type="text" value="Good"/>

Original Limestone Details, Brick Corbels

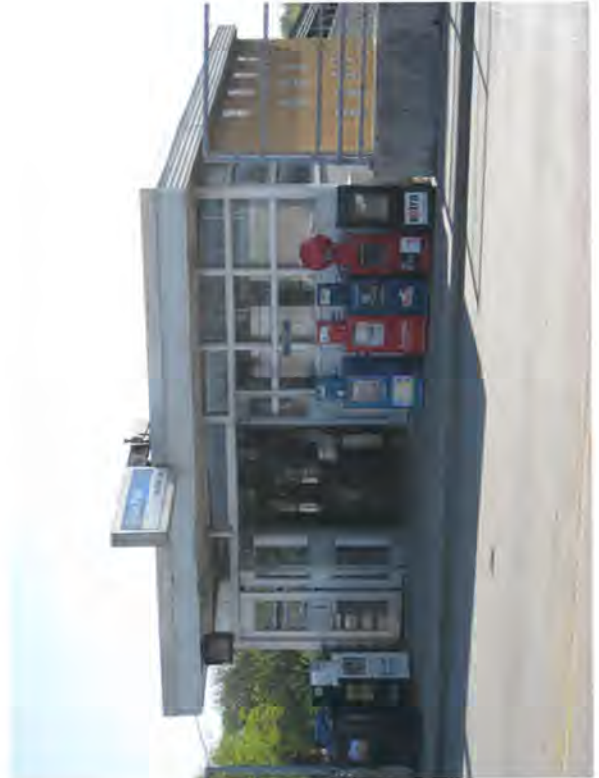
Address	950 S. Oak Park	Map ID Number	SE11	PIN Number	
Significance	Significant Merit				
Current Owner	CTA				
Current Use	"Oak Park" Blue Line Station

Front Orientation	<input type="checkbox"/>	Number of Stories	<input type="checkbox"/>
Style/Detailing	Mid Century Modern		
Wall Material(s)	Brick		
	Glass and glass block		
Storefront	<input type="text"/>		
Other Windows	Aluminum		
Visible Roof Materials	<input type="text"/>		
Overall Condition	Good		
Notable Features	<input type="text"/>
